POWER SYSTEM INCIDENT REPORT TREVALLYN POWER STATION TRIP 19 OCTOBER 2009

PREPARED BY: ESOPP

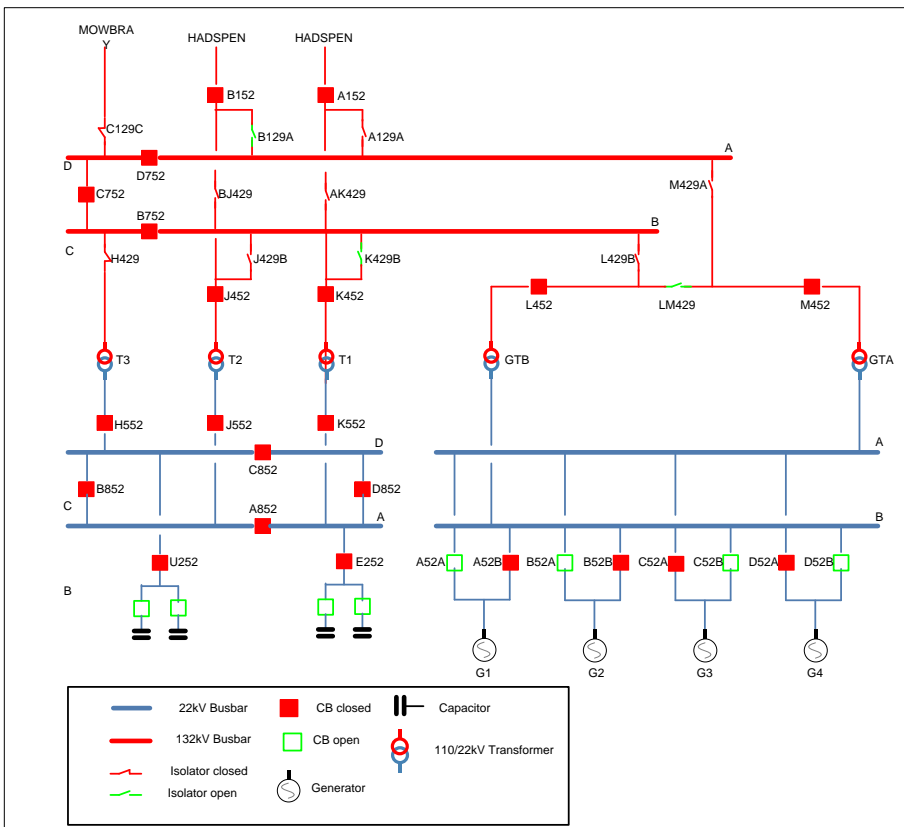
Figure 1: Trevallyn switchyard just before the incident

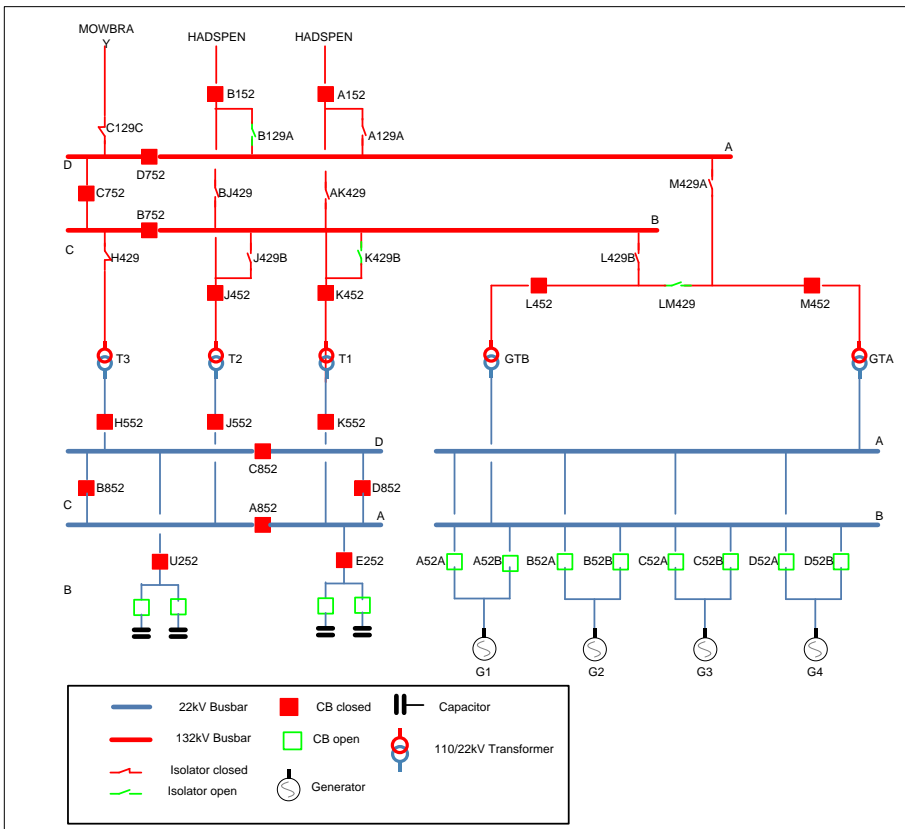
Figure 2: Trevallyn switchyard immediately after the incident
