POWER SYSTEM INCIDENT REPORT - INSECURE OPERATION OF THE POWER SYSTEM IN VICTORIA, 6TH OCTOBER 2009

PREPARED BY: ESOPP

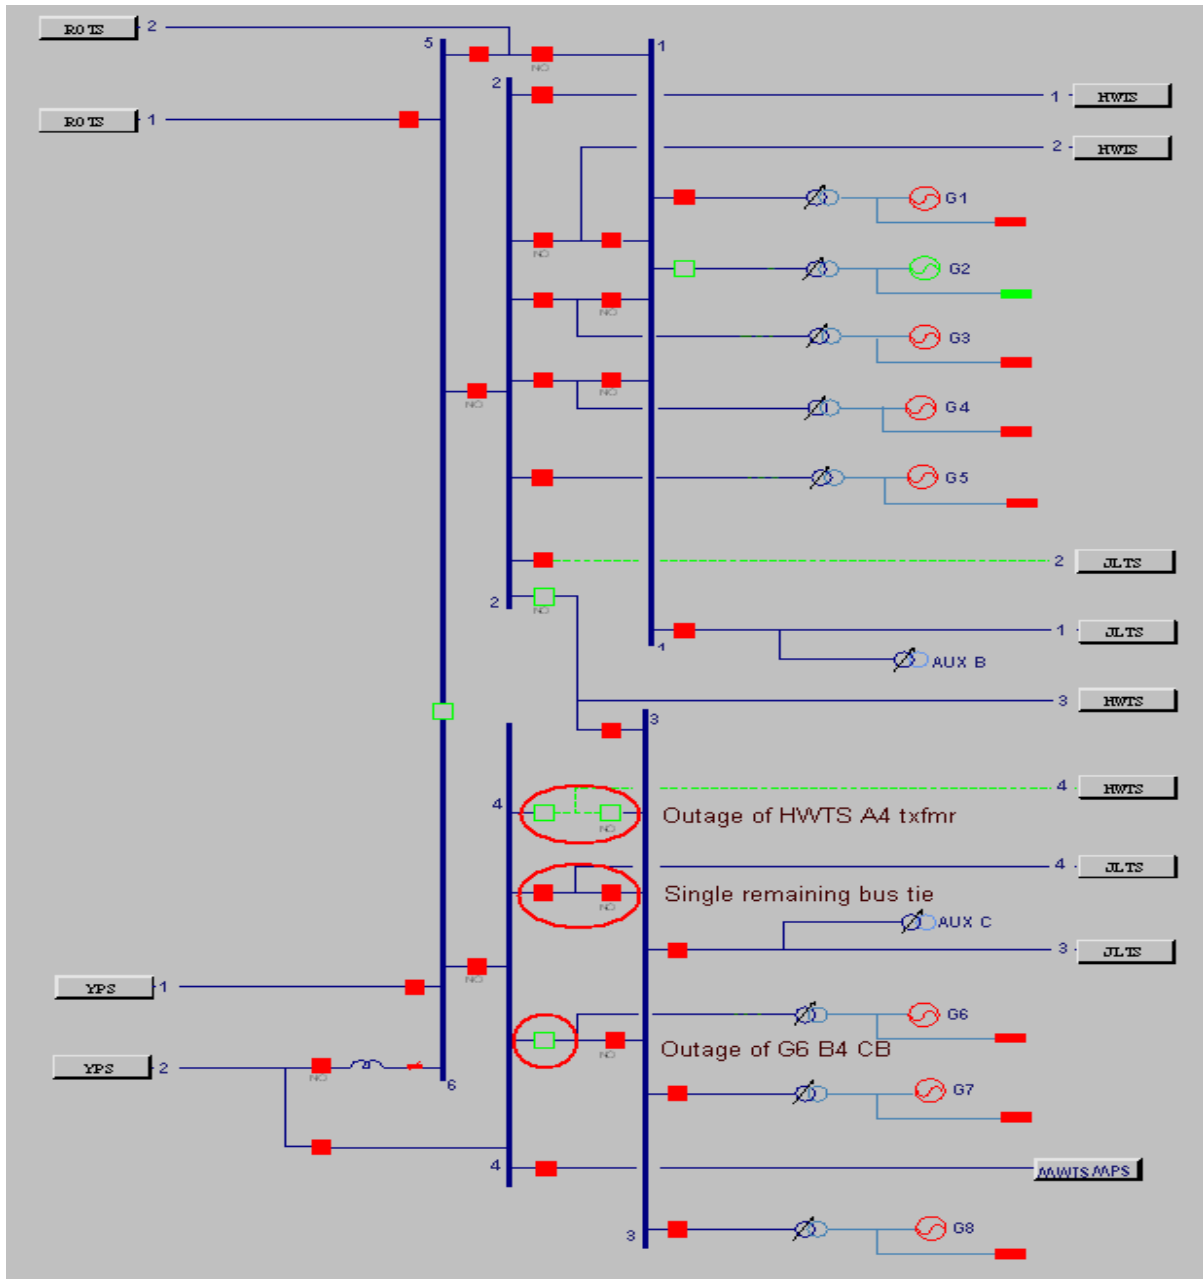
FIGURE 1 – ARRANGEMENT OF HWPS 220 KV SWITCHYARD ON 6TH OCTOBER 2009

These concurrent outages resulted in only one bus tie between the No. 3 and No. 4 220 kV buses at HWPS. With all plant in service there are normally three bus ties. When operating in 3/5 parallel mode at HWPS, it is necessary to have a secure bus tie between the No. 3 and No. 4 220 kV busses at HWPS – i.e at least two bus ties in place.

In particular the outage constraints used were not appropriate due to the fact that there was only one 220 kV bus tie in place between the HWPS No. 3 and No. 4 220 kV busses. Loss of the HWPS-JLTS No. 4 220 kV line would have resulted in loss of the last remaining bus tie, producing a significantly different network arrangement to that which the constraints were designed for.

AEMO's procedures for assessing similar outages at HWPS will be reviewed and updated by the end of March 2010 to specifically consider bus tie capability, and the use of maximum generation output in addition to the generation dispatch predicted by PreDispatch.

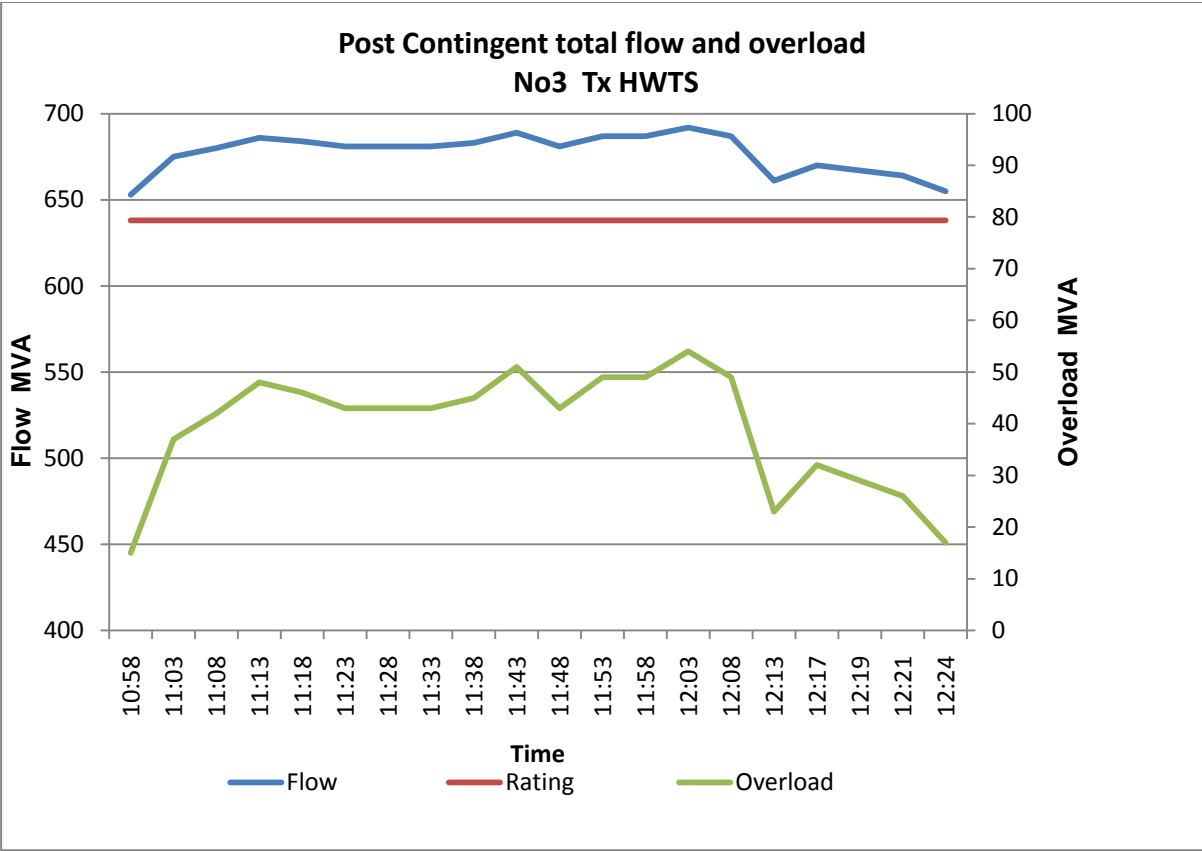
FIGURE 2 – POST CONTINGENT LOADING ON THE HWTS A3 500/220 KV TRANSFORMER

Beginning at 10:58 hrs on 6th October contingency violations for an overload on the HWTS A3 500/220 kV transformer for the trip of the HWPS to JLTS No. 4 220 kV line were recorded in AEMO's Contingency Analysis facilities. These violations increased over time to a maximum post contingent overload of 54 MVA at around 12:03 hrs.

As indicated by AEMO’s contingency analysis facilities, and confirmed by subsequent analysis, if the HWPS-JLTS No. 4 220 kV line had tripped between 10:58 hrs and 12:24 hrs on 6th October, the loading on the HWTS A3 550/220 kV transformer would have exceeded its short time rating.

Figure 2 below shows the post contingent overload of the A3 500/220 kV transformer. The peak overload was approximately 54 MVA, above a short time overload rating for this transformer of 638 MVA.
