# POWER SYSTEM INCIDENT REPORT: SIMULTANEOUS TRIP OF AETV CCGT AND OCGT UNITS – 30/09/2009

PREPARED BY: Electricity System Operations Planning and Performance

FINAL

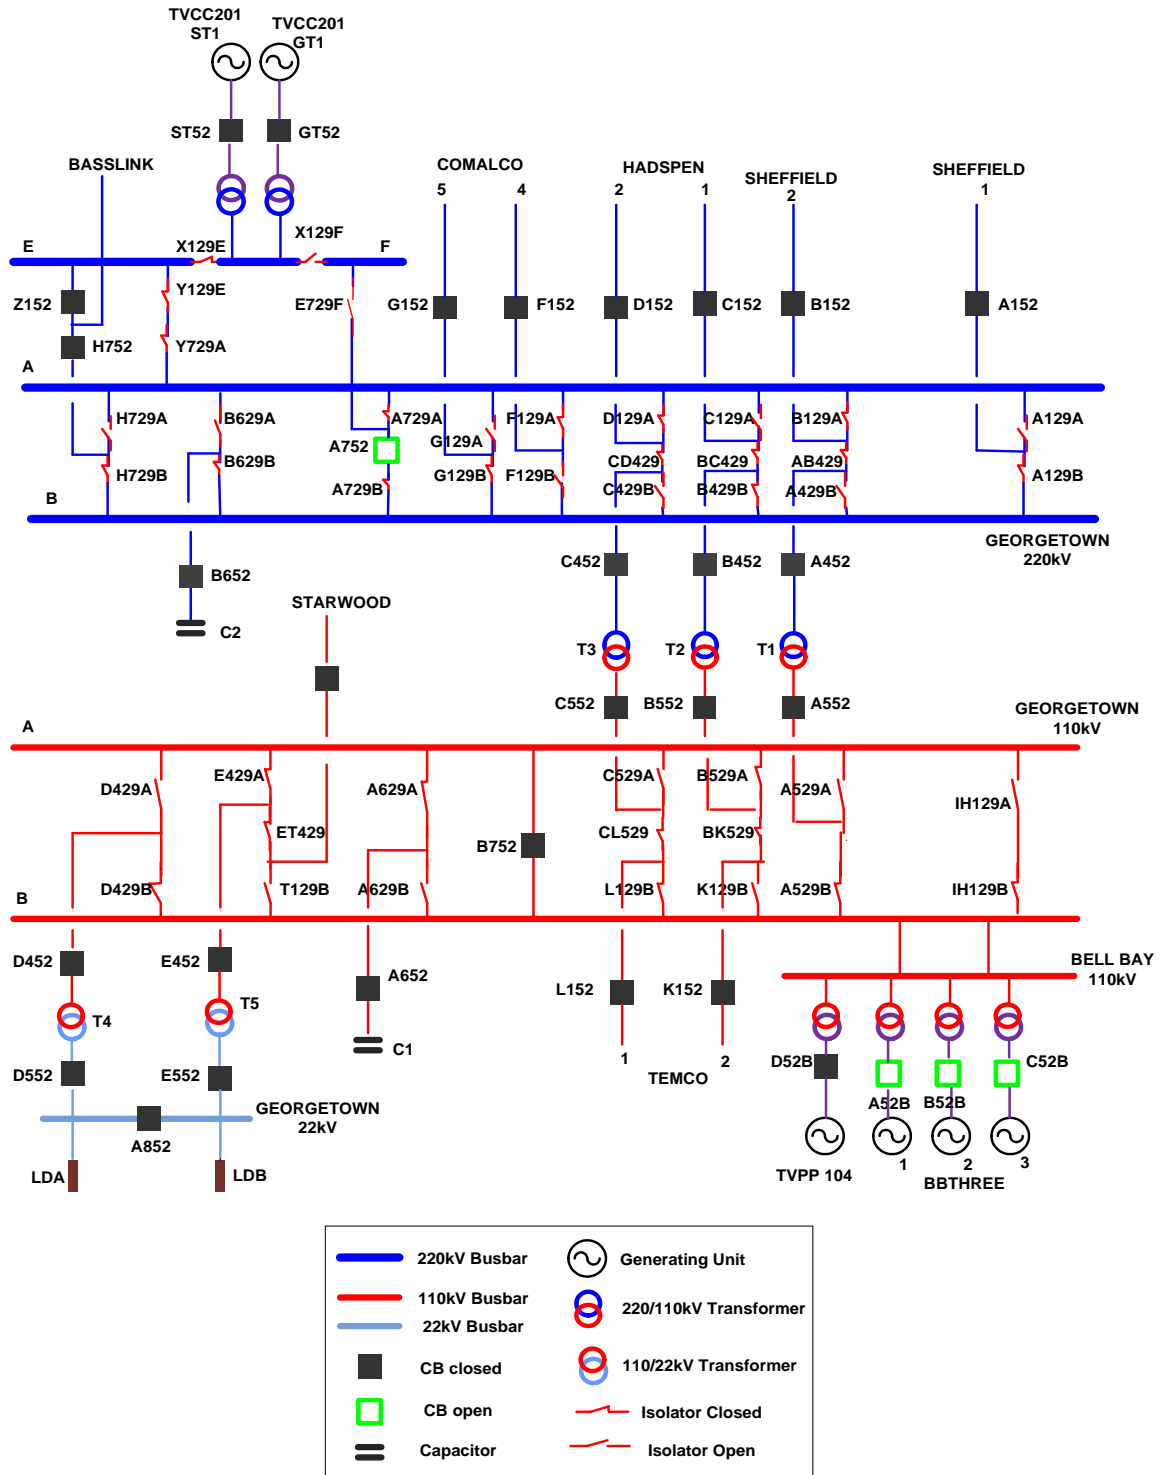
Figure1 above: Simplified Network Topology at George Town substation and connection to TVCC201/TVPP104 generating units before trip

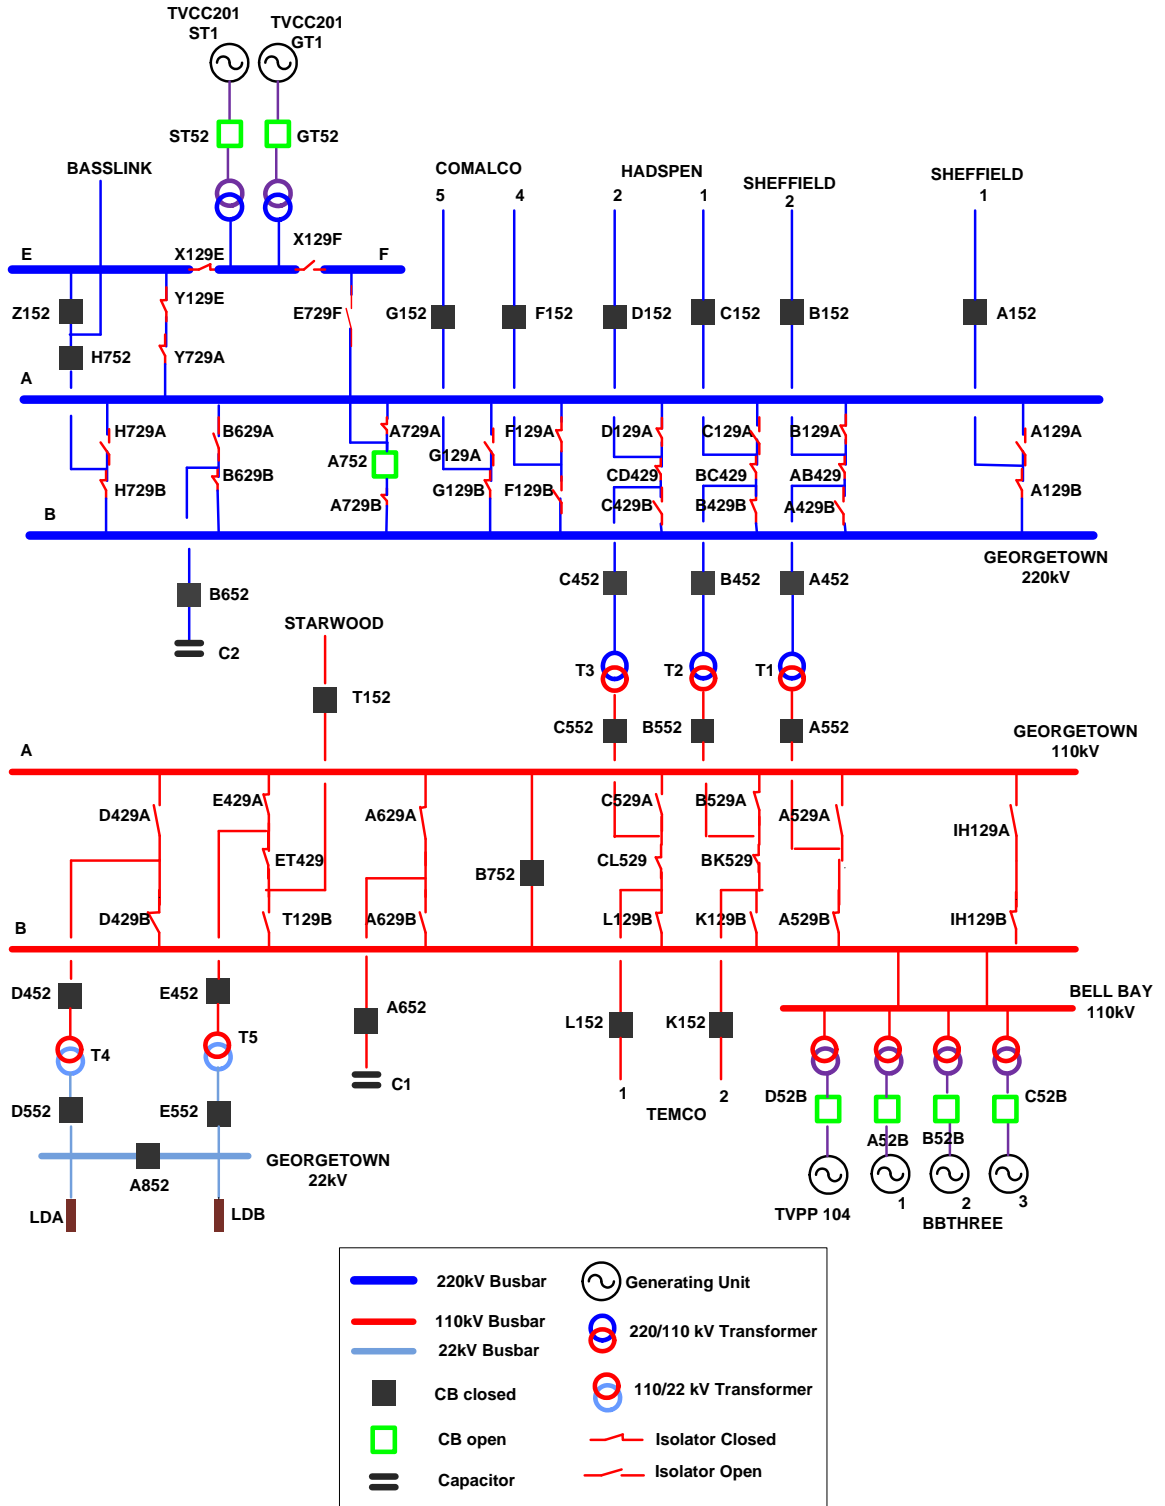
Figure 2 above: Simplified Network Topology at George Town substation and connection to TVCC201/TVPP104 generating units after trip

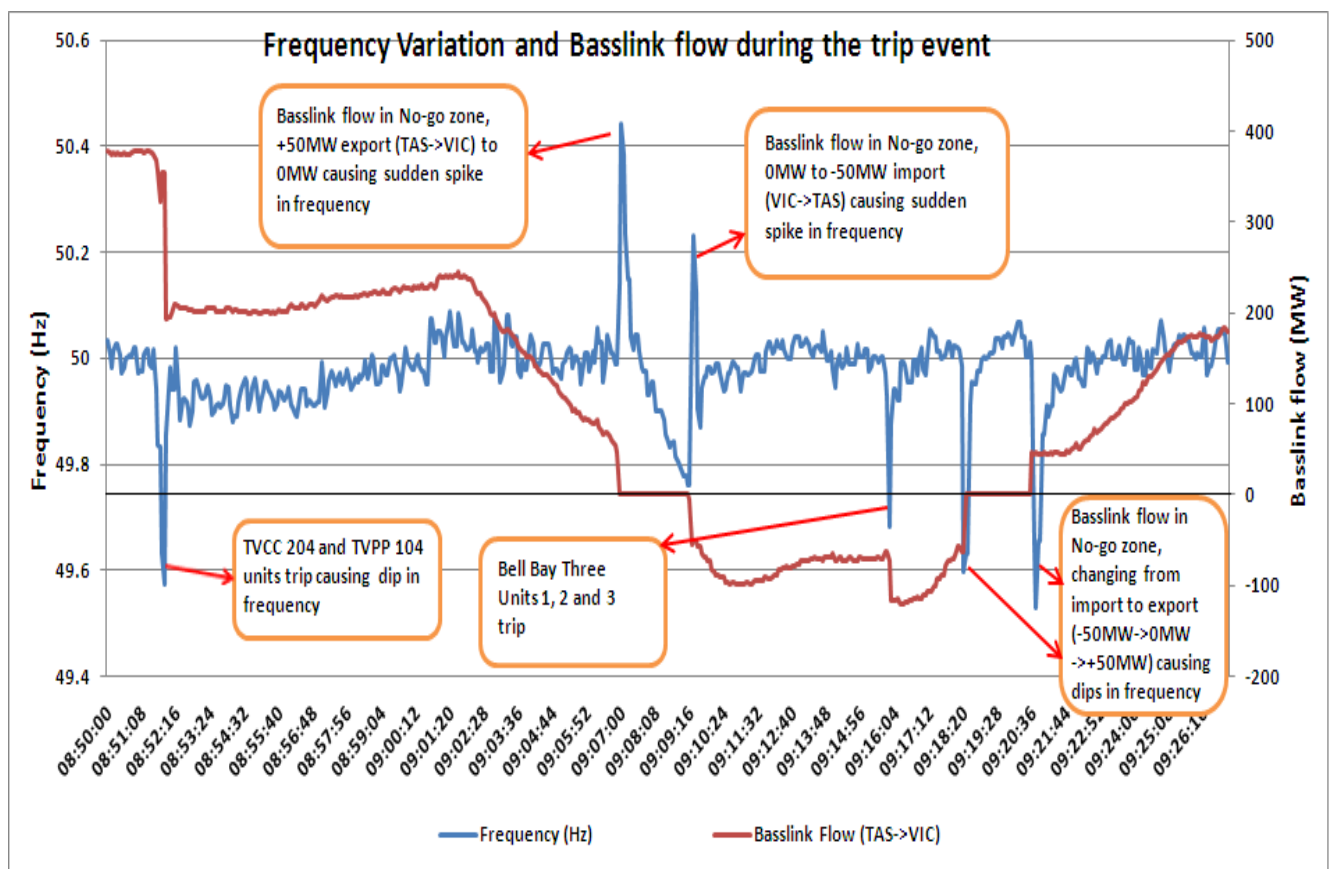
The normal operating frequency band for Tasmania is between 49.85Hz – 50.15Hz. At the time the TVCC 204 and TVPP104 tripped (08:52 hrs), the frequency declined to a minimum of 49.57Hz and stayed below the normal frequency band for 12 seconds. However, the frequency band that applies for multiple contingency events in Tasmania as per the frequency operating standards is 47- 55Hz. The frequency did not reach 47Hz at any instant of time during this event hence the frequency in Tasmania remained within the frequency operating standard.

As seen in the plot above, the first dip in frequency around 08:52 hrs indicates the trip of the TVCC201 and TVPP104 generating units. Basslink was exporting to Victoria at the time. Soon after the trip, the export reduced and eventually reversed to importing into Tasmania. The first spike in frequency around 09:07 hrs was a result of Basslink flow in the No-go

zone<sup>3</sup> (+50MW to 0MW) while reversing flow from export to import. There's a 2 minute waiting period (09:07-09:09 hrs) before Basslink actually starts to import power. The second spike in frequency is a result of Basslink exiting the No-go zone (between 0MW->-50MW).

The dip in frequency at 09:15 hrs indicates the trip of the Bell Bay Three units BBTHREE1, BBTHREE2 and BBTHREE3. Soon after, the Basslink flow reverses yet again from import into Tasmania to export to Victoria. The dip in frequency at 09:18 hrs indicates Basslink flow entering the No-go zone (-50MW to 0MW) while reversing flow from import to export. Again there's a 2 minute waiting period (09:18-09:20 hrs) before Basslink starts to export power. The last dip in frequency after 09:20 hrs is a result of Basslink exiting the No-go zone (between 0MW-> 50MW).
