POWER SYSTEM INCIDENT REPORT: TRIP OF B1 132KV BUSBAR AT SYDNEY EAST ON 20 OCTOBER 2009

PREPARED BY: Electricity System Operations Planning and Performance

FINAL

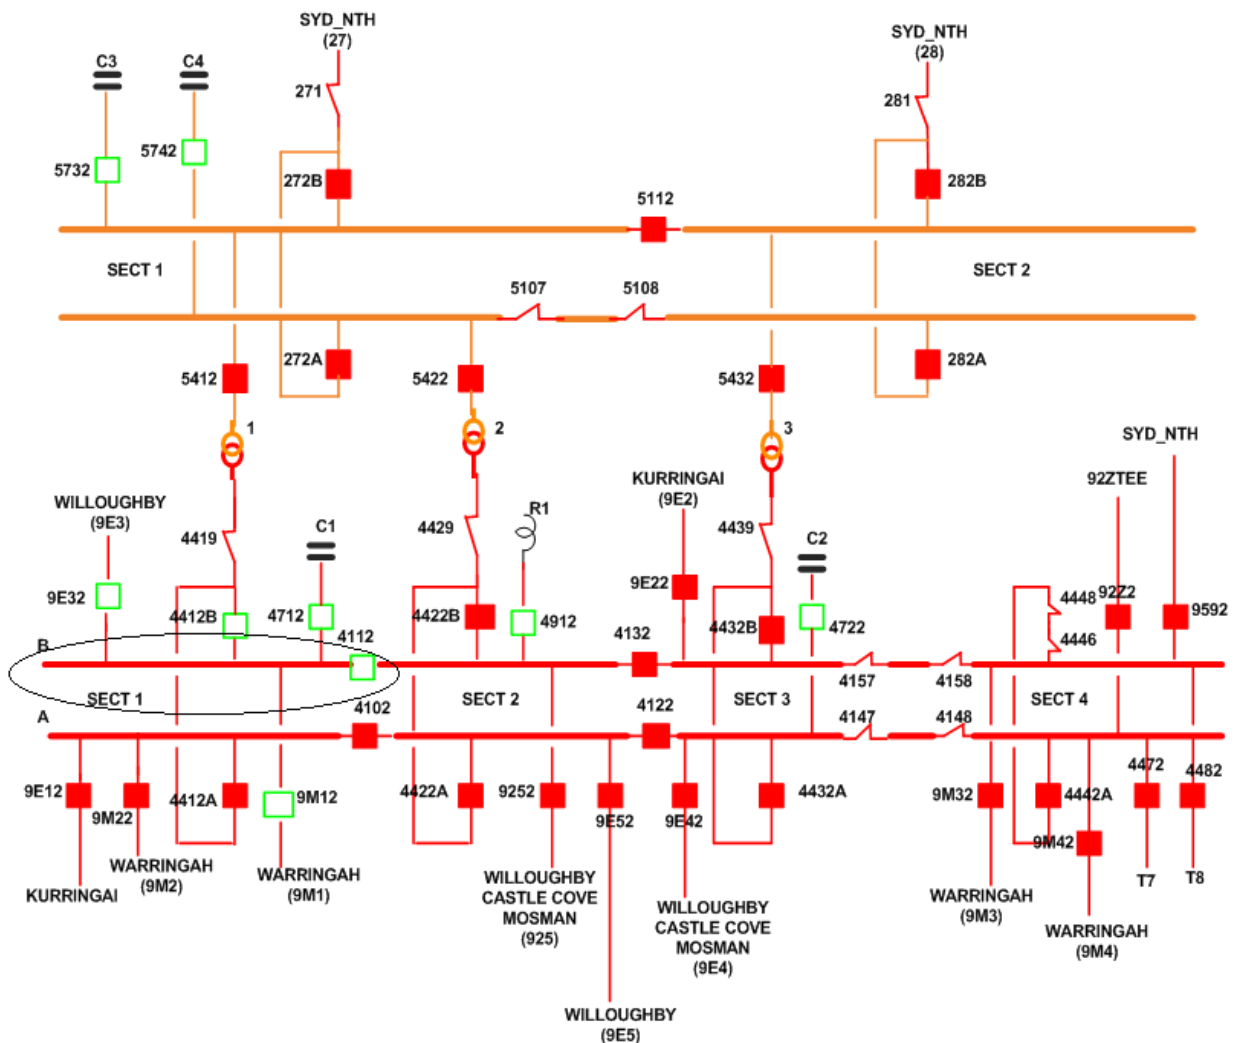
Figure 2: Network Topology at Sydney East after Busbar B1 trip

The incident occurred when TransGrid maintenance staff were preparing for maintenance testing of the No.1 capacitor connected to 132kV B1 bus section. After the capacitor was taken out of service in preparation for Insulation Resistance (IR) tests, maintenance staff started isolating the secondaries of the current transformer (CT) associated with the No.1 capacitor. The order in which the CT secondaries of metering, indication and protection CTs were isolated caused 260mA current to flow through the No.2 protection circuits of the No.1 capacitor. This residual current triggered the earth fault relay of No.2 protection to operate which subsequently resulted in the operation of B1 busbar protection and thus tripping circuit breakers 9E32, 4412B, 4112 and 9M12. No constraints were invoked and Market Notice 28310 was issued at 13:57 hrs.

There was 72MW flowing to Willoughby via the 9E3 line prior to the incident. No load was interrupted since the 925, 9E4 and 9E5 alternate lines to Willoughby took on the extra load after the busbar trip.

In response to this incident, TransGrid has updated its service instructions and reviewed technical training to clarify the requirements for similar testing to be conducted in future.
