POWER SYSTEM INCIDENT REPORT

TRIP OF NO.1 KEILOR TERMINAL STATION 220KV BUSBAR ON 08 OCTOBER 2009

PREPARED BY: ESOPP

FINAL

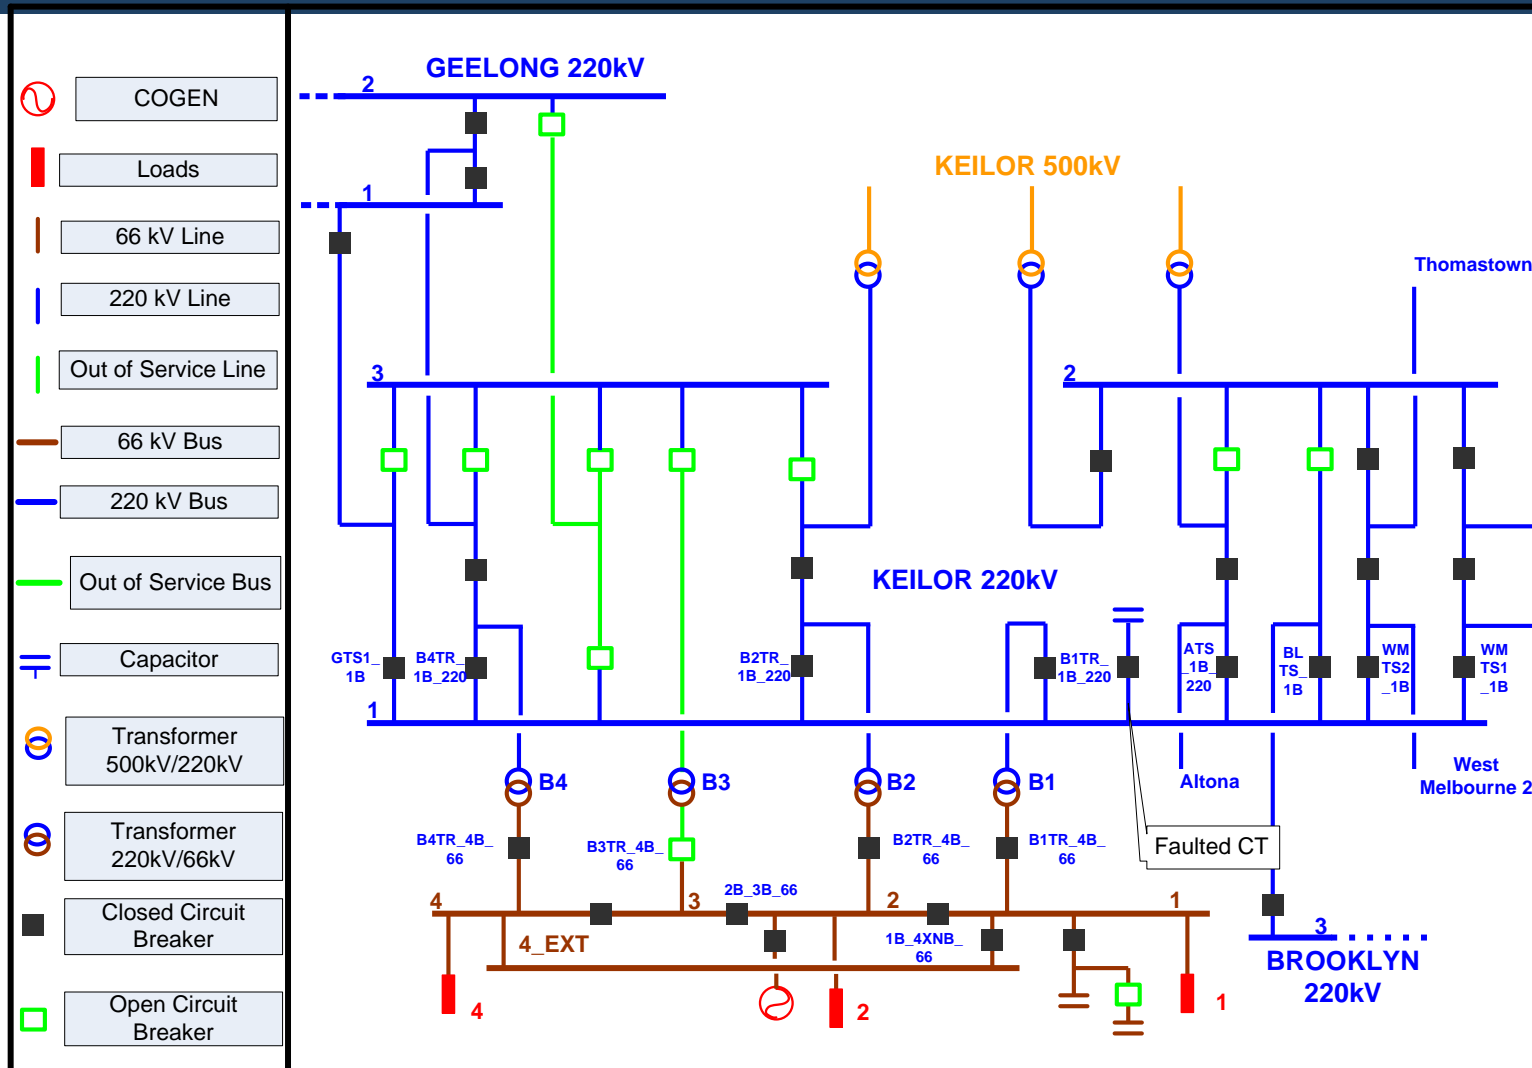
FIGURE 1: PLANNED OUTAGE ON.3 BUSBAR 220KV PRIOR TO OCCURENCE OF EVENT

The No.3 220kV busbar was out of service for planned work. As a consequence, the B3 220/66kV transformer connecting No.3 busbar to 66kV busbar within the same terminal station was also out of service. The load on the 66kV side of the transformer was consequently being supplied by the B1, B2 and B4 transformers. All 66kV bus section breakers were closed. Figure 1 shows the KTS single line diagram with its 220kV and 66kV connections, including statuses of all relevant circuit breakers (CBs) prior to the incident.

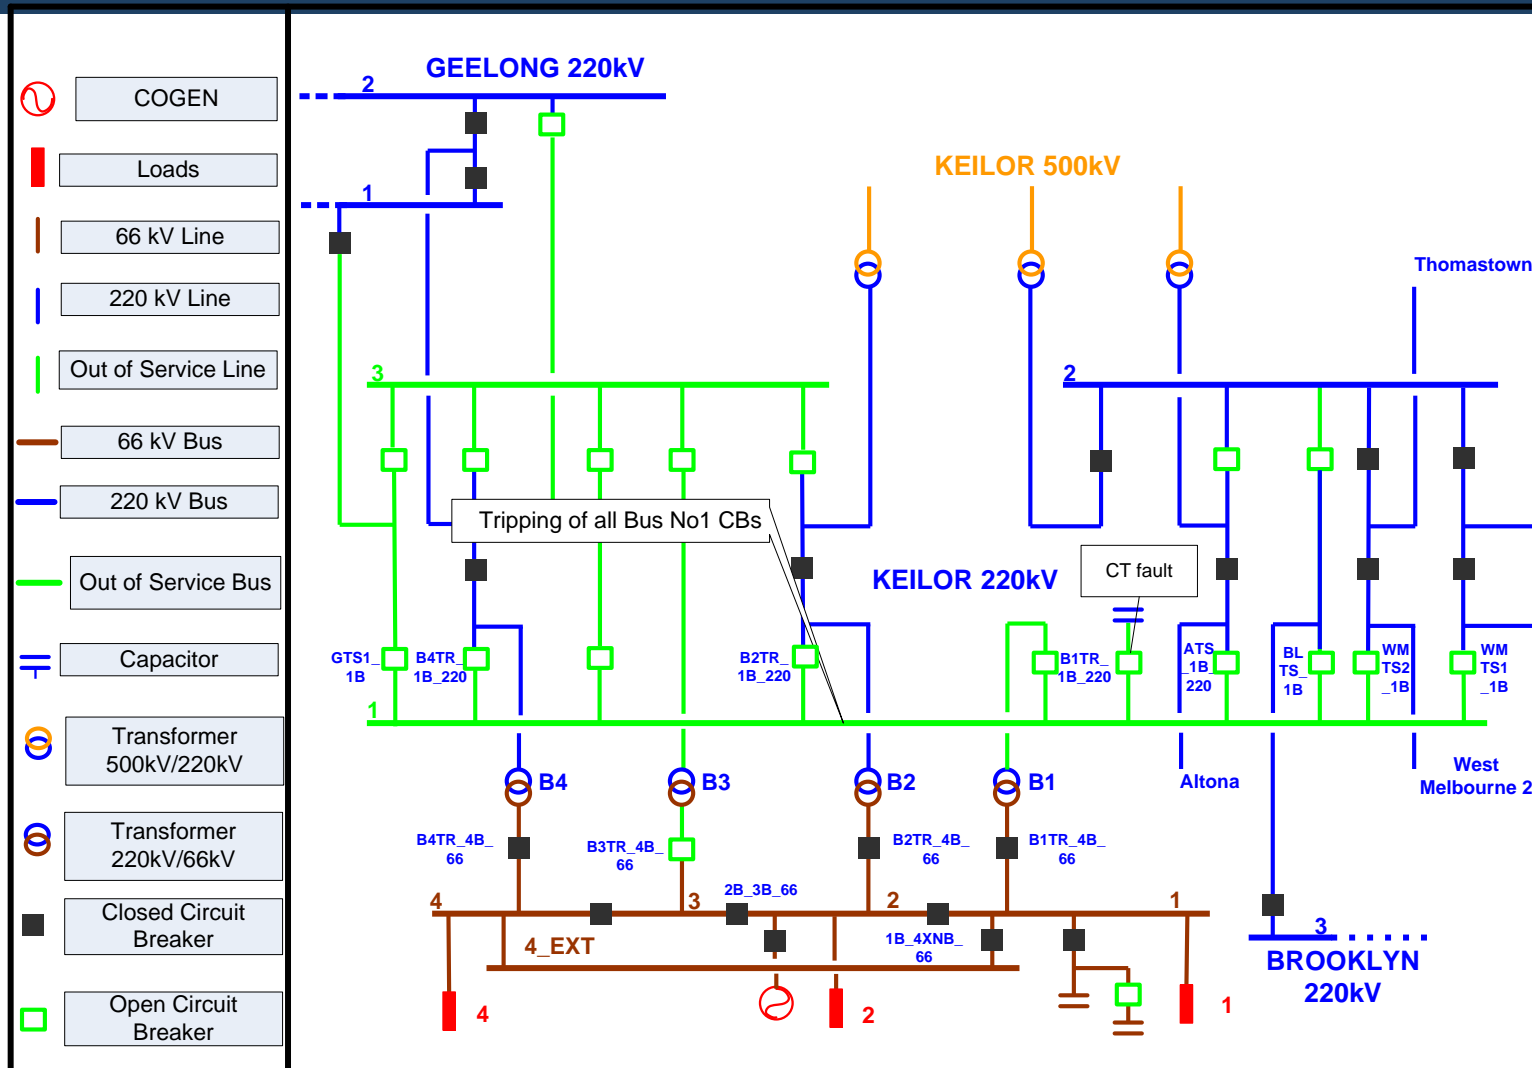
FIGURE 2: TRIPPING OF NO.1 220KV BUSBAR ON KEILOR TERMINAL STATION

At 15:00:54 hrs, the No.1 220kV busbar at KTS tripped due to the operation of its X busbar protection. This was caused by damaged secondary wiring within the marshalling box of the current transformer (CT) associated with the capacitor bank connected to the No.1 220kV busbar. This resulted in the tripping of all CBs associated with the No1 220kV busbar.

Investigation carried out by SP AusNet revealed that arcing had resulted in short circuiting of a CT secondary wiring connection; this was associated with the capacitor bank connected to the No.1 220kV busbar at KTS. The short circuit caused the X protection of the No.1 220kV busbar to operate and trip the busbar.

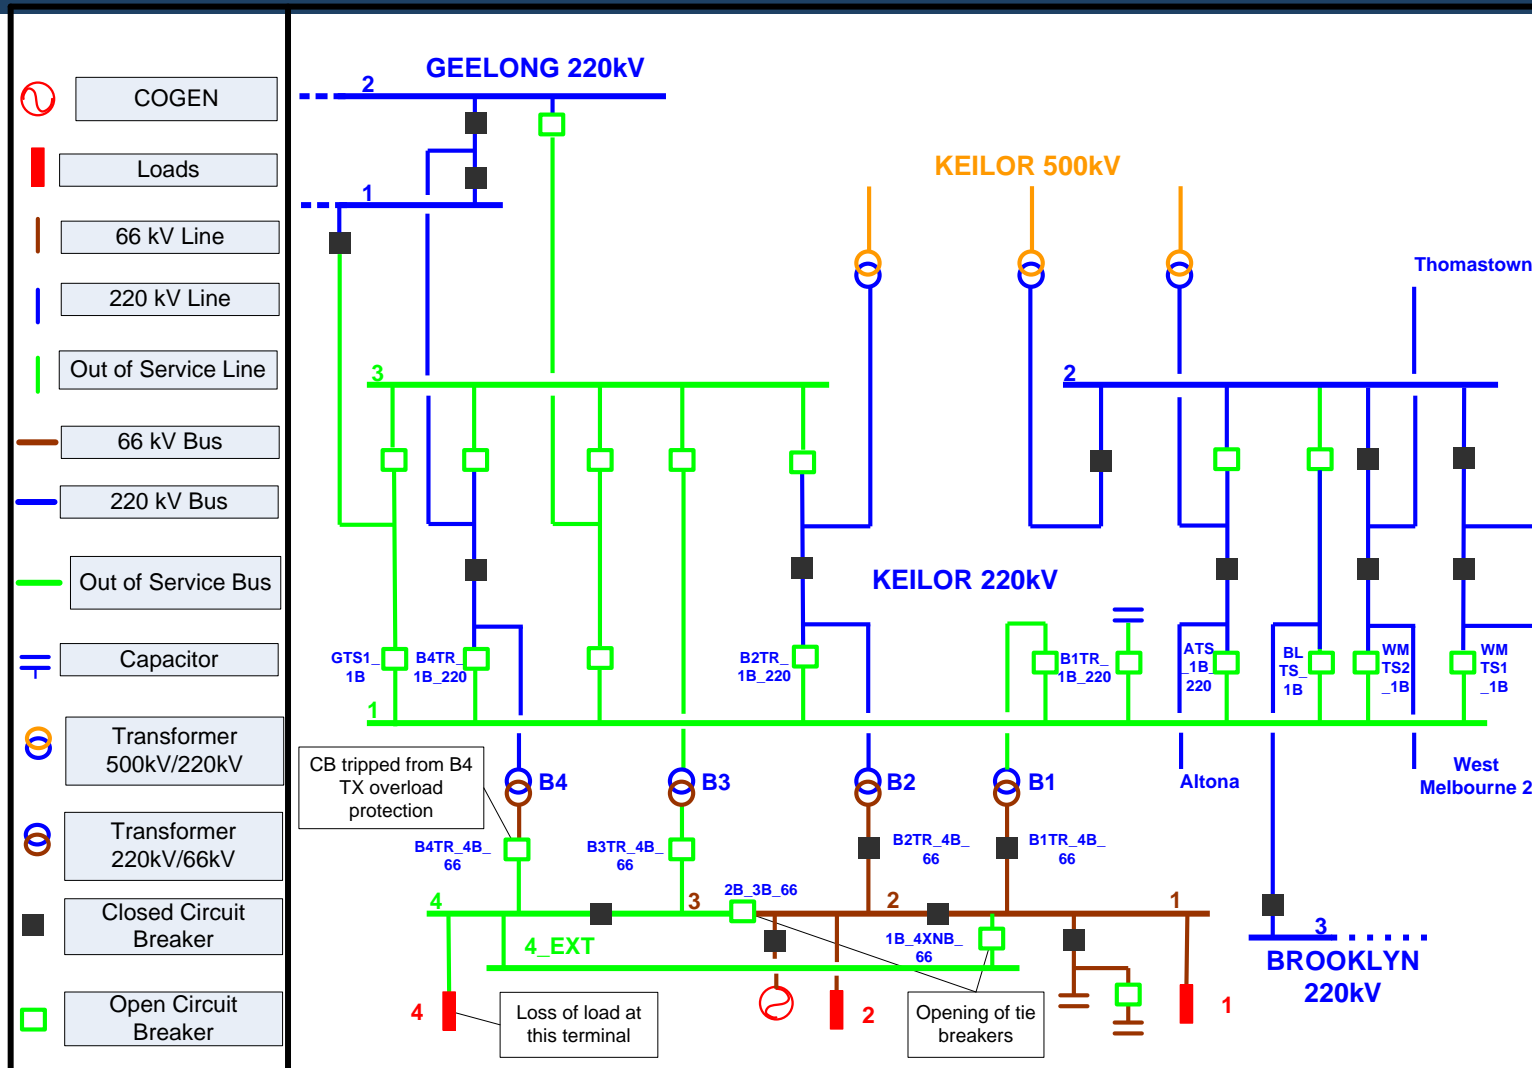
FIGURE 3: CB B4TR_4B_66 TRIPPED FROM B4 TX OVERLOADING

However, there were still ties across the Keilor 66 kV buses due to the 66 kV sub-transmission loops. There was a gradual rearrangement of 66kV load after the bus split through the opening of these 66 kV loops, with load on the B2 transformer reducing to 52 MW. During the same period loading on the B4 transformer increased to approximately 242 MW. This resulted in the B4 transformer tripping on overload protection with the consequent loss of 242 MW of load.

It is believed the tripping of the B4 transformer occurred because opening the Keilor 66 kV buses and sub-loop ties resulted in considerable load imbalance between:

- the Keilor No. 1 and 2 buses being supplied by the B2 transformer (242 MW), and
- the Keilor No. 3 and 4 buses being supplied by the B4 transformer (52 MW).

A possible approach to avoid this in future would be to open the 66 kV sub-loop ties before opening the Keilor 66 kV bustie cbs. This would allow the operator to observe the radial load being supplied from each of the Keilor 66 kV buses prior to opening the Keilor bustie cbs. By judicious opening of the 66 kV sub-loop ties and bustie cbs a better sharing of the loading on the B2 and B4 transformers could be achieved.

In future, balancing the transformer flows will not be manually performed, as SP AusNet will instead rely on an automated overload protection system to trip load following such an event. Thereafter SP AusNet will explore all possible means in an effective manner to restore load in the shortest possible time.

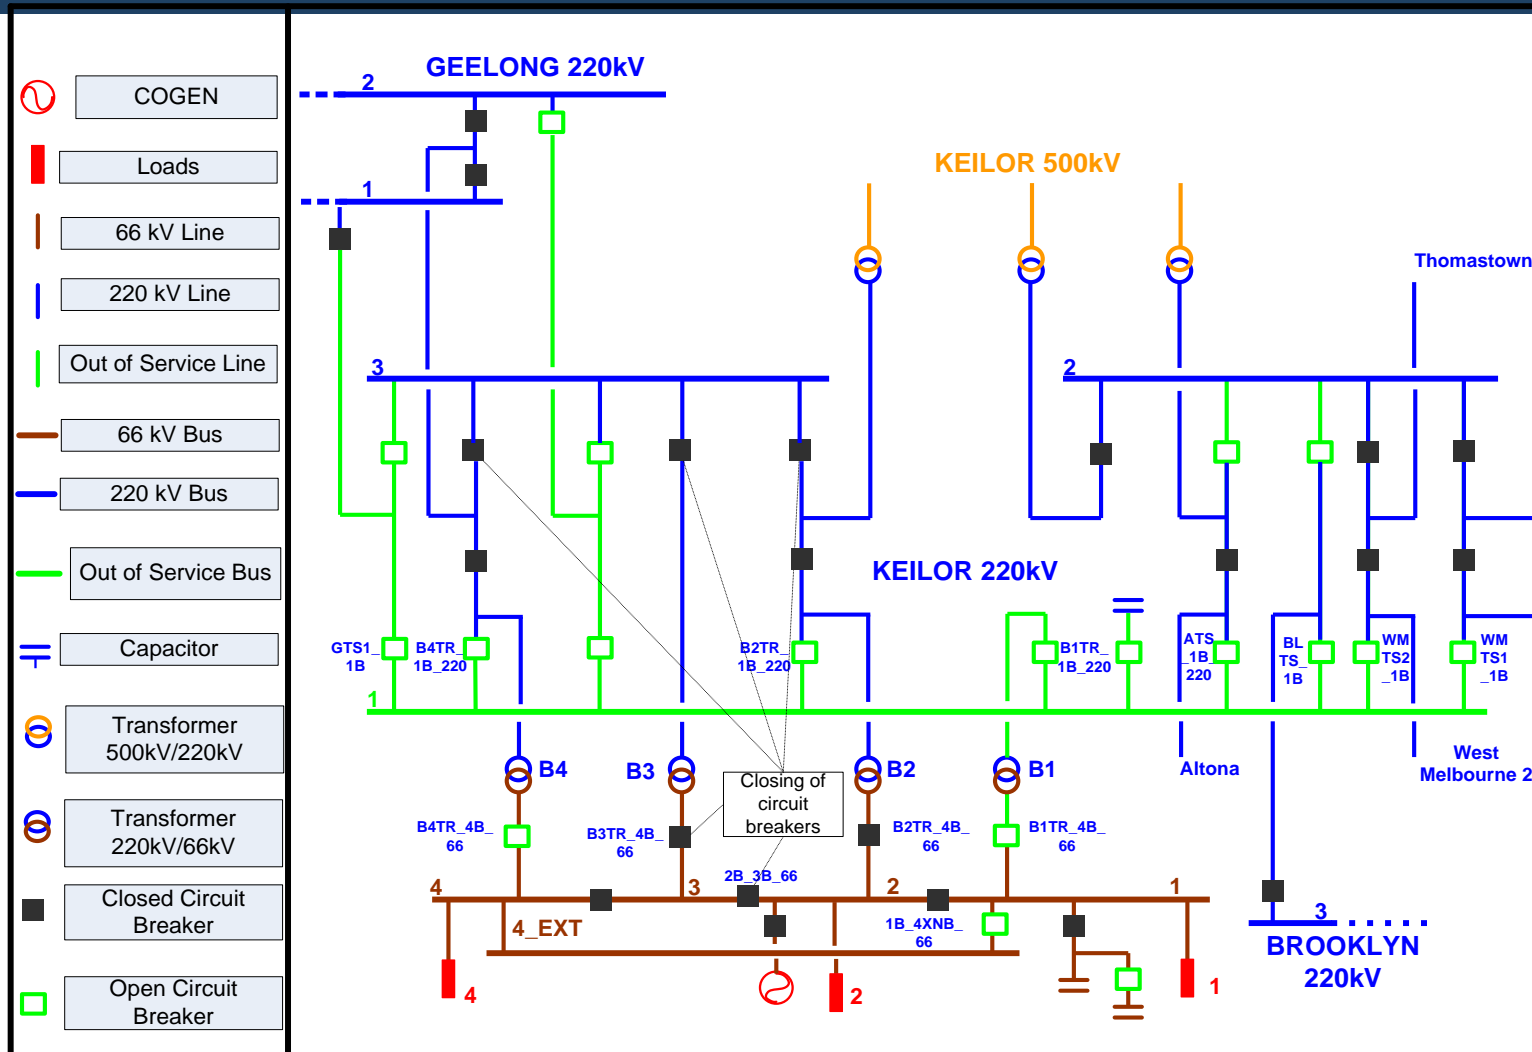
FIGURE 4: RECALLING OF B3 TX AND RESTORATION OF LOAD

At 16:17:10 hrs, the B3 transformer was returned to service and a 220kV system tie was re-established between GTS and the KTS 500kV busbar via the KTS No.3 220kV busbar (refer Figure 4). This allowed all load to be restored.

Load was progressively restored after 16:17hrs, when the B3 transformer was returned to service. The capacitor bank on No.1 220kV busbar at KTS could not be energised until the faulty CT was replaced on 9th October 2009.

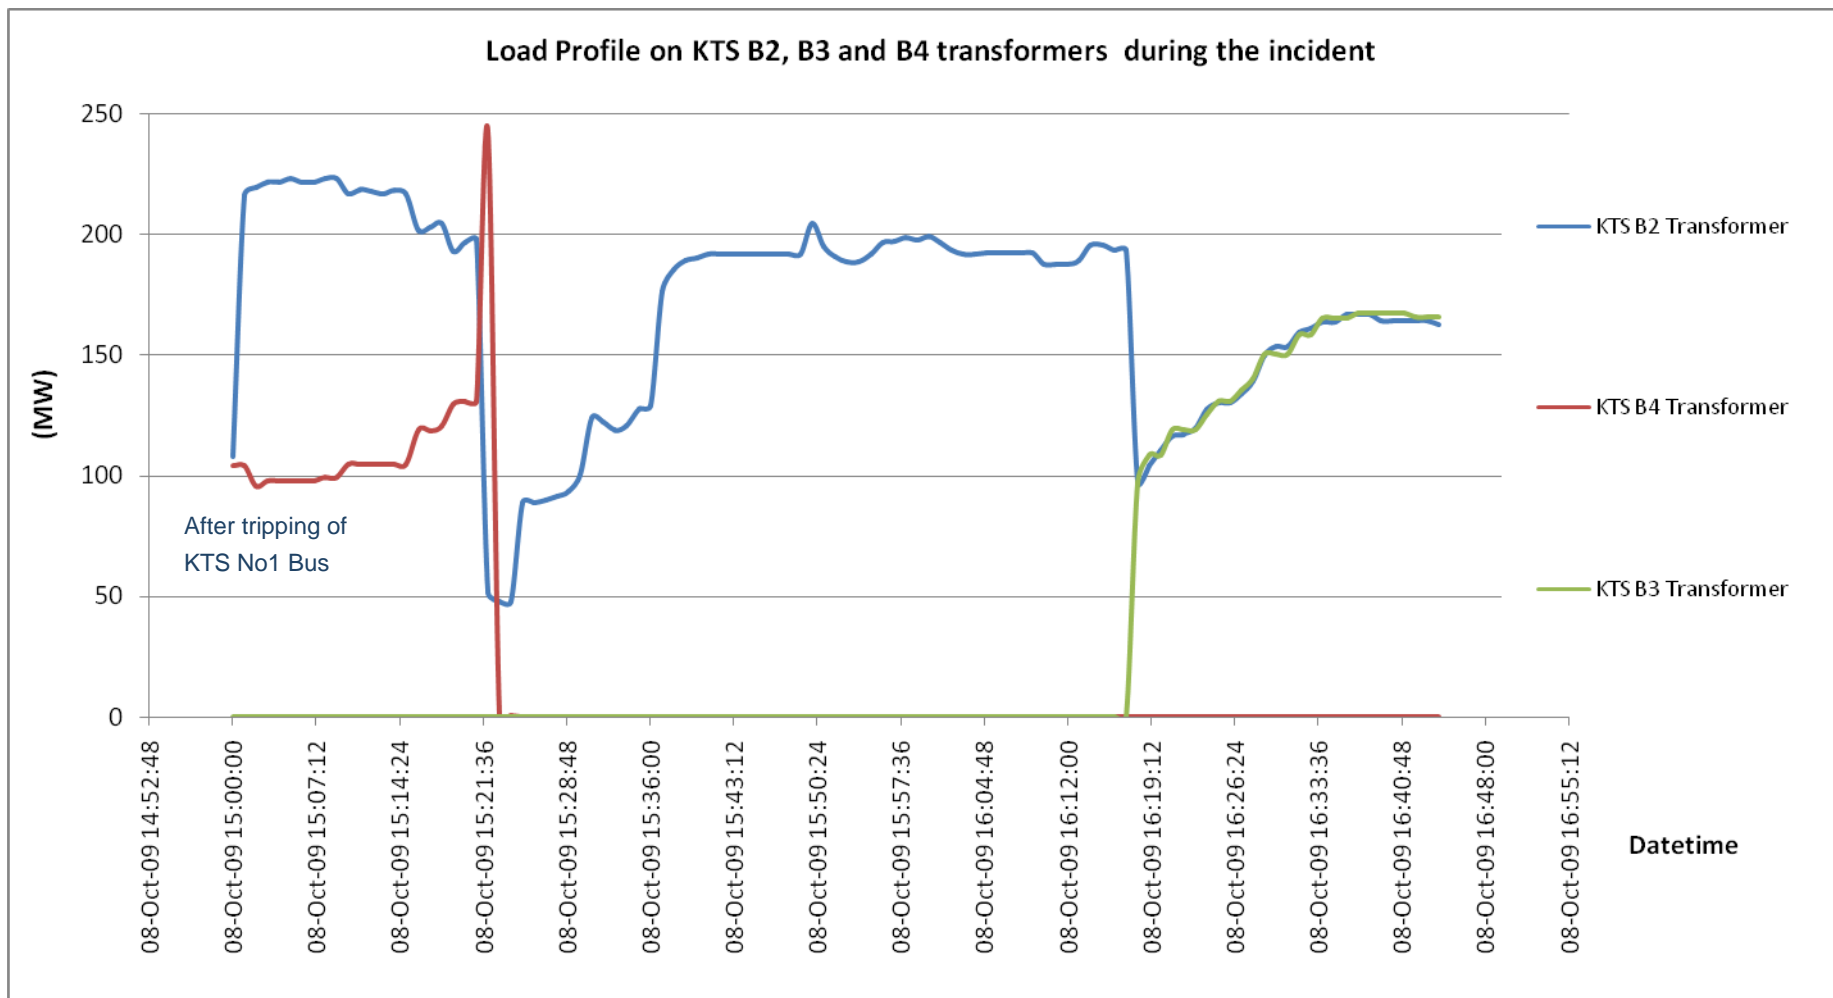
FIGURE 5: LOAD PROFILE OF KTS B2, B3 AND B4 TRANSFORMERS

At 15:09:35 hrs, the B2 transformer with a rating of 185MVA was loaded up to about 222MW. At the same time the loading on the B4 transformer was 99 MW. To avoid automatic load shedding due to the thermal overloading on the B2 transformer, the following tie breakers were opened to split the 66kV system tie:

Between 15:09 hr and 15:21 hr the loading on the B2 transformer reduced from 222 MW to 197 MW, while the loading on the B4 transformer increased from 99 MW to 133 MW. The loading on the B4 transformer then rapidly increased to 242 MW, while the loading on the B2 transformer reduced to 52 MW due to the opening of the 66kV sub loop ties. The B4 transformer remained at 242 MW for 68 seconds, at which time it tripped on overload protection. This resulted in the loss of 242 MW of load supplied via the No. 4 66kV bus. Figure 3 shows the statuses of relevant CBs immediately following the tripping of B4 transformer. B2 transformer remained on load allowing quick partial load recovery up to the limit of the transformer rating.
