POWER SYSTEM INCIDENT REPORT

SIMULTANEOUS TRIP OF HAZELWOOD TO ROWVILLE NO.1 AND NO.2 220 KV TRANSMISSION LINES ON 27 FEBRUARY 2010

PREPARED BY: Electricity System Operations Planning and Performance

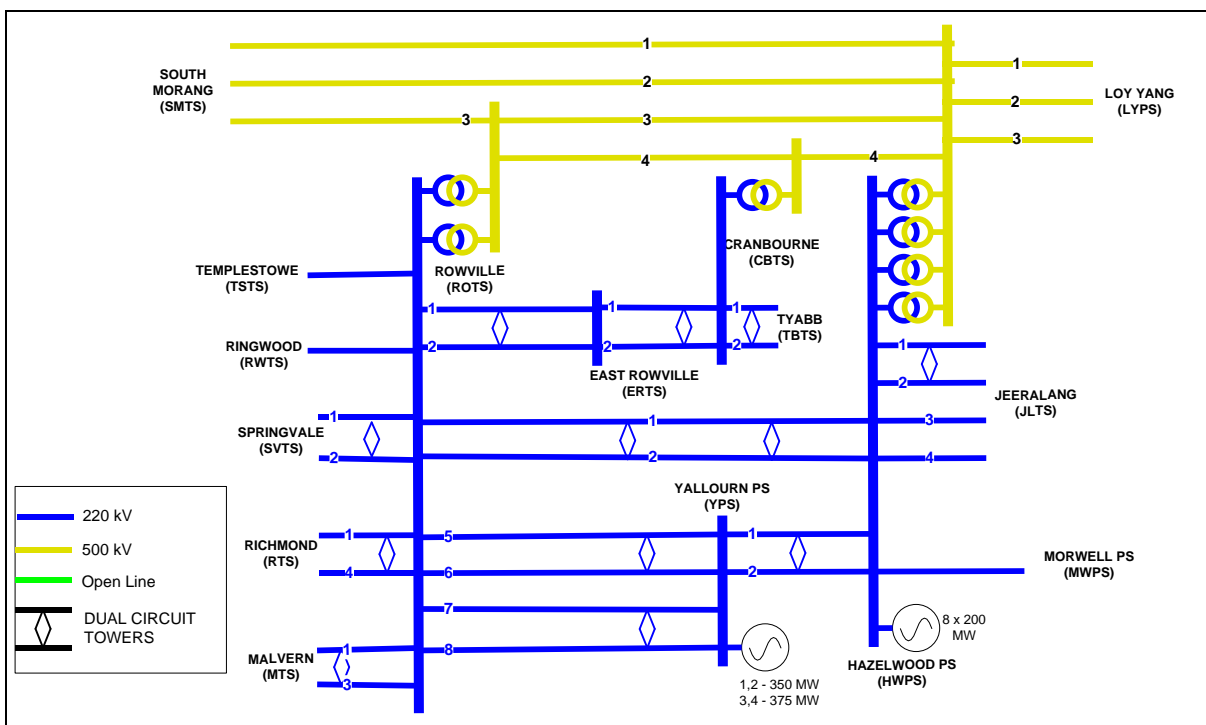
FIGURE 1: TRANSMISSION NETWORK PRIOR TO THE EVENT

Figure 1 shows the single line diagram of the transmission network between Hazelwood and Rowville terminal stations immediately prior to the event.

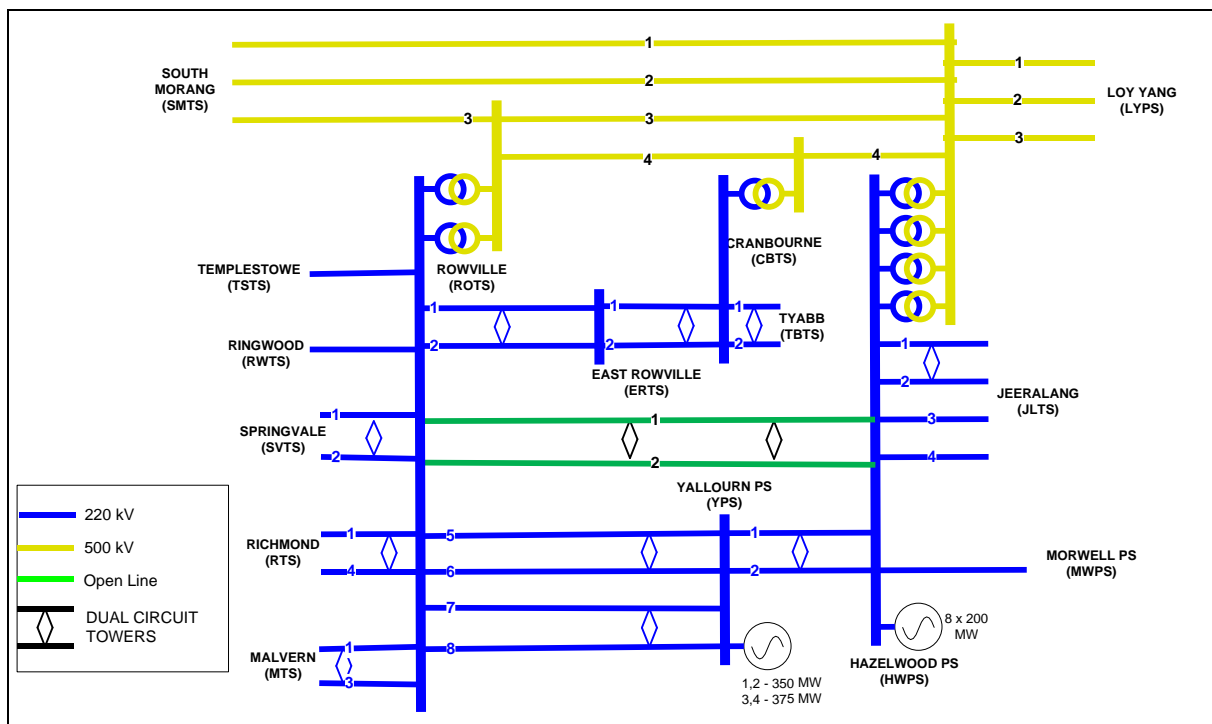
FIGURE 2: TRANSMISSION NETWORK WITH BOTH HAZELWOOD – ROWVILLE LINES OUT OF SERVICE

Figure 2 shows the single line diagram of the transmission network between Hazelwood and Rowville Terminal Stations with Hazelwood to Rowville No.1 and No.2 lines out of service. These two Hazelwood to Rowville lines are on dual circuit towers.
