POWER SYSTEM INCIDENT REPORT

TRIP OF PENOLA WEST NO. 1 AND NO. 2 132/33KV TRANSFORMERS ON 15 APRIL 2010

PREPARED BY: ESOPP
FINAL

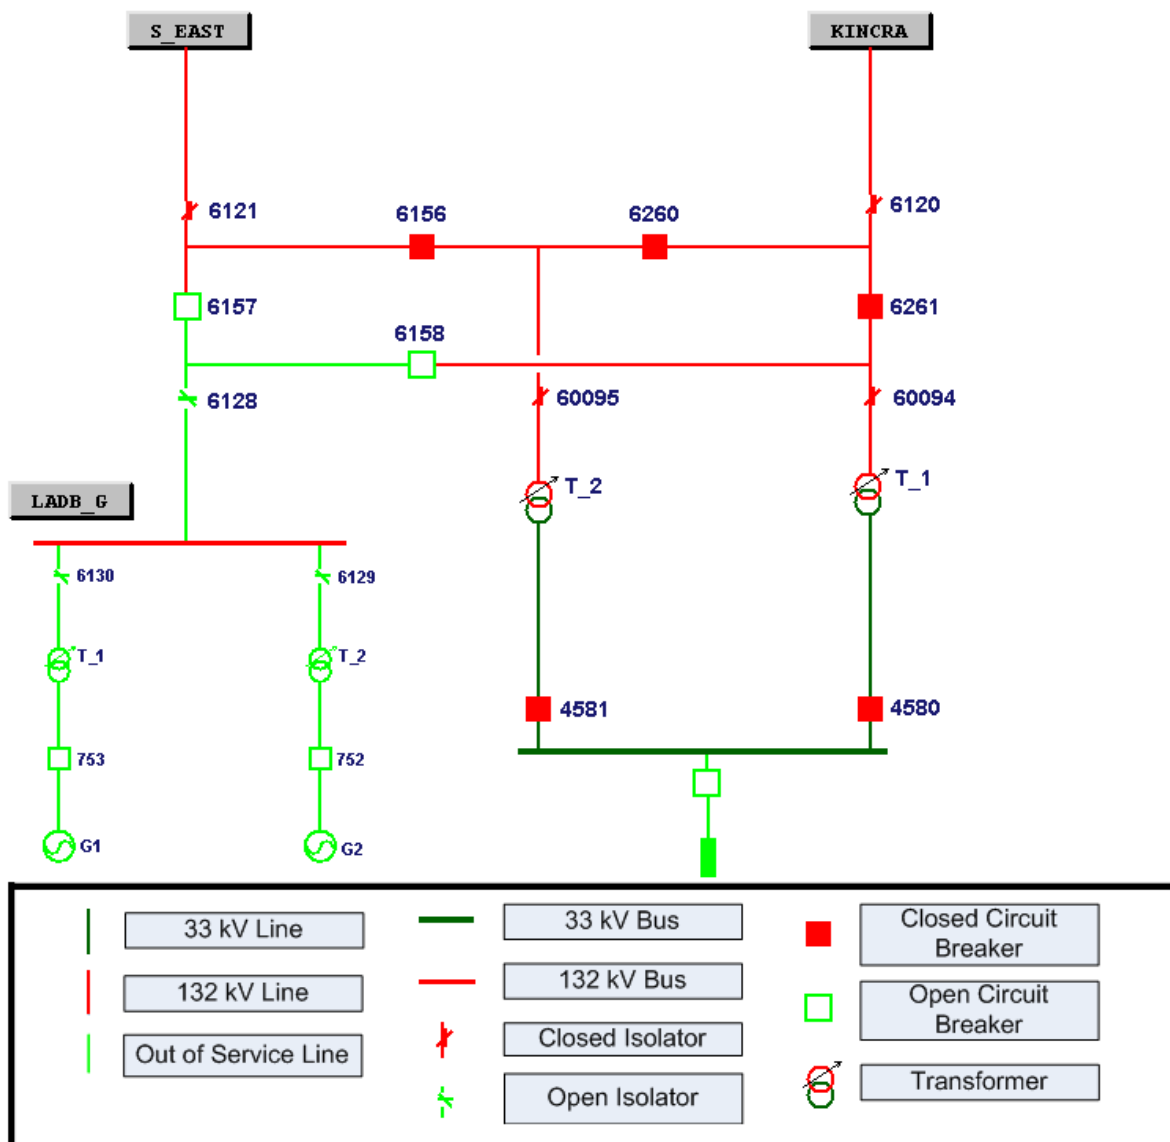
FIGURE 1. PENOLA WEST SUBSTATION DURING PLANNED OUTAGE OF PENOLA WEST TO LADBROKE GROVE PS 132 KV LINE (BEFORE THE INCIDENT)

At 15:50 hrs, upon completion of the line outage, Penola West to Ladbroke Grove PS 132kV line and both 11/132 kV step-up transformers at Ladbroke Grove were energised by closing isolator 6128 and circuit breaker (CB) 6157 at Penola West (refer Figure 1). The protections of both Penola West 132/33 kV transformers operated on closing of the CB. This resulted in the tripping of CB 4580, CB 4581, CB 6260, CB 6261 and CB 6156, which caused the Penola West to Kincaig 132 kV line to be opened at Penola West (refer Figure 2) and the No. 1 and No. 2 132/33 kV transformers at Penola West substation to be de-energised.

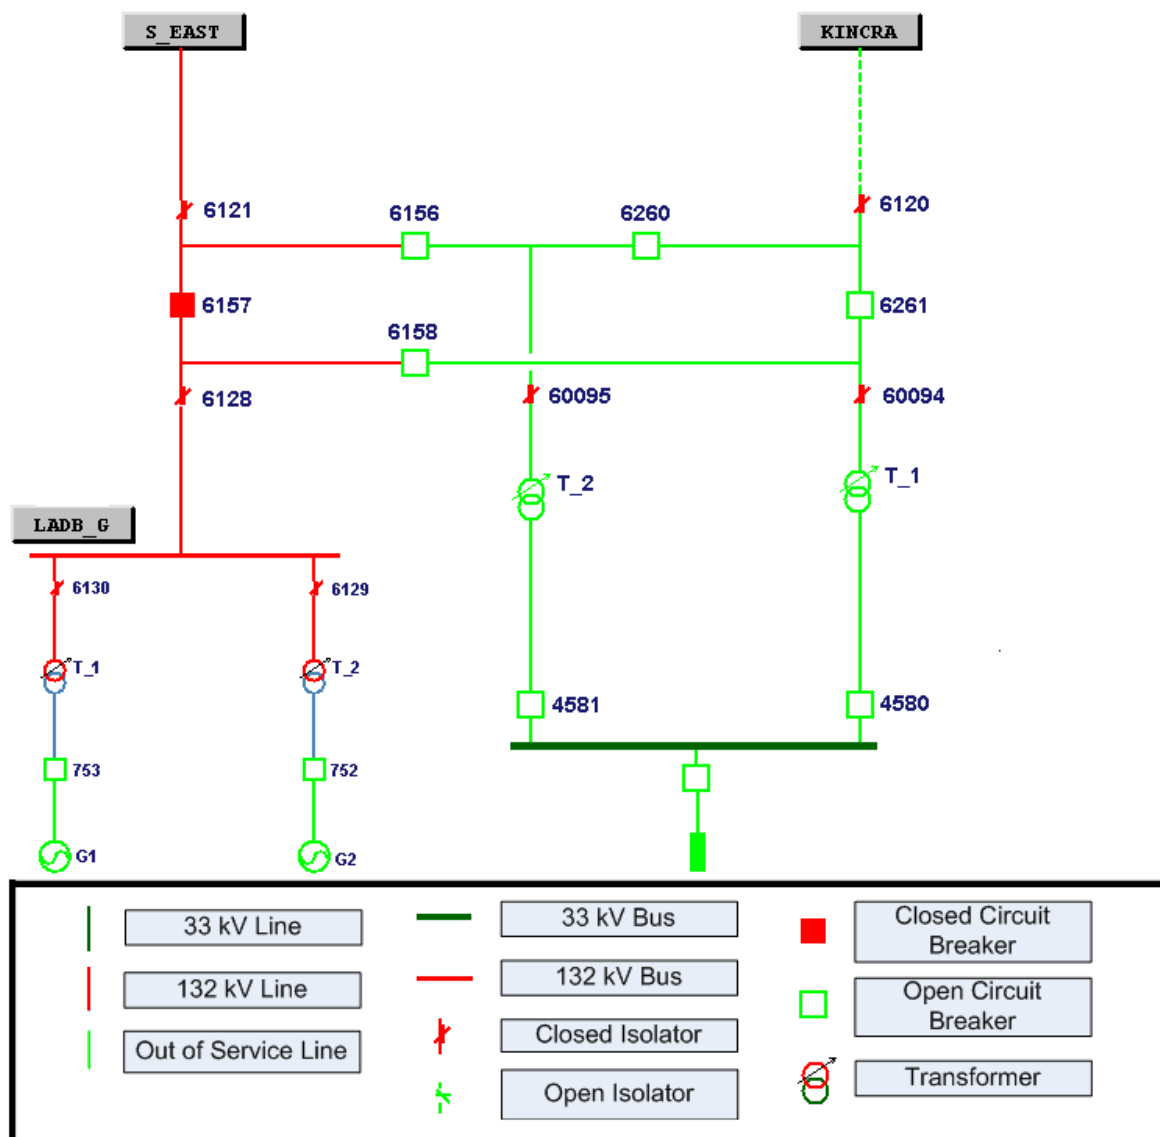
FIGURE 2. PENOLA WEST SUBSTATION IMMEDIATELY FOLLOWING THE CLOSURE OF CB 6157

The initial investigation conducted by ElectraNet suggested the energising of Penola West to Ladbroke Grove 132 kV line and both Ladbroke Grove 11/132 kV transformers had caused in-rush currents in these transformers. The in-rush currents were thought to have caused the restricted earth fault protection of both Penola West transformers to operate tripping the CBs (refer Figure 2).

However, further investigation revealed that the tripping was due to incorrect low-voltage (LV) current transformer (CT) connections associated with the two transformers at Penola West.

The CT connections were rectified on 11th May 2010.
