POWER SYSTEM INCIDENT REPORT

TRIPPING OF MULTIPLE 275 kV TRANSMISSION LINES NEAR BRINKWORTH SUBSTATION IN SOUTH AUSTRALIA ON 3 SEPTEMBER 2010

PREPARED BY: Electricity System Operations Planning and Performance

FINAL

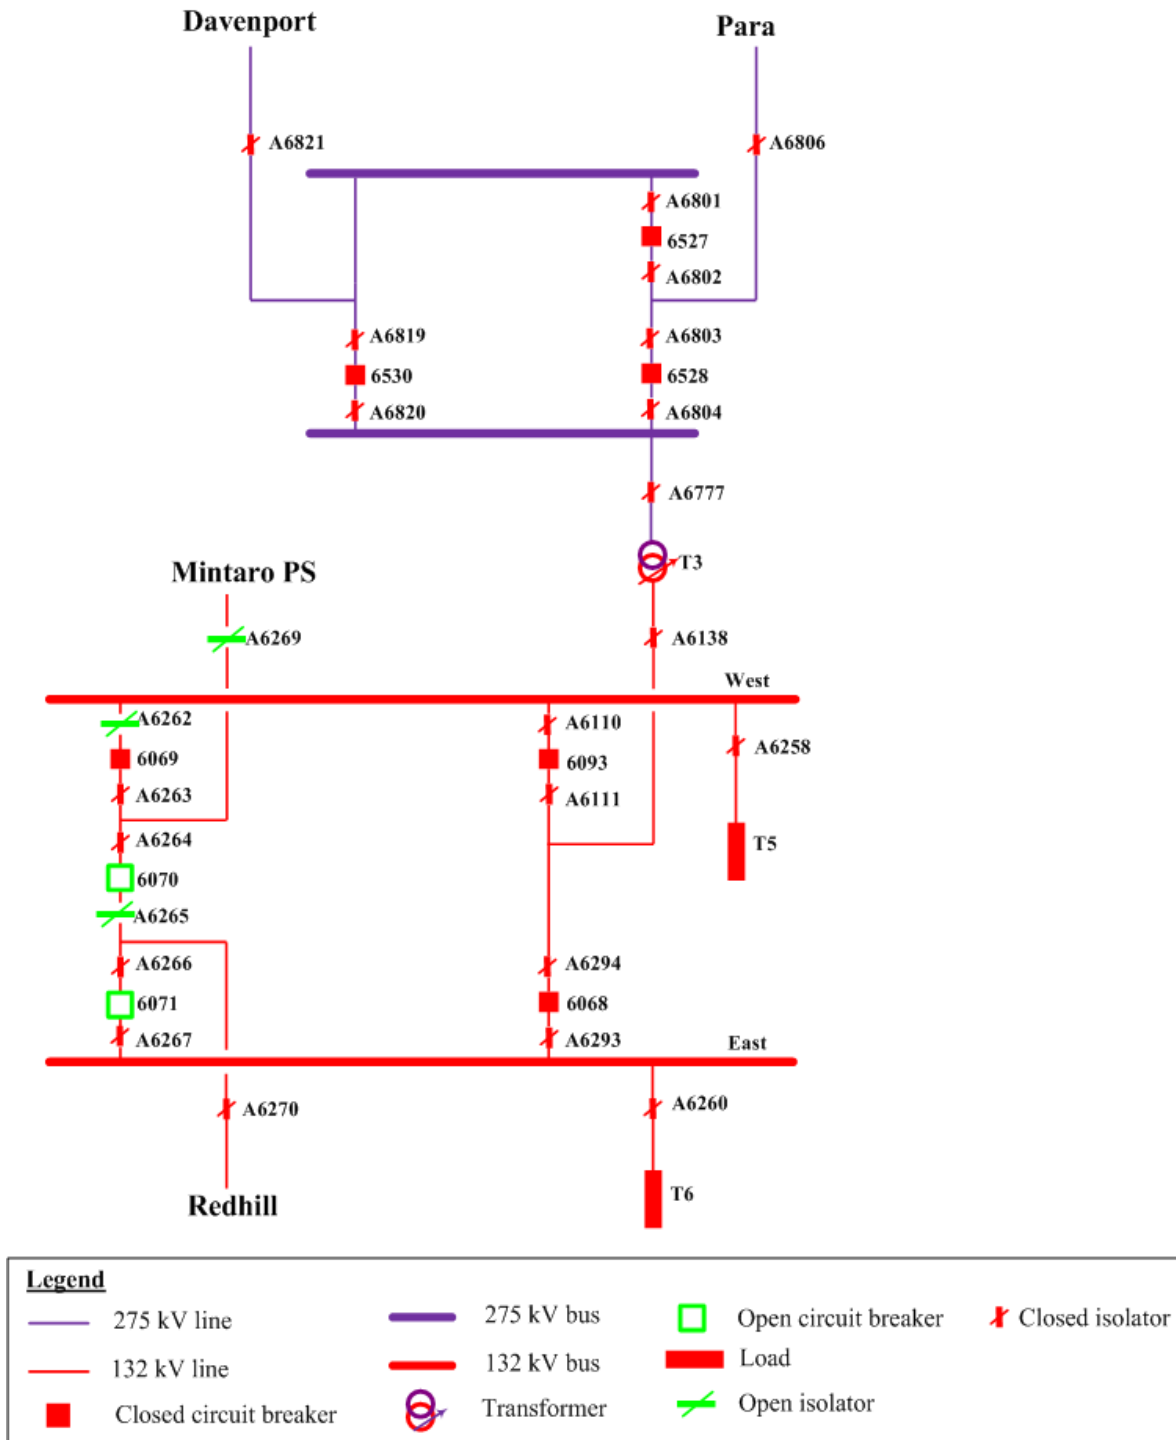
Time	Event/Action	Impact on Transmission Network
	<p>Para – Brinkworth line.</p> <p>The circuit breaker 6528 at Brinkworth (refer Figure 1) was slow to open causing circuit breaker failure protection to operate tripping the circuit breakers 6530, 6527, 6528, 6093 and 6068 at Brinkworth (see Figure 2) and sending an inter-trip signal to open circuit breakers 6517 and 6518 at Para (see Figure 4).</p> <p>The circuit breakers 6517 and 6518 at Para single phase auto-reclosed but tripped again on the receipt of the inter-trip signal from Brinkworth.</p>	<p>energised from Davenport.</p> <p>Brinkworth 132/275 kV transformer (T3) was disconnected (Figure 2).</p> <p>The 275 kV transmission lines between Davenport, Para and Tungkillo reduced to Robertstown – Para and Robertstown – Tungkillo lines. Loss of these two lines had been declared as a credible contingency event at the time.</p>

Figure 1: Single line diagram showing the status of important switchgear at Brinkworth 275 kV switching station just before the multiple 275 kV transmission line outages.

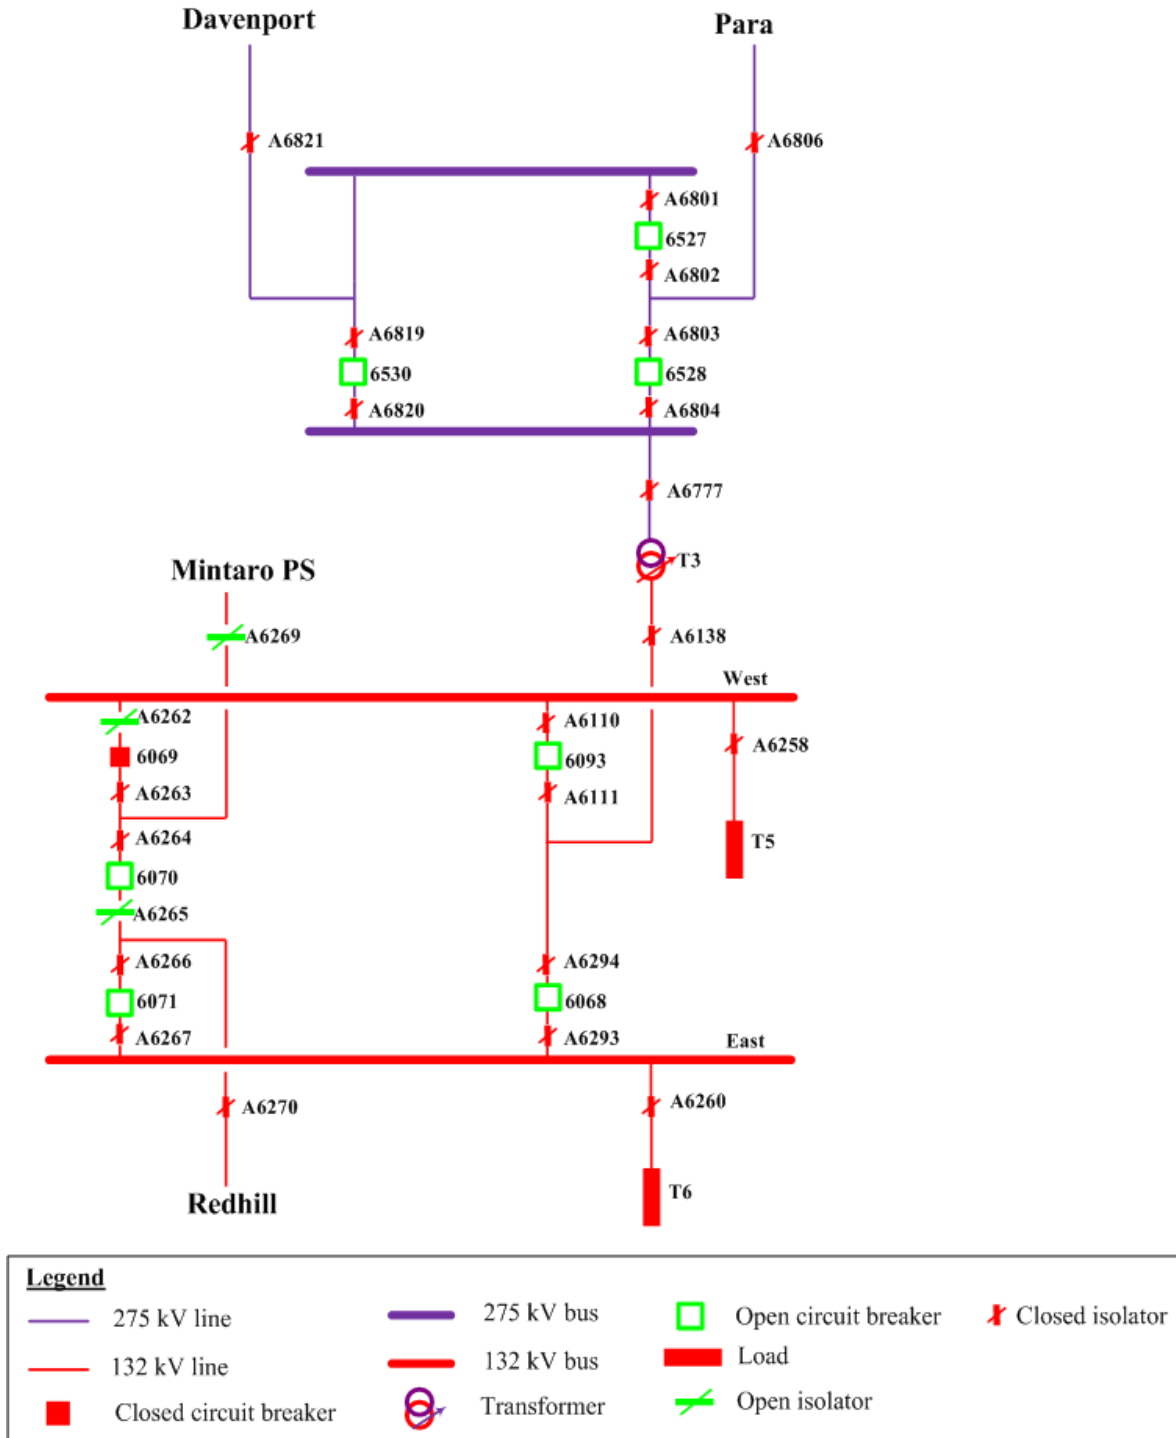
Figure 2: Single line diagram showing the status of important switchgear at Brinkworth 275 kV switching station just after the multiple 275 kV transmission line outages.

The investigation further revealed that circuit breaker 6528 at Brinkworth failed to operate for the three phase trip signal triggering the operation of backup protection systems at Brinkworth.

On 30 November 2010 ElectraNet completed additional maintenance on circuit breakers 6527, 6528 and 6530 at Brinkworth as an interim measure until these circuit breakers are replaced. These circuit breakers are scheduled to be replaced by the end of December 2011.

- Logic errors in programming of auto-reclosing relays were corrected on 1 November 2010.
- Additional maintenance of circuit breakers 6527, 6528 and 6530 at Brinkworth was completed on 30 November 2010.
- Replacement of circuit breakers 6527, 6528 and 6530 at Brinkworth has been scheduled to be completed by the end of December 2011.

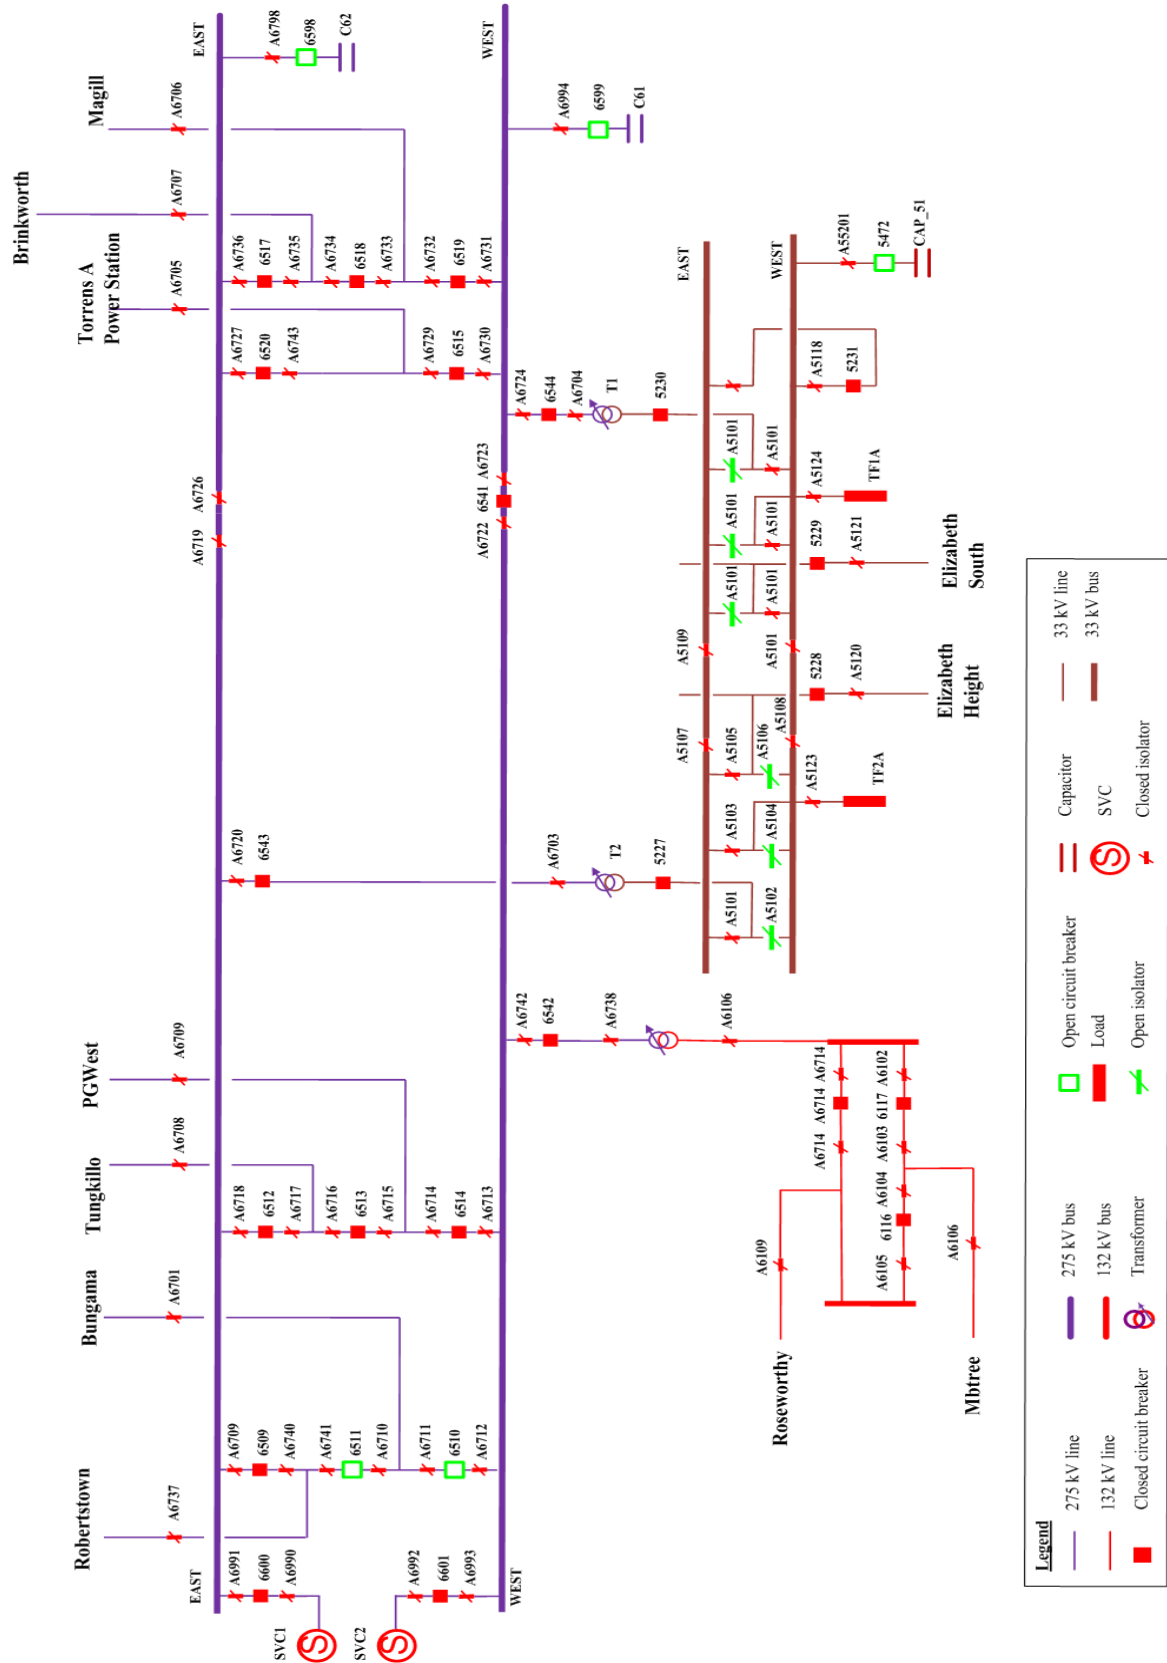
Figure 3: Single line diagram showing the status of the important switchgear at Para 275 kV switching station just before the multiple 275 kV transmission line outages.

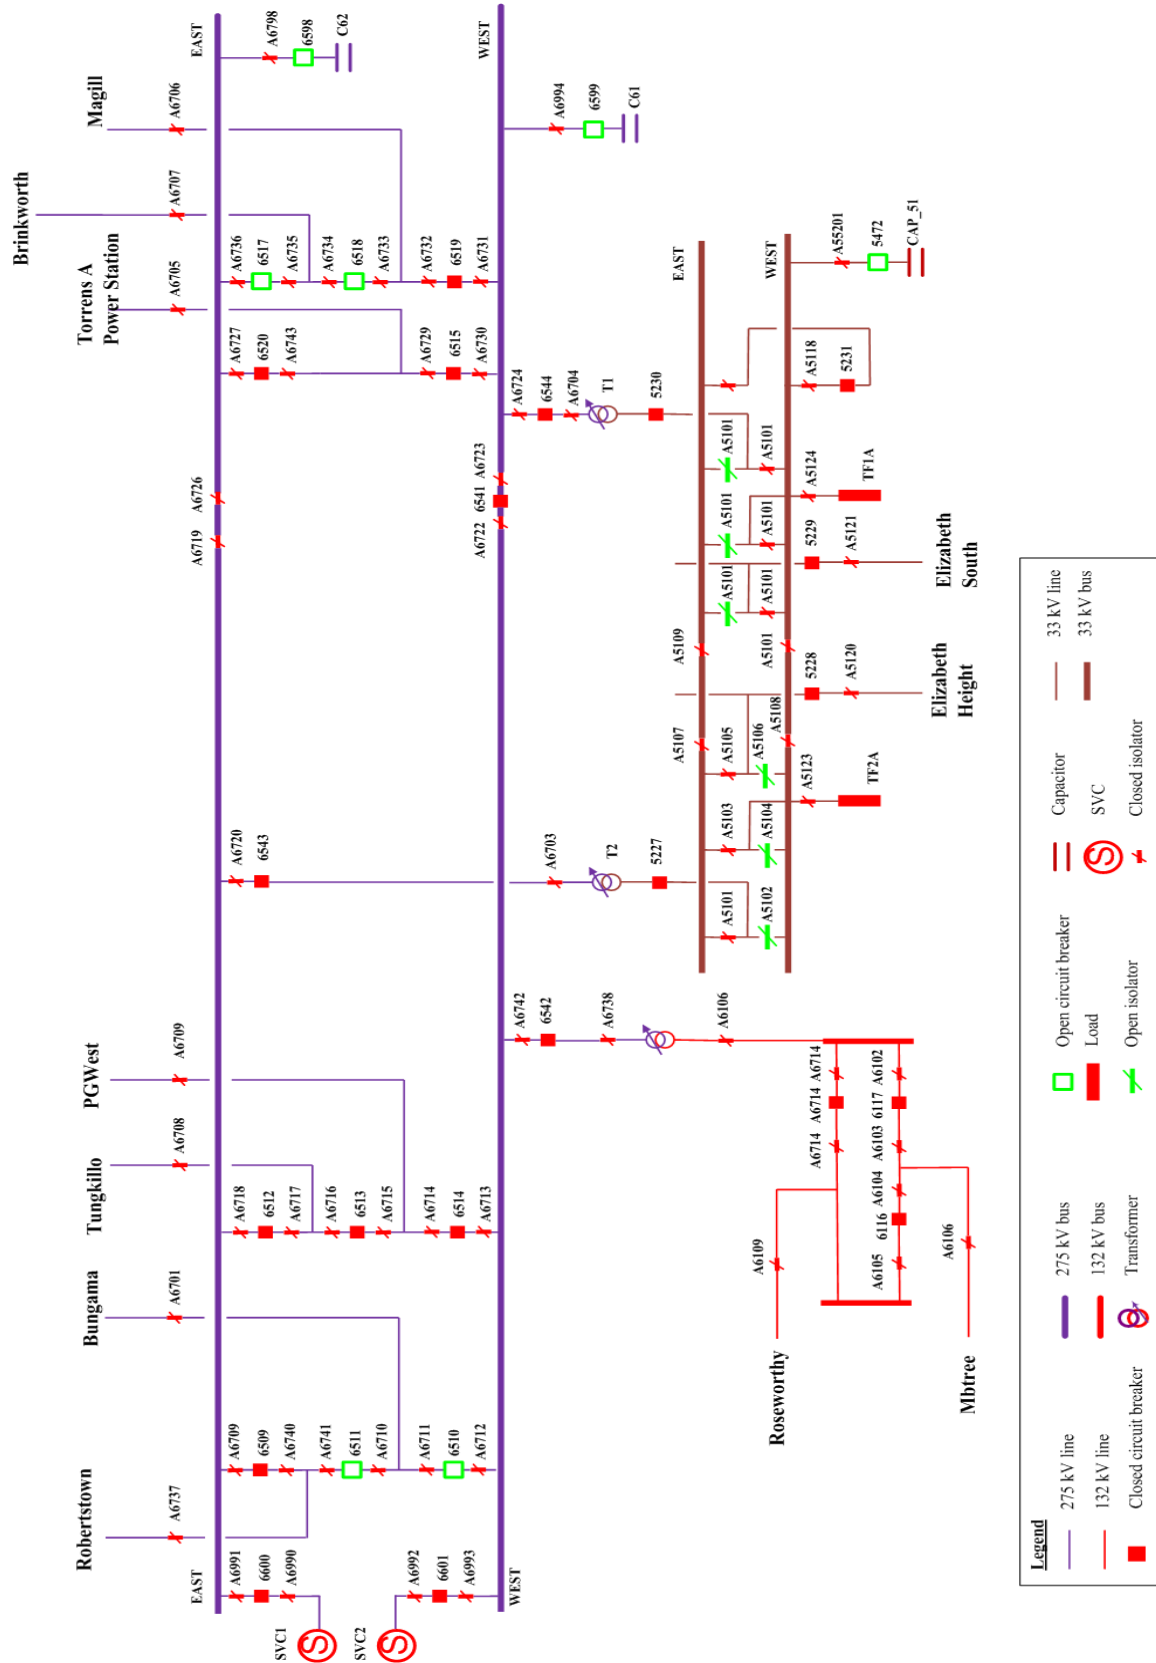
Figure 4: Single line diagram showing the status of important switchgear at Para 275 kV switching station just after the multiple 275 kV transmission line outages.
