GLEN INNES 132 KV BUSBAR TRIP ON THE 10 JANUARY 2011

PREPARED BY: Electricity System Operations Planning and Performance

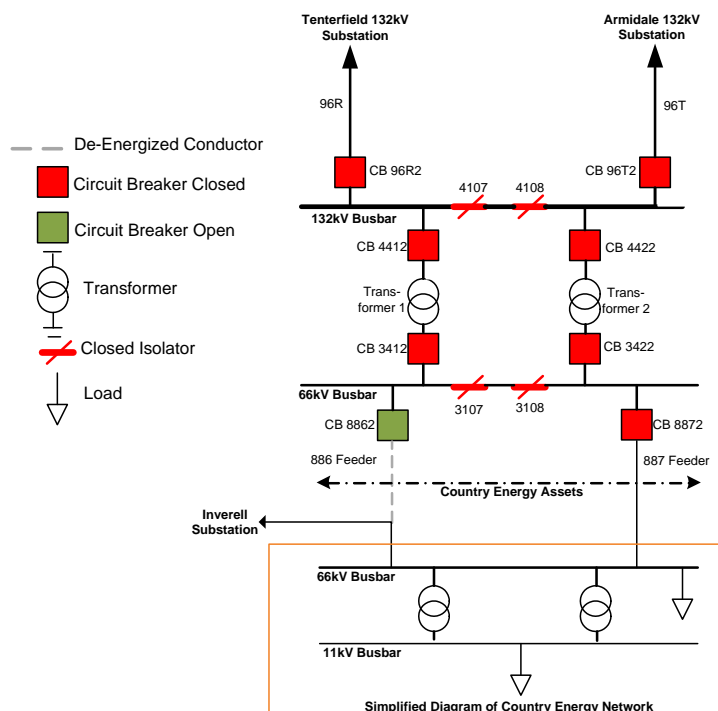
Figure 1: Status of Equipment at Glen Innes substation Prior to the Incident

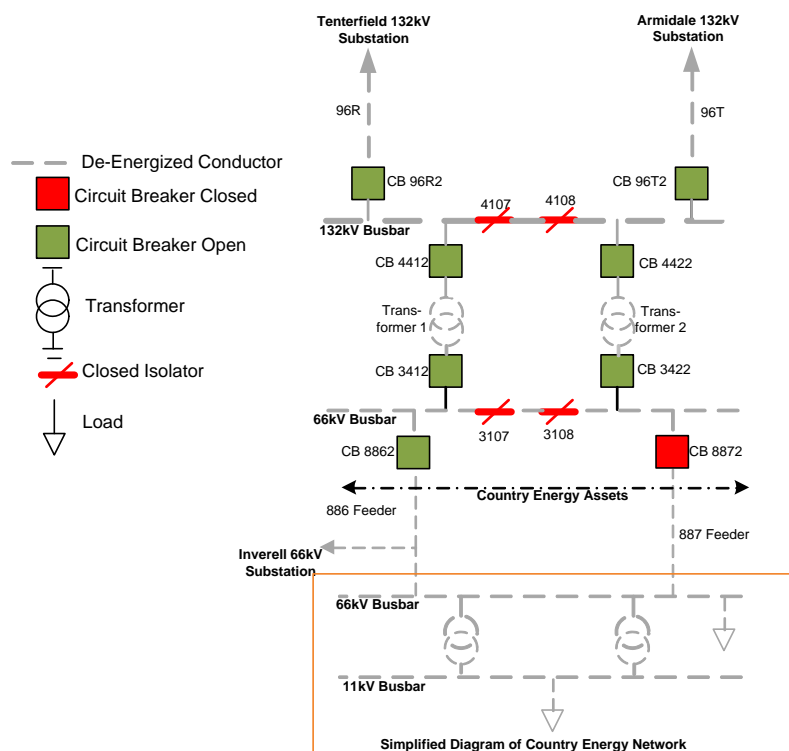
Both No.1 and No.2 protections of the 132 kV busbar were in service at the time. The No.2 busbar protection operated when an electrical fitter was tightening a cable tie within the 132 kV busbar protection kiosk and a CT summation connection wire came loose from the connection link set, initiating the operation of the 132kV busbar No.2 protection.

Figure 2: Status of Equipment at Glen Innes substation after the Incident

Following preliminary investigations, the CT connections to the 132 kV busbar protection were checked, all the link set screws holding connections were tightened prior to returning the busbar to service.

In light of this power system incident, TransGrid will review its work practices to ensure the integrity of secondary wiring prior to commencing work on any secondary circuits and advise AEMO after any updates to its relevant procedures, by the end of May 2011.
