POWER SYSTEM INCIDENT REPORT TRIP OF MULTIPLE 132 KV TRANSMISSION LINES NEAR MACKAY SUBSTATION AND NEBO SVC ON 3 JANUARY 2011

PREPARED BY: ESOPP
VERSION: 1.0
DATE: 29 April 2011
FINAL

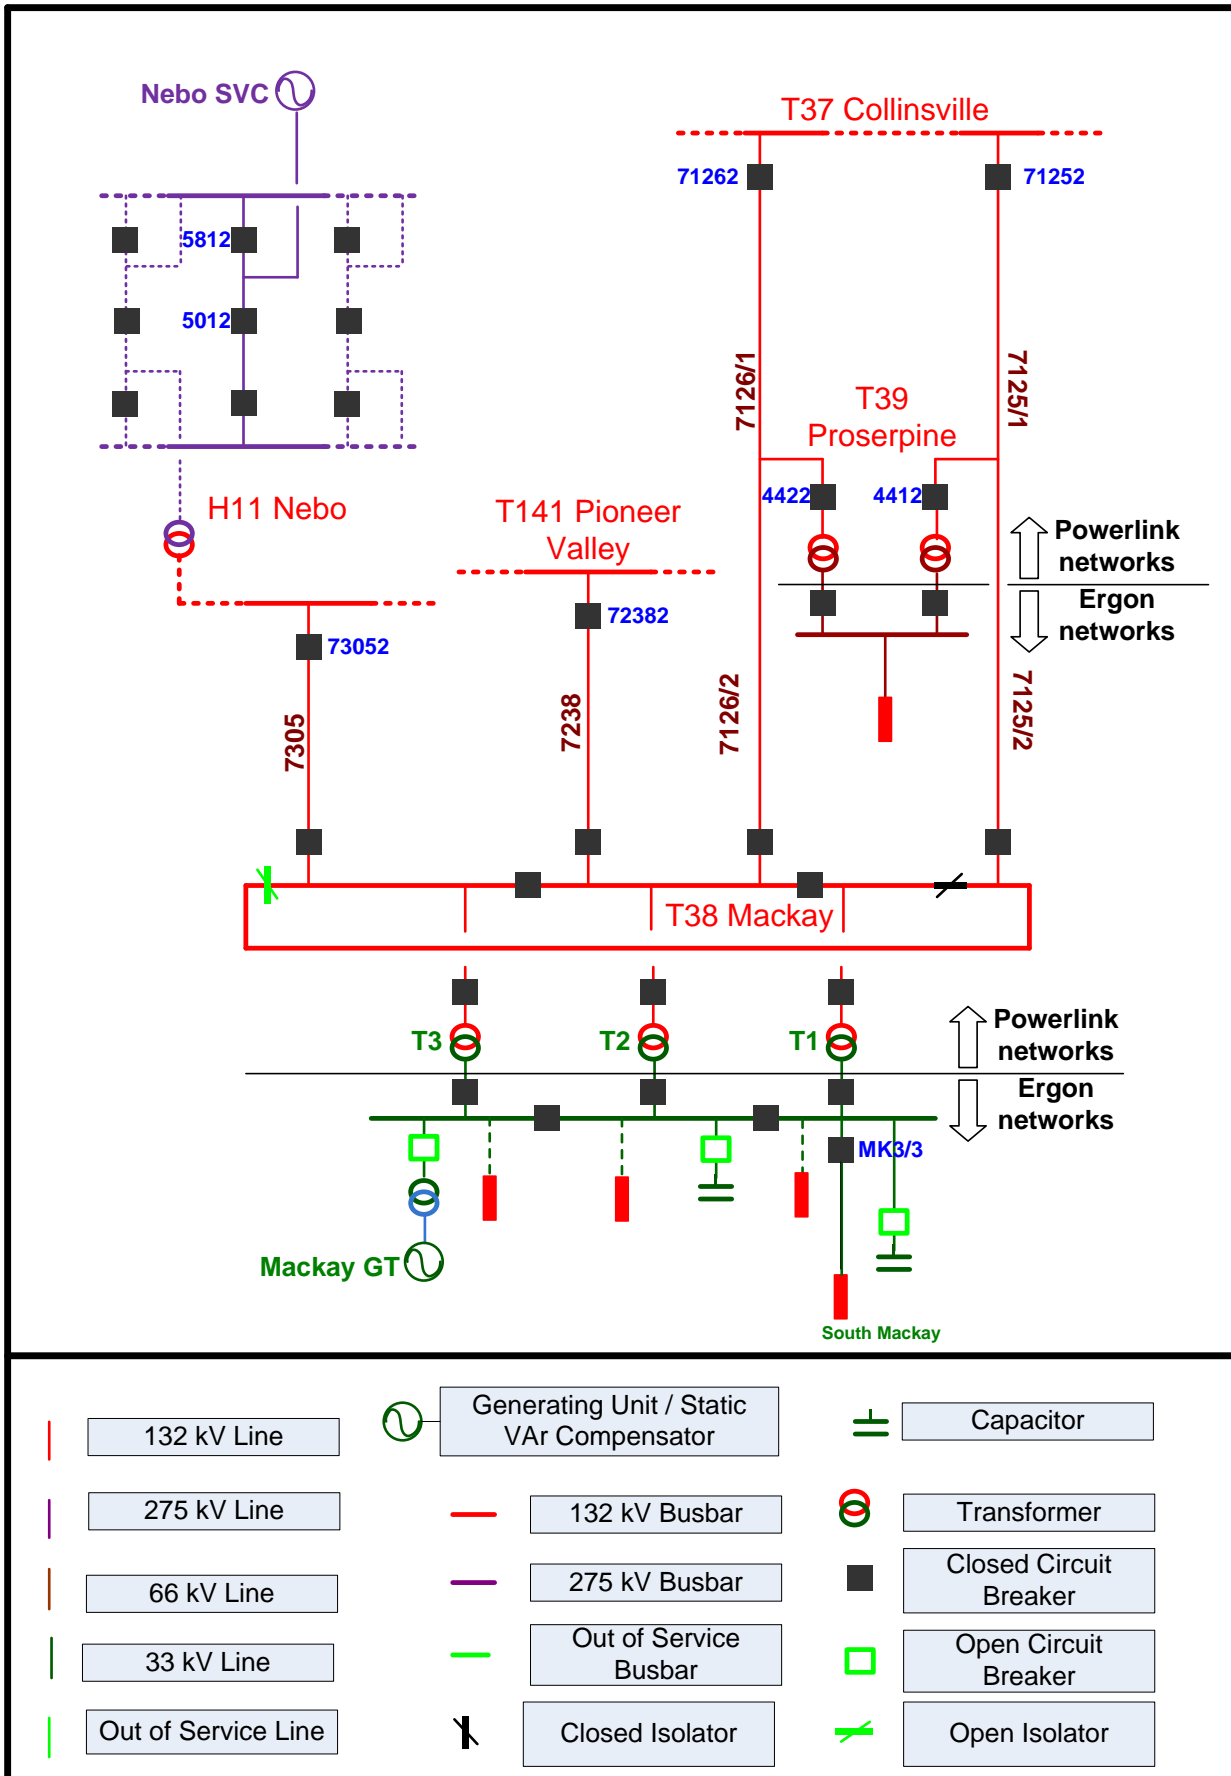
Figure 1 –Network in the vicinity of T38 substation and the connections to H11, T141, and T37 substations before the event

On 3 January 2011 the T38 Mackay 132 kV substation was operating in its system normal configuration. The Mackay gas turbine (Mackay GT) was not in service at the time. Refer Figure 1 for the network configuration at T38 Mackay substation and the network connections to H11 Nebo, T141 Pioneer Valley and T37 Collinsville substations before the event. For clarity, only plant and equipment that operated or provided connectivity between affected sites are shown in the diagram.

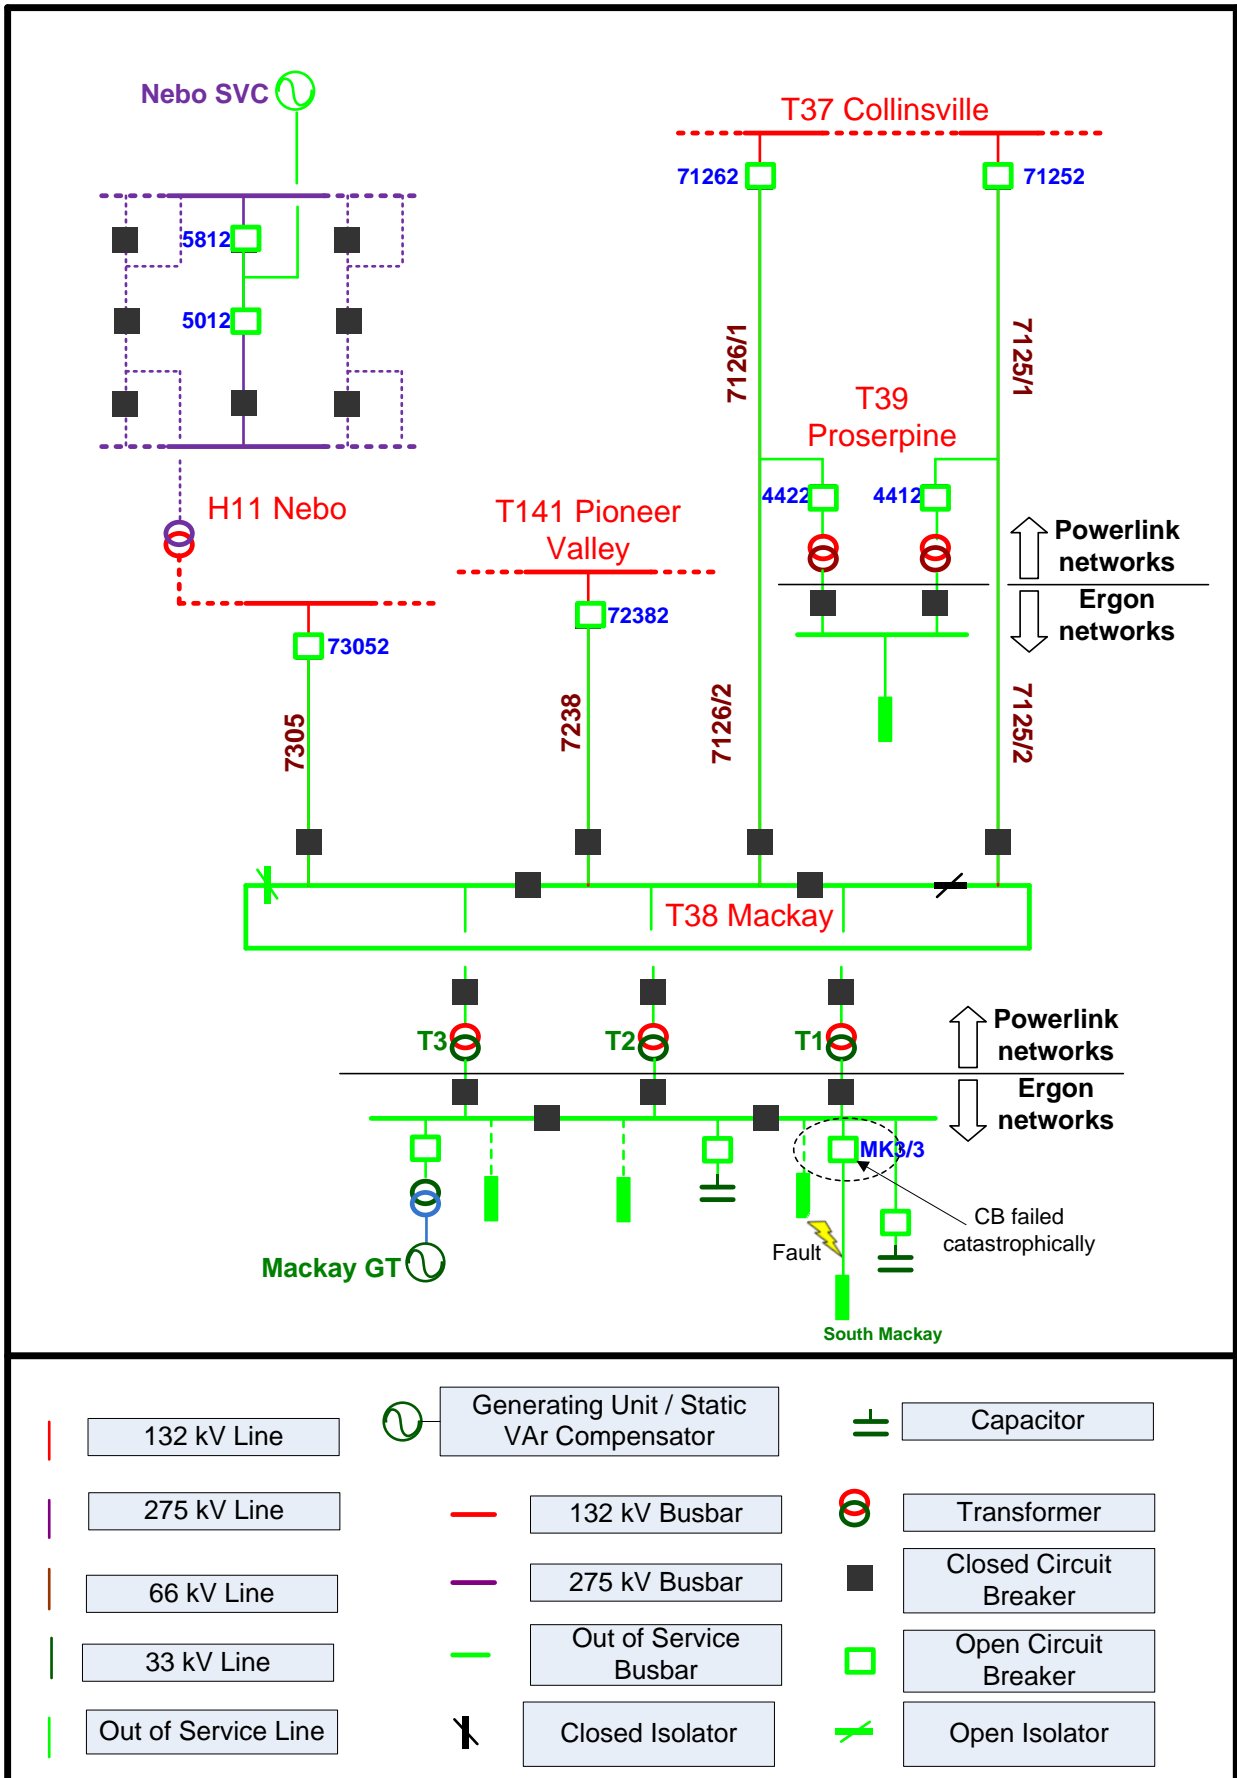
Figure 2 – Network in the vicinity of T38 substation and the connections to H11, T141, and T37 substations immediately after the event

The fault was detected by the protection systems in substations at remote ends of 132 kV lines that connect T38 Mackay. These lines are 7125, 7126, 7238 and 7305. The protection systems cleared the fault from the system by opening circuit breakers 71252, 71262, 72382 and 73052.

The tripping of these four lines resulted in the loss of 132 kV supply to Mackay and Proserpine substations. As a result, approximately 36 MW load supplied from Proserpine substation and approximately 40 MW load supplied from T38 Mackay substation was interrupted. Ergon Energy restored some load via their 33kV system and performed rotational shedding of load that could not be supplied.

The high voltage condition caused the static VAR compensator's protection system to trip the compensator by opening circuit breakers 5812 and 5012 at the Nebo 275 kV substation.

Refer Figure 2 for the network configuration at T38 substation and the connections to H11, T141 and T37 substations immediately after the two faults.
