POWER SYSTEM OPERATING INCIDENT REPORT

TRIP OF 132 KV CENTRAL QUEENSLAND FEEDERS ON 8 FEBRUARY 2011

PREPARED BY: Electricity System Operations Planning and Performance

DATE: 7 June 2011

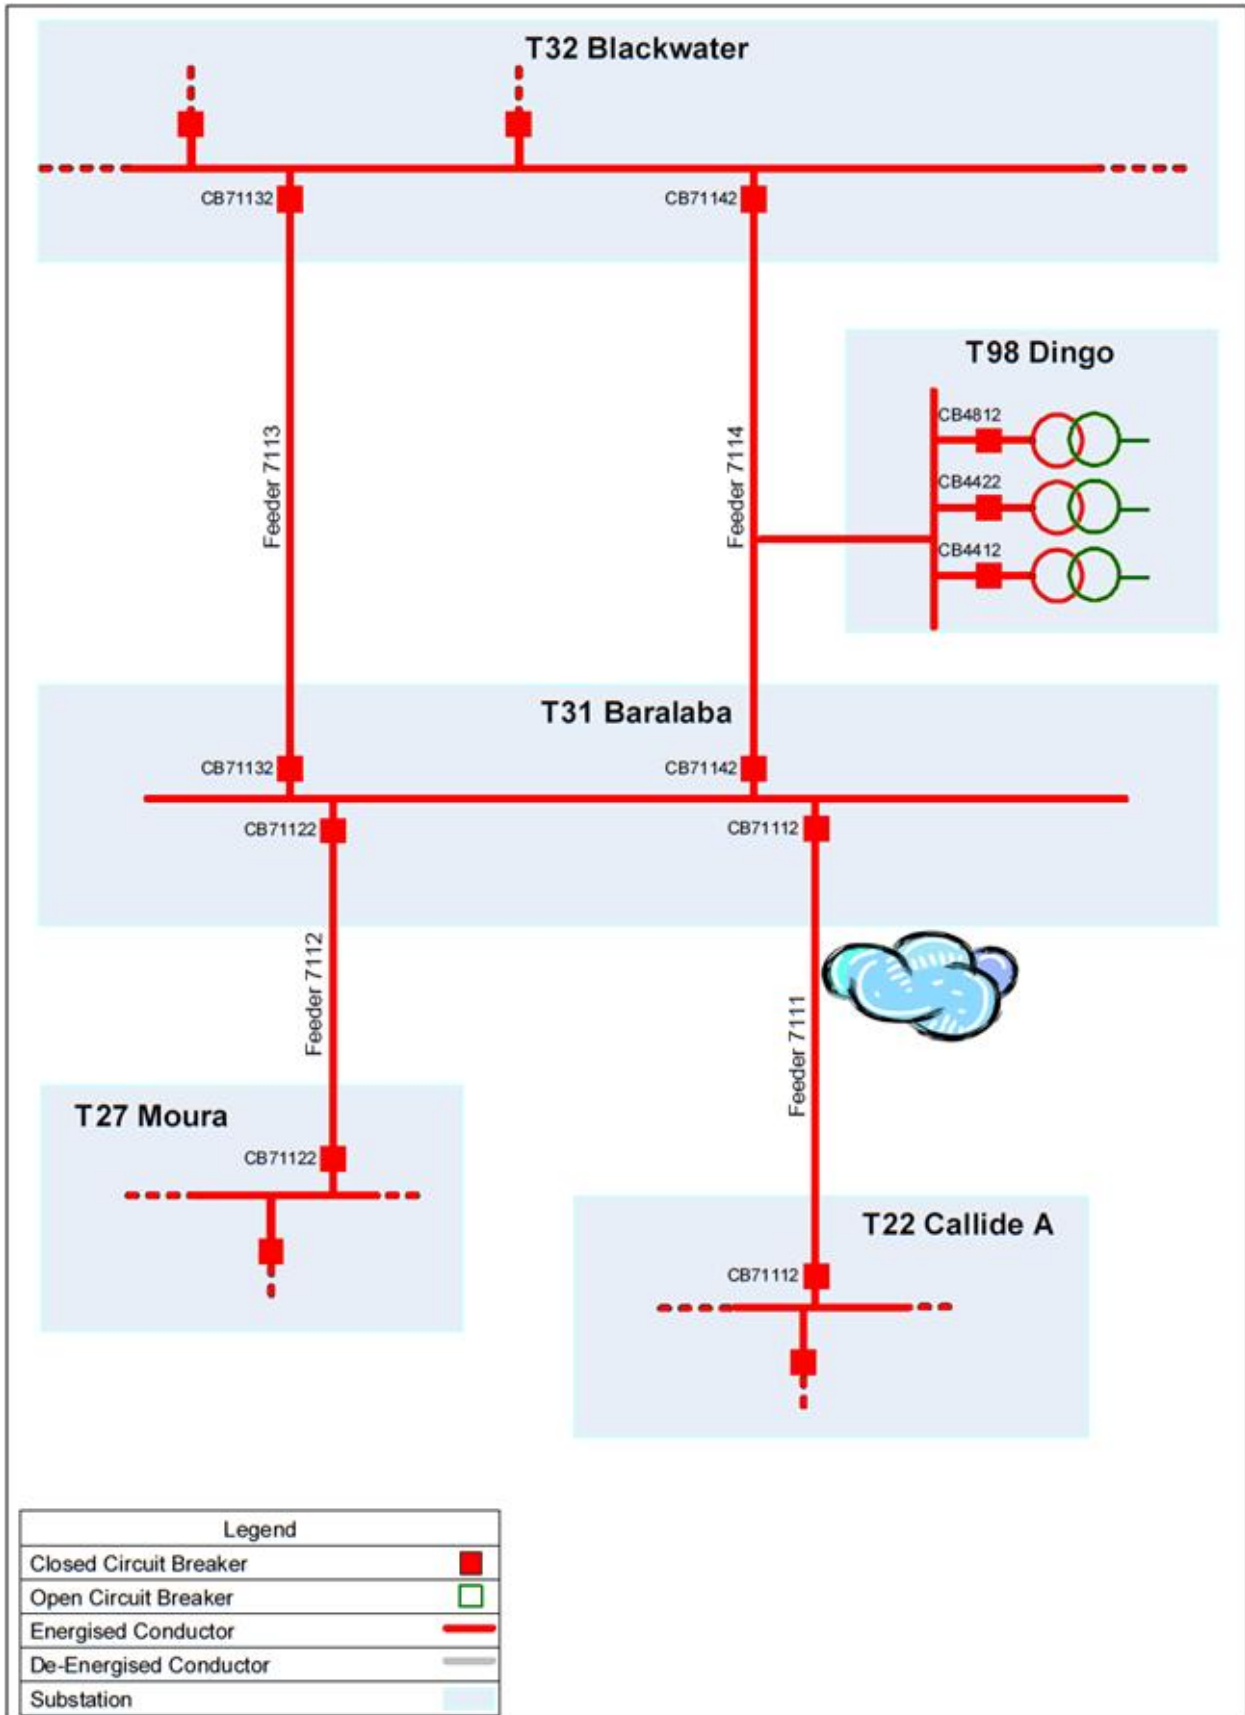
The status of power system equipment prior to the incident is shown in Figure 1. For clarity only equipment relevant to this incident has been included in the diagram.

Figure 1 – Status of the power system connected to the Baralaba 132 kV substation prior to the incident

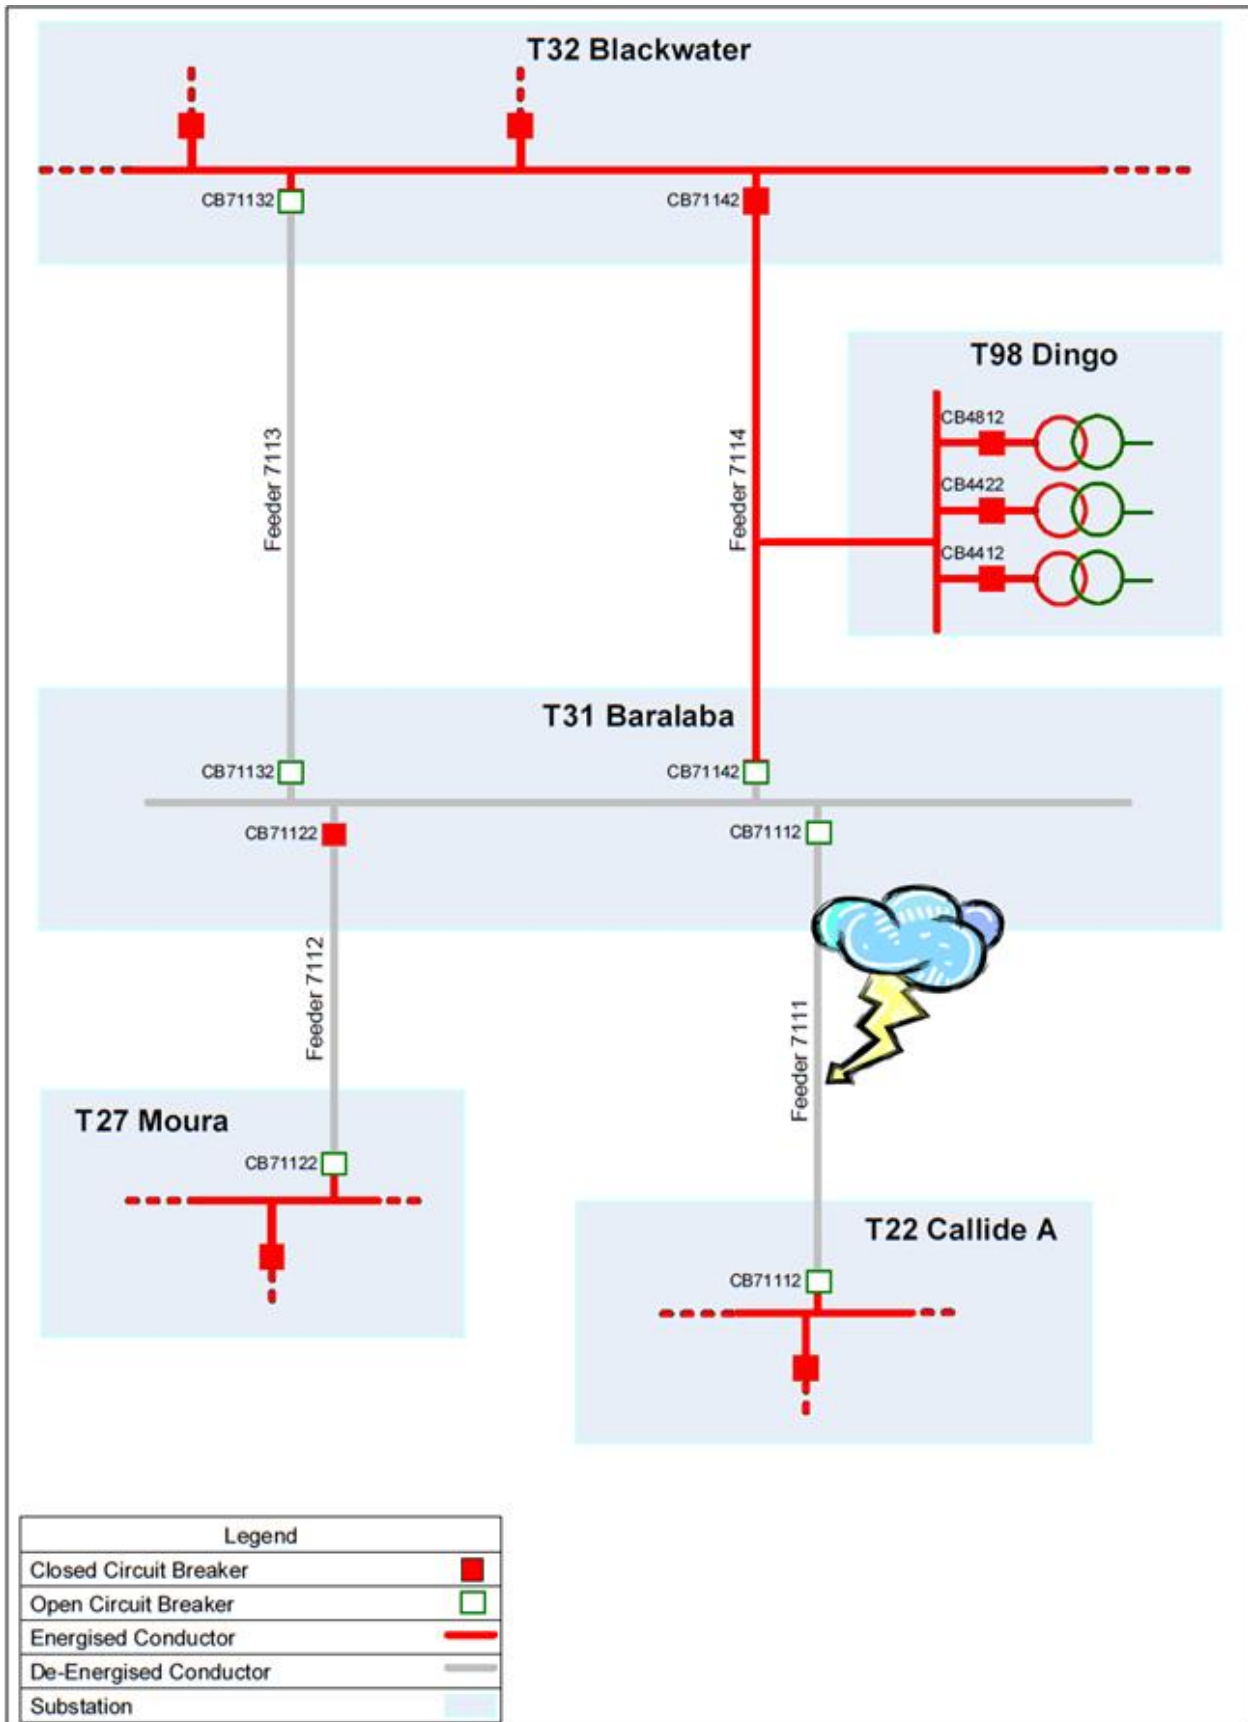
The status of the power system immediately following the incident is shown in Figure 2.

Figure 2 - Status of the power system connected to the Baralaba 132 kV substation immediately after the incident
