POWER SYSTEM OPERATING INCIDENT REPORT

TRIP OF MULLUMBIMBY 132 KV BUSBAR AND MULTIPLE TRANSMISSION LINES ON 13 MARCH 2011

PREPARED BY: Electricity System Operations Planning and Performance

DATE: 09 August 2011

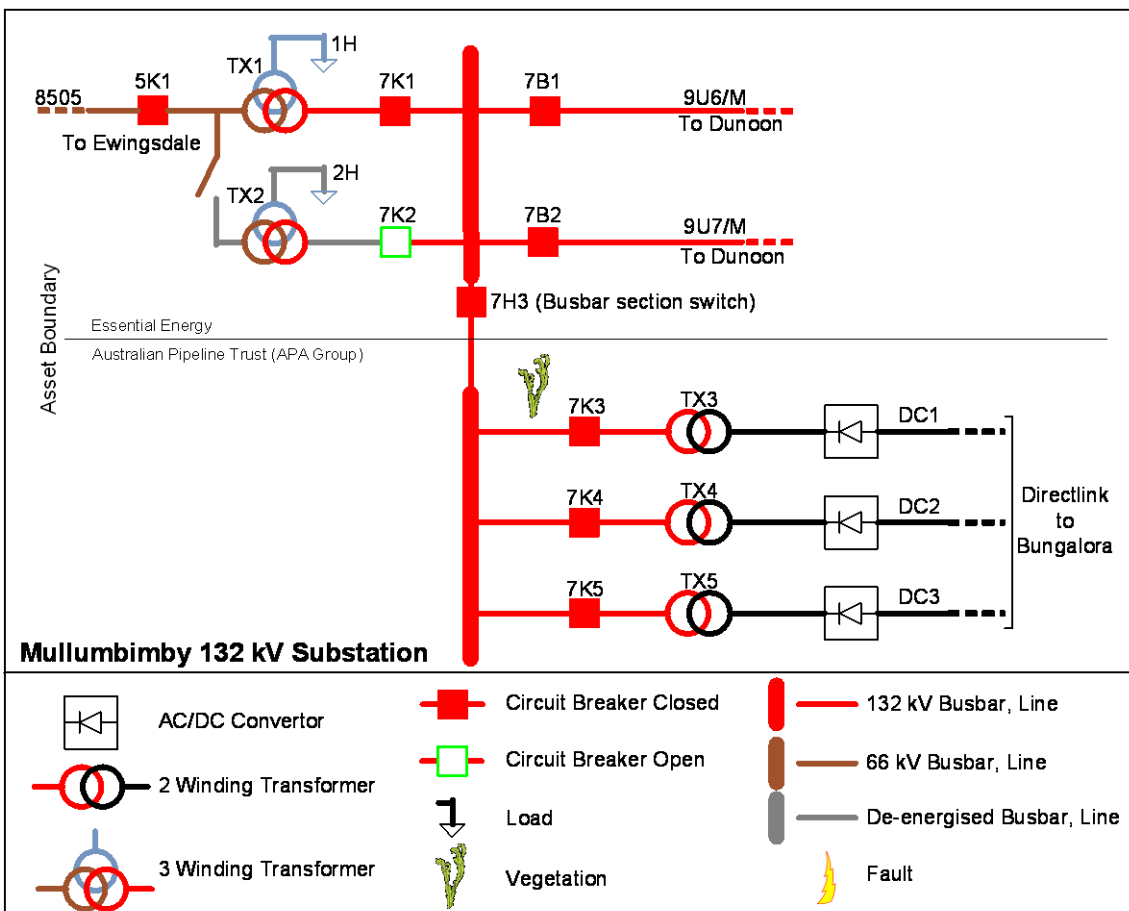
Figure 1 – Status of the power system prior to the incident

The status of the power system prior to the incident is shown in Figure 1. For clarity only equipment relevant to this incident has been included in the diagram.

Prior to the incident, all circuit breakers and transmission elements at Mullumbimby were operating in their normal state. The TX2 transformer is normally switched out of service. The Directlink cables were transferring approximately 20 MW from Bungalora to Mullumbimby.

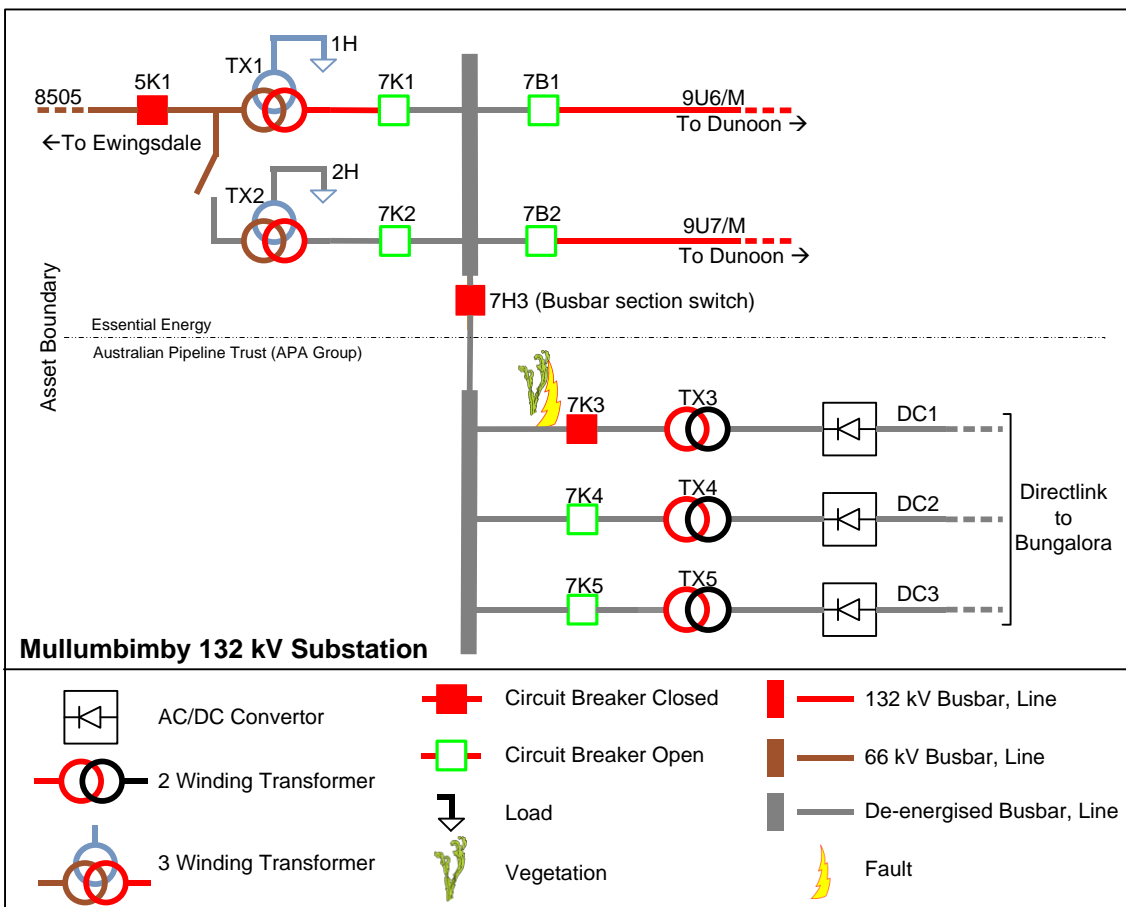
Figure 2 - Status of the power system immediately after the incident

At 1224 hrs on 13 March 2011, the vegetation in the filter yard of Mullumbimby substation caused a one phase to ground fault on the busbar during a period of heavy rain. The fault occurred near the 7K3 circuit breaker as shown in Figure 2 below. A protection operation cleared the fault by opening circuit breakers 7K1, 7K2, 7K4, 7K5, 7B1 and 7B2, de-energising the Mullumbimby 132 kV busbar. One phase of circuit breaker 7K3 failed to open, but the fault was isolated from the system because the DC1 converter valves blocked when the fault occurred, so energy could not be transferred over the DC link at this time.

The busbar section switch 7H3 currently has no protection or control functions, so it remained closed.

The status of the power system immediately after the incident is shown in Figure 2.

Work is planned to be completed by January 2012 that will incorporate busbar section switch 7H3 into the protection schemes so that a similar fault will split the Mullumbimby busbar, leaving other Essential Energy assets at Mullumbimby in service.

In light of this incident, APA Group will review their schedule for vegetation management adjacent to high voltage equipment. APA Group will inform the progress of this review to AEMO by the end of July 2011.
