# POWER SYSTEM OPERATING INCIDENT REPORT

## TRIP OF NO. 1 GLADSTONE 275 KV BUSBAR ON 13 MAY 2011

PREPARED BY: Electricity System Operations Planning and Performance

DATE: 22 August 2011

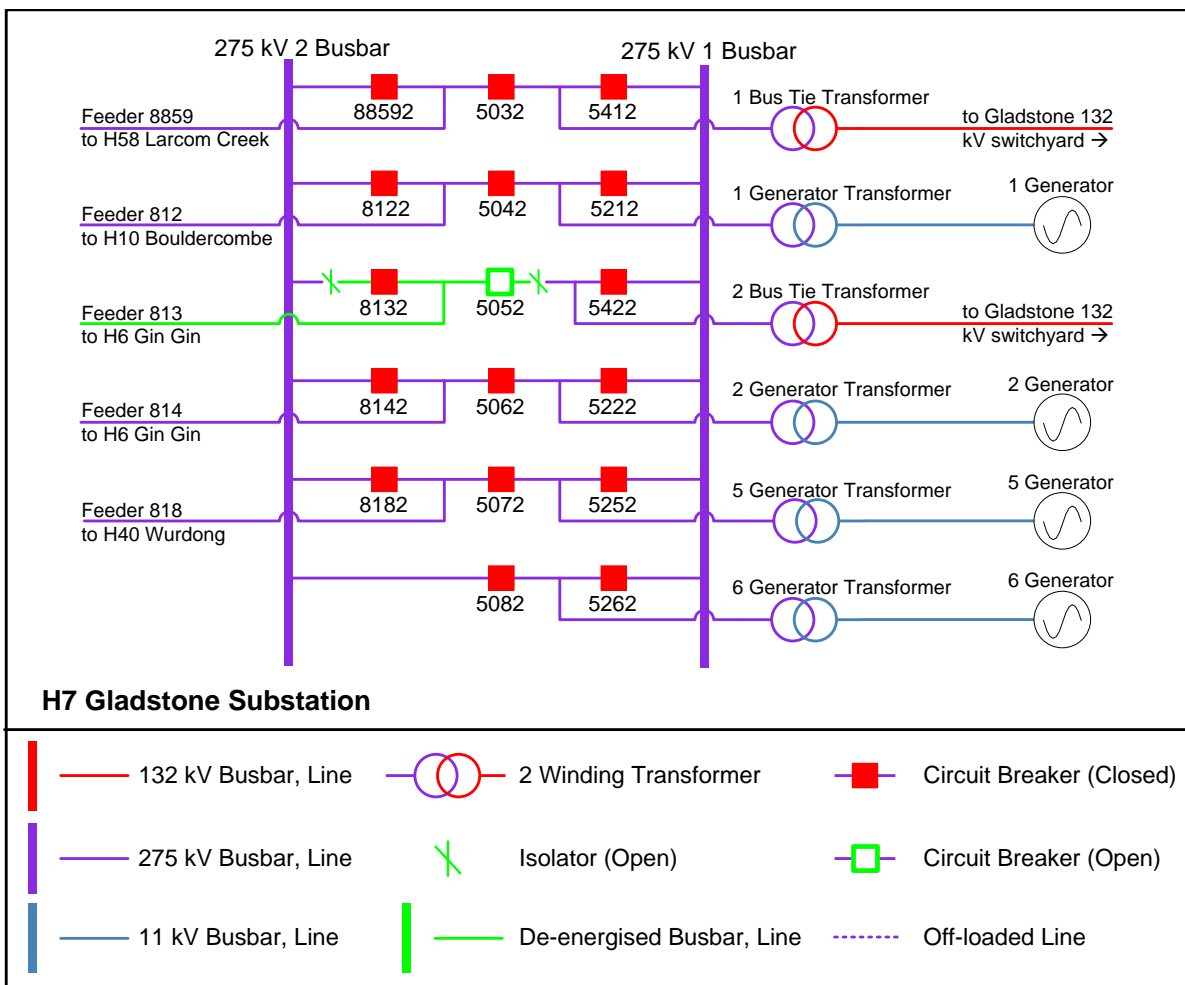
Figure 1 – Status of the Gladstone 275 kV switchyard prior to the incident

The Gladstone 275 kV switchyard is a breaker and a half electrical layout comprising two 275 kV busbars. Prior to the incident, the 813 Gladstone—Gin Gin 275 kV transmission line had been taken out of service and Gladstone 275 kV circuit breaker 5052 was open for planned work. The status of the Gladstone 275 kV switchyard prior to the incident is shown in Figure 1.

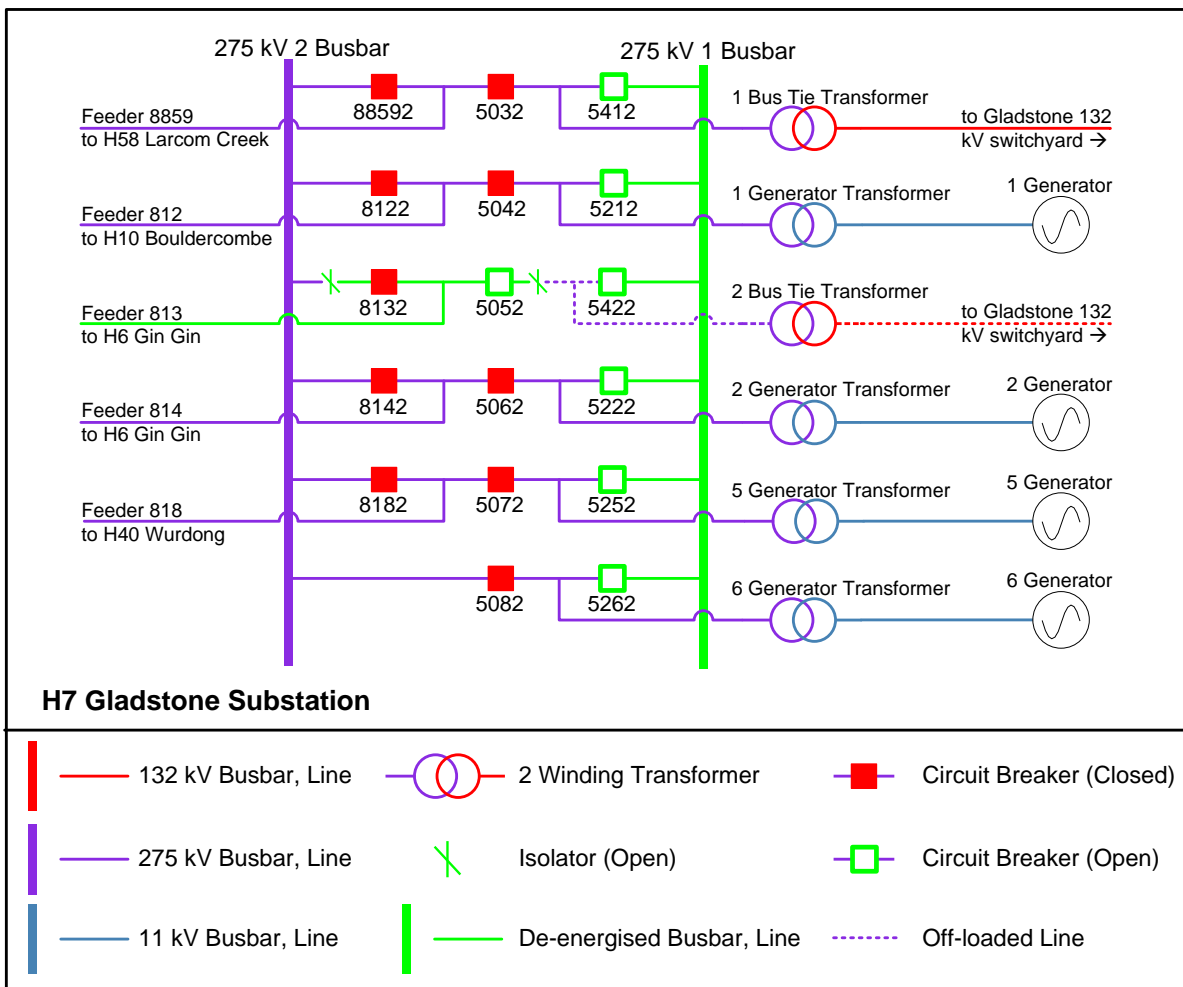
Figure 2 - Status of the Gladstone 275 kV switchyard immediately after the incident

At 0822 hrs on 13 May 2011 the No. 1 275 kV busbar trip relay<sup>1</sup> operated at Gladstone substation during planned work on protection systems. The operation of this relay opened all of the circuit breakers connected to the Gladstone No. 1 275 kV busbar. A high voltage fault was not experienced at the time and the operation of the busbar trip relay was unexpected.

Circuit breaker 5052 at Gladstone was open for planned work prior to the incident. The combination of this outage and the busbar trip caused the Gladstone No. 2 275/132 kV bus tie transformer to be off-loaded. The transformer remained energised from the Gladstone 132 kV switchyard.
