POWER SYSTEM OPERATING INCIDENT REPORT TRIP OF NO.2 EILDON GENERATING UNIT ON 18 AUGUST 2011

PREPARED BY: Electricity System Operations Planning and Performance

DATE: 2 February 2012

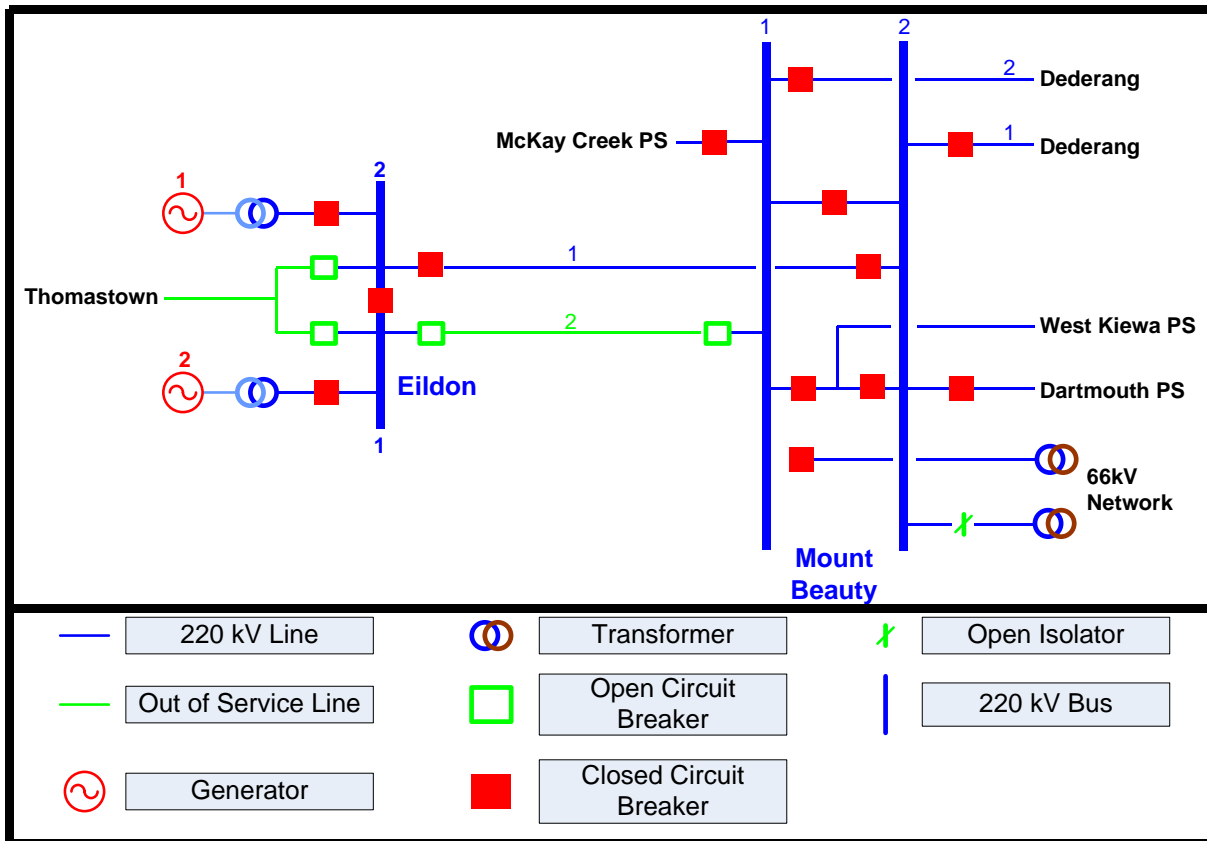
Figure 1 – Status of Eildon terminal station and connections to Mount Beauty prior to the incident

The status of EPS and connections to MBTS prior to the incident are shown in Figure 1³. Only the equipment relevant to this incident has been included in the diagram for clarity.

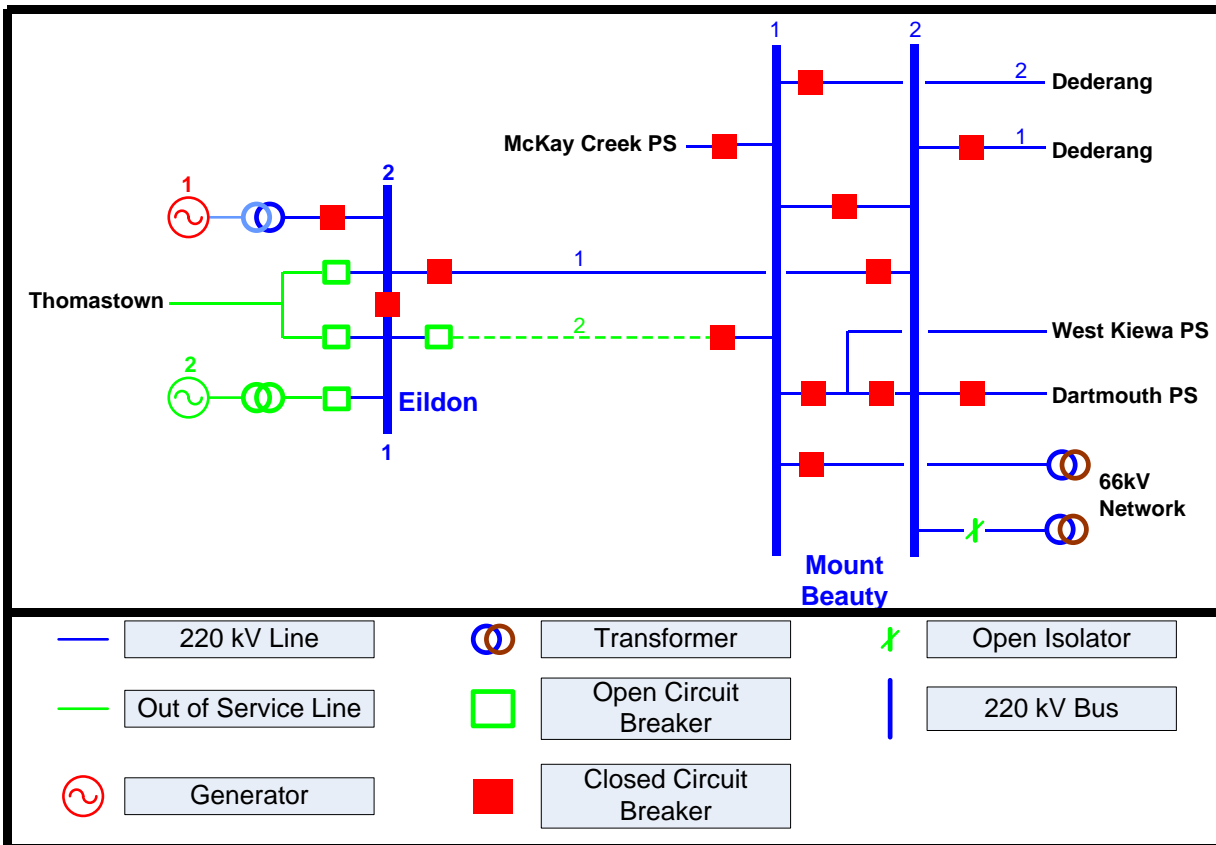
Figure 2 - Status of Eildon terminal station and connections to Mount Beauty immediately after the incident

At 0851 hrs, No.2 Eildon generating unit tripped out of service on closing of the No.2 EPS – MBTS 220 kV line circuit breaker (CB) at MBTS end. No.1 Eildon generating unit remained in service.

The status of EPS and connections to MBTS immediately after the incident are shown in Figure 2.

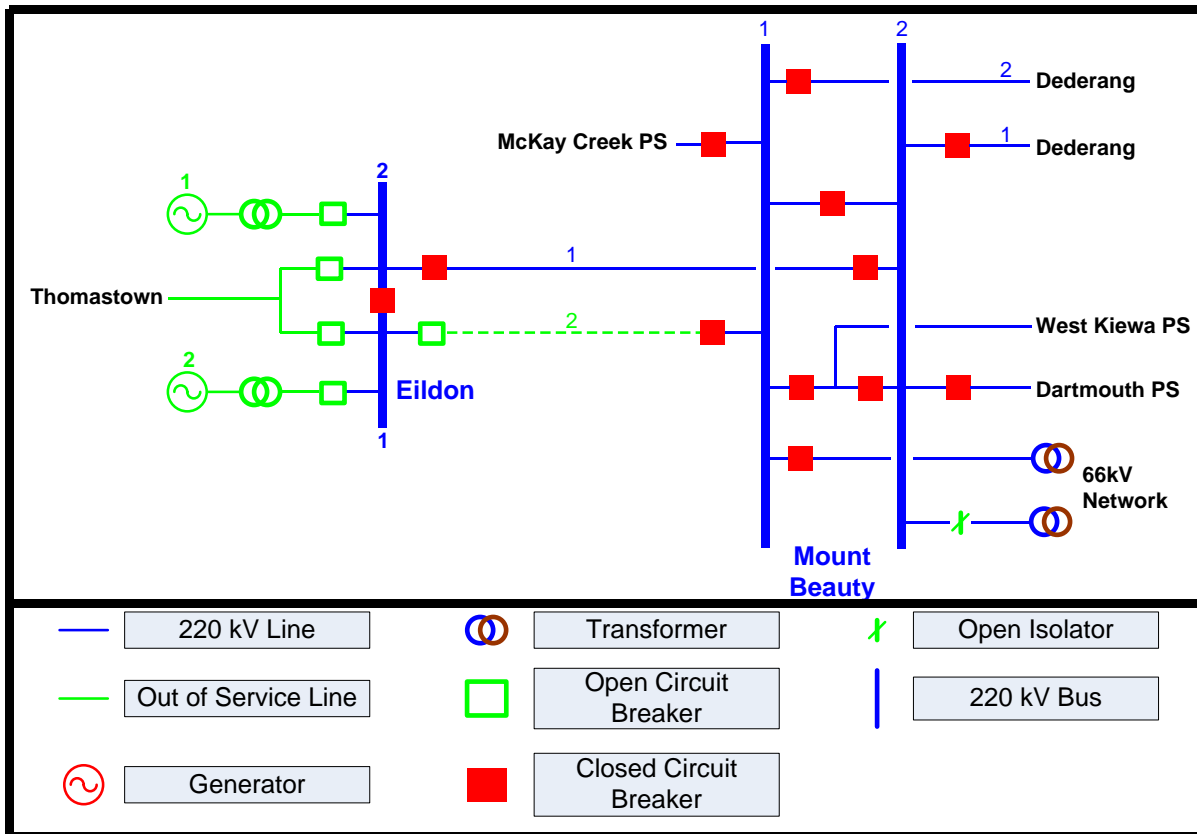
Figure 3 - Status of Eildon terminal station and connections to Mount Beauty immediately after the test

The EPS No.2 unit was brought back to service and at 1044 hrs, the CB of No.2 EPS – MBTS 220 kV line at MBTS was closed. On this occasion both No. 1 and No. 2 generating units tripped out of service.

The status of EPS and connections to MBTS immediately after the test are shown in Figure 3.

Onsite investigations showed that the trip of the 220 kV generator CBs at EPS were initiated by the operation of generator transformer protection relays. However, the exact reason for operation of these relays was not clear at this time.

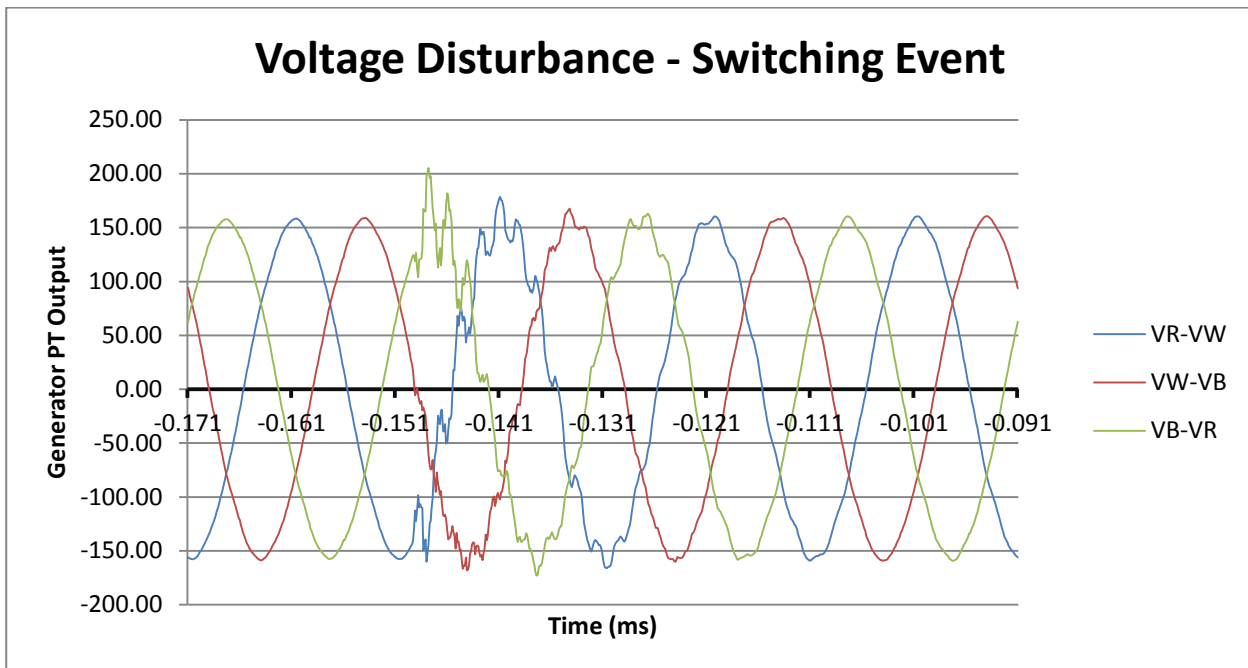
Figure 4 – Voltage disturbance during switching event of No.2 EPS – MBTS 220 kV line (Source: AGL)⁴

Further investigations by AGL revealed that the generating unit's governor system had sent a trip signal to the generator transformer protection relay 150 ms after a line voltage disturbance caused by the closing of CB at MBTS end.

The governor electrical over-speed protection of EPS generating units had been set to operate instantaneously at the time. The speed measurement used by the governor electrical over-speed protection is derived using the voltage waveform of 220 kV voltage at the EPS switchyard. AGL determined that whenever a significant level of harmonics was present in this high voltage measurement, the governor electrical over-speed would operate.

During this power system incident and during the subsequent testing, closing of the EPS–MBTS line CB at MBTS resulted in a voltage disturbance which operated the governor electrical over-speed protection. The governor electrical over-speed protection then sent a trip signal to the generator transformer protection relay, resulting in the Eildon generating units tripping out of service. The testing conducted by AGL also confirmed that the generator transformer protection relay operated as designed during the incident.

Figure 4 shows the voltage disturbance that occurred as a result of the closure of CB at MBTS end at 1044 hrs on 18 August 2011.

Initially, AGL inhibited the electrical over-speed protection as a temporary measure until a permanent solution could be implemented. Note that generator over-speed protection is also provided by two other independent protection systems.

Subsequently, AGL placed the governor electrical over-speed protection in service after introducing a time delay setting of 0.5 seconds. The new protection setting was tested and found to operate satisfactorily.
