MULTIPLE CONTINGENCY EVENT FOLLOWING AN EARTHQUAKE IN VICTORIA ON 19 JUNE 2012

PREPARED BY: Systems Capability

DATE: 11 December 2012

FINAL (Version 2)

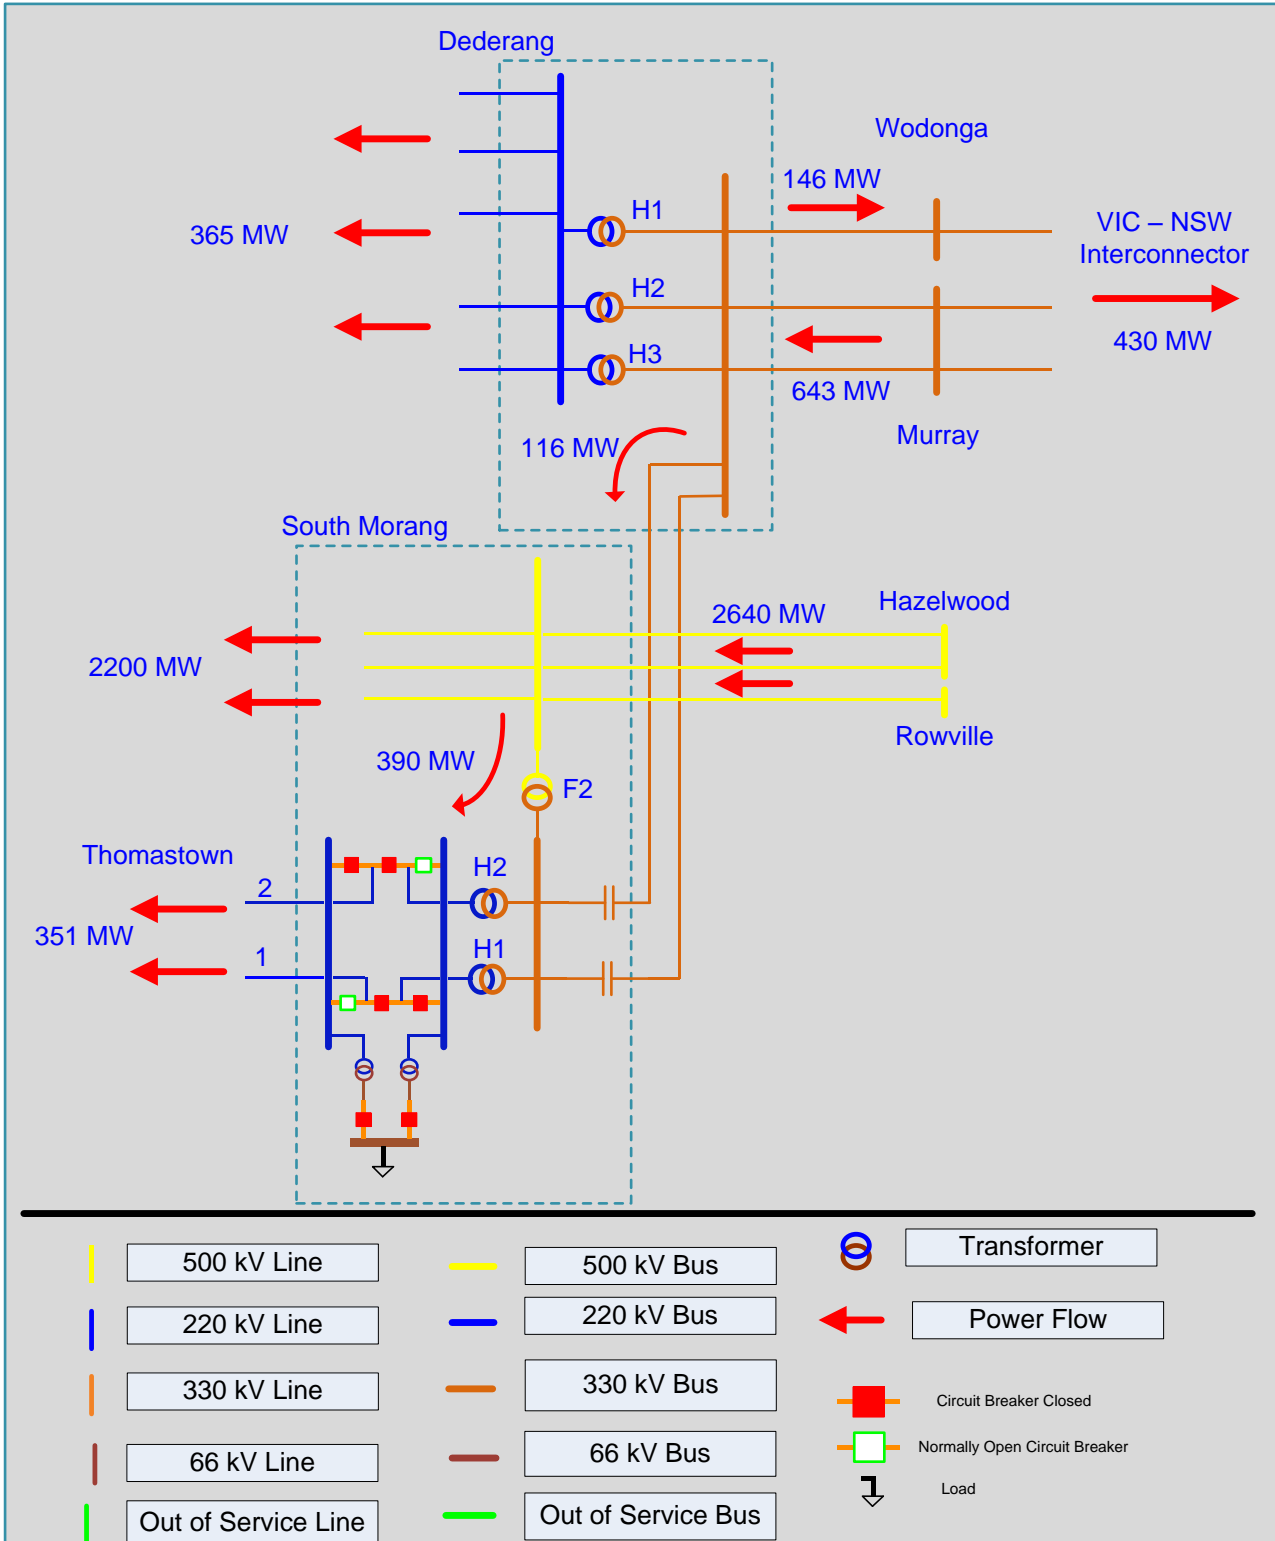
Figure 3 Pre event system conditions

The status of the power system prior to the incident is shown in Figure 3. For clarity, only equipment relevant to this incident has been included in the diagram.

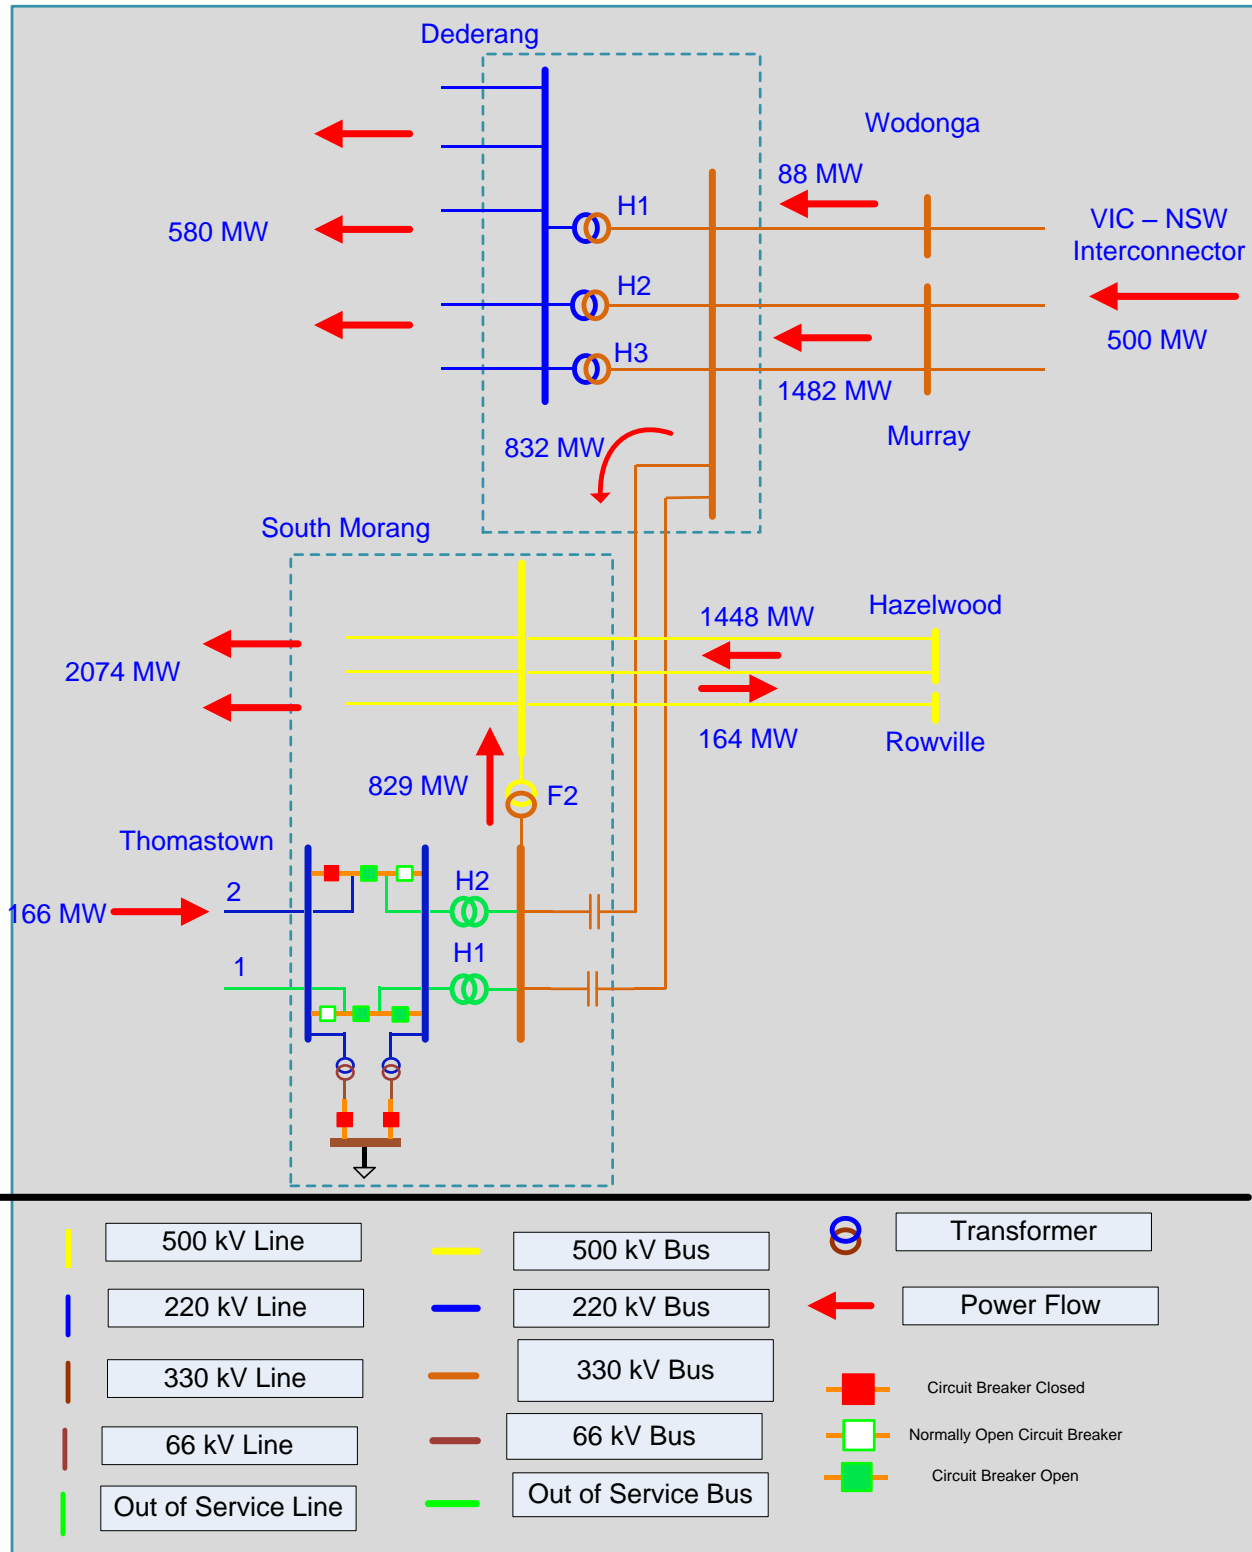
Figure 4 Post event system conditions

The South Morang H1 and H2 transformers tripped at 2054 hrs on Buchholz relay operation. Due to the switching arrangement at the South Morang station, the No.1 South Morang – Thomastown 220 kV transmission line also de-loaded with the H1 transformer. Figure 4 shows the state of the network following the event.

After further investigation, SP AusNet advised that the earth tremors triggered an oil surge within the transformers causing the Buchholz relay operation. SP AusNet has advised that the type of Buchholz relay used at South Morang is exclusive to the South Morang station. SP AusNet found no evidence of damage to the transformers or associated plant. In addition, inspection and checks carried out on the Buchholz relays found the Buchholz relays to be operating correctly.

SP AusNet has advised that due to the low probability of earthquakes in the region and based on its cost/benefit analysis, there are no immediate plans to replace the Buchholz relays. However, the South Morang H1 and H2 transformers are expected to be replaced within the next 10 years subject to regulatory approval.

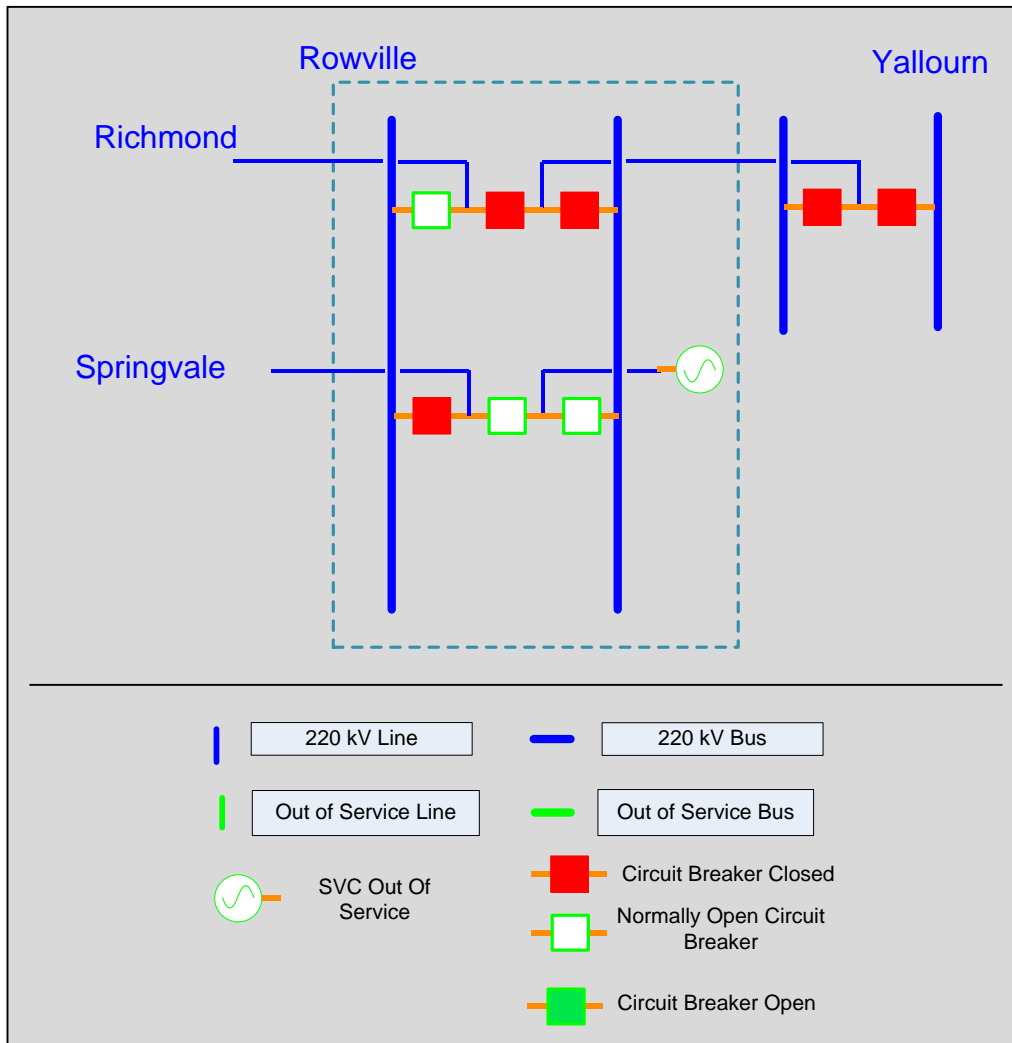
Figure 5 Pre-event system conditions

The status of the power system at Rowville station prior to the incident is show in Figure 5. For clarity, only equipment relevant to this incident has been included in the diagram.

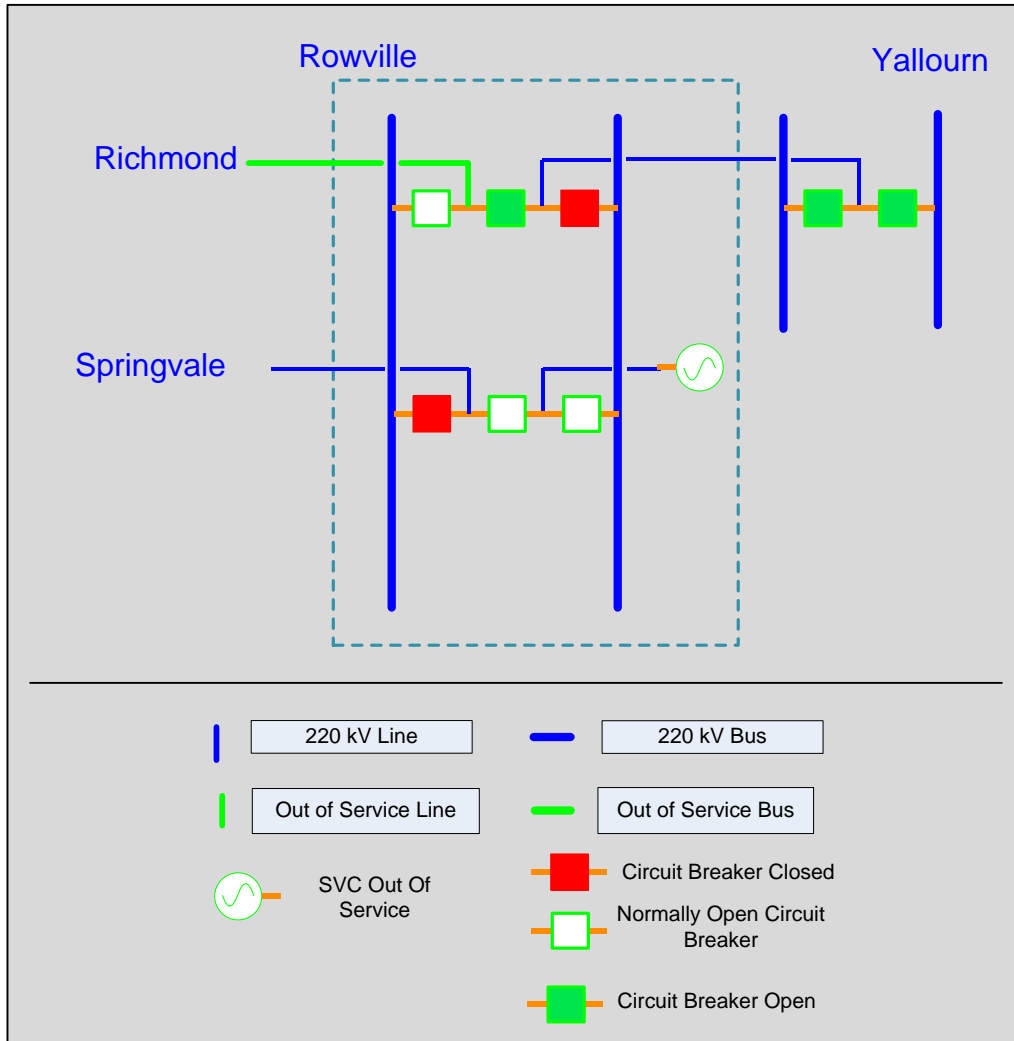
Figure 6 Post event system conditions

At 2118 hrs, approximately 25 minutes after the earthquake, the No.5 Rowville – Yallourn 220 kV transmission line tripped on X and Y protection at both ends of the transmission line. The line auto reclosed at the Rowville end as a result of the Single End Auto Reclose (SEAR) function at Rowville. Due to the switching configuration at Rowville terminal station, the No.4 Rowville - Richmond 220 kV transmission line was also unloaded. The state of the power system following the incident is shown in Figure 6.

At 2125 hrs, the V-ROYP5_R constraint set was invoked by AEMO. The No.4 Rowville – Richmond 220 kV transmission line was restored at 2152 hrs by closing the CB at the Rowville end. The Yallourn end of the Rowville – Yallourn 220 kV transmission line was restored at 0051 hrs on 20/06/2012 after a line patrol was completed by SP AusNet staff and found no cause of a fault.

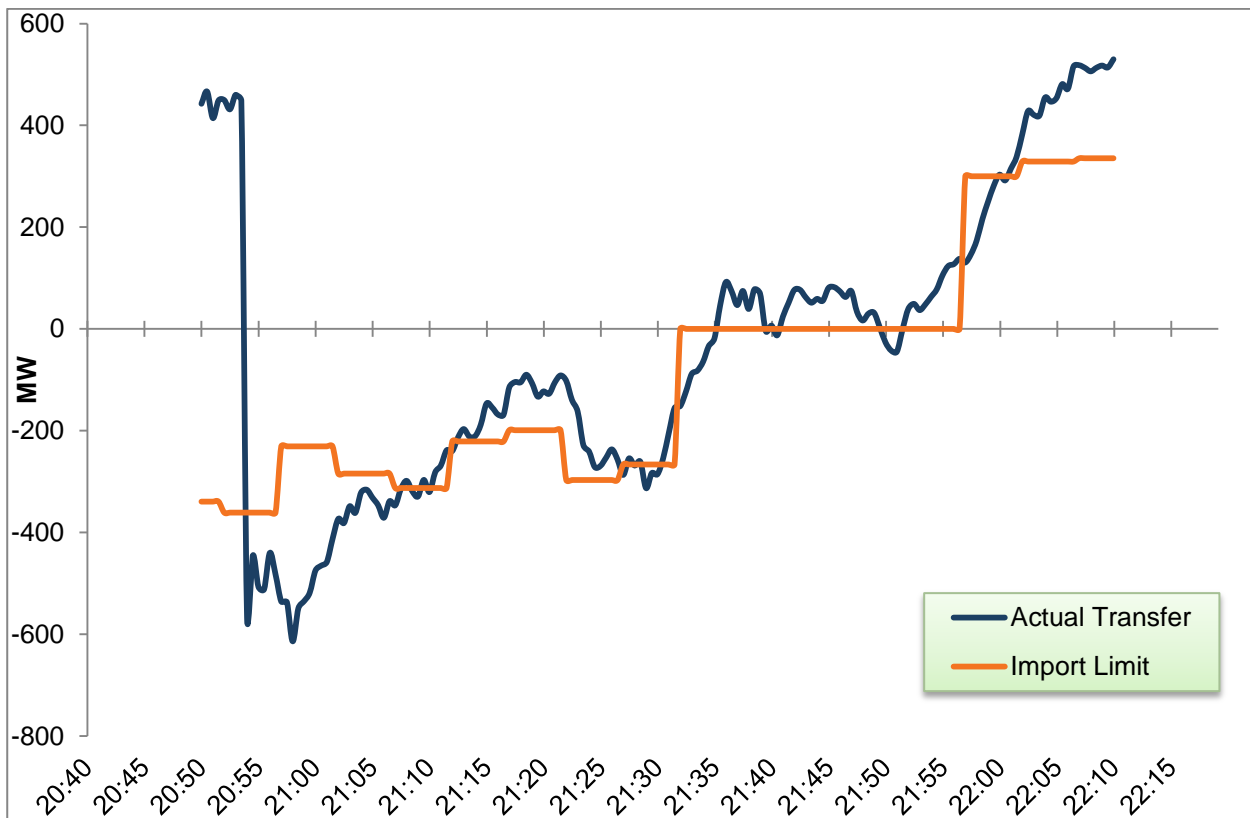
Figure 7 Victoria - New South Wales Interconnector Flows

Prior to the event, Victoria was transferring approximately 430 MW into New South Wales. Following the tripping of the generating units, the interconnector flow reversed with New South Wales transferring approximately 500 MW to Victoria, representing a change of approximately 930 MW. The limit at this time was set by voltage stability constraints for flow out of NSW. Given the revised technical envelope these limits were no longer applicable.

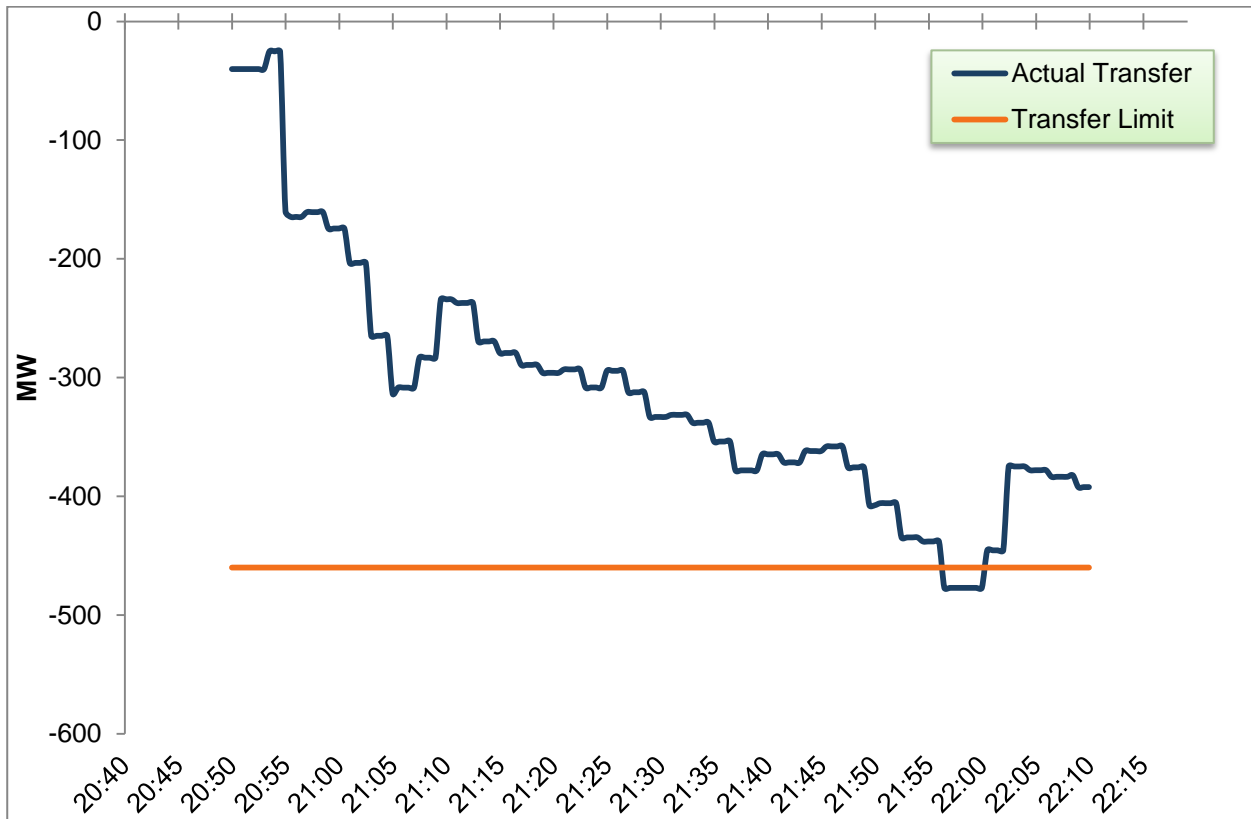
Figure 8 Victoria - South Australia Interconnector Flows

At the time of the event, South Australia was transferring approximately 15 MW to Victoria. The transfer increased to approximately 180 MW immediately following the event, representing a change of approximately 195 MW. The transfer eventually increased up to the transfer limit of 460 MW at 2155 hrs as the transfer from NSW was reduced. The transfer limit was set by the S>V_NIL_HYTX_HYTX thermal constraint equation to avoid overloading the remaining Heywood 275/500 kV transformer for the trip of the other Heywood 275/500 kV transformer.

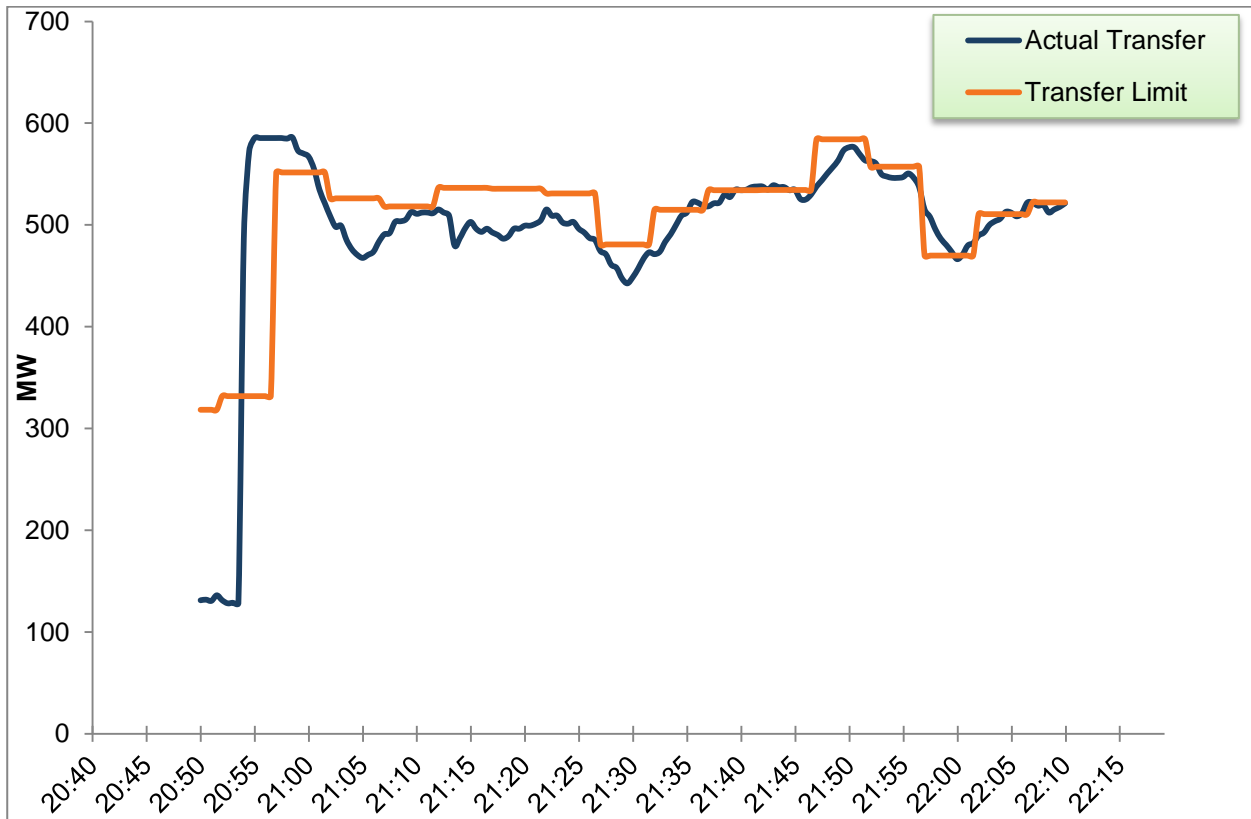
Figure 9 Basslink Flows

Prior to the event, Tasmania was transferring about 130 MW to Victoria. In response to the frequency excursion in Victoria, the interconnector increased power flow into Victoria close to its design limit at approximately 580 MW, representing a change of approximately 450 MW. The transfer exceeded the transfer limits set by FCAS requirements, for short durations due to the normal action of the Basslink frequency controller.

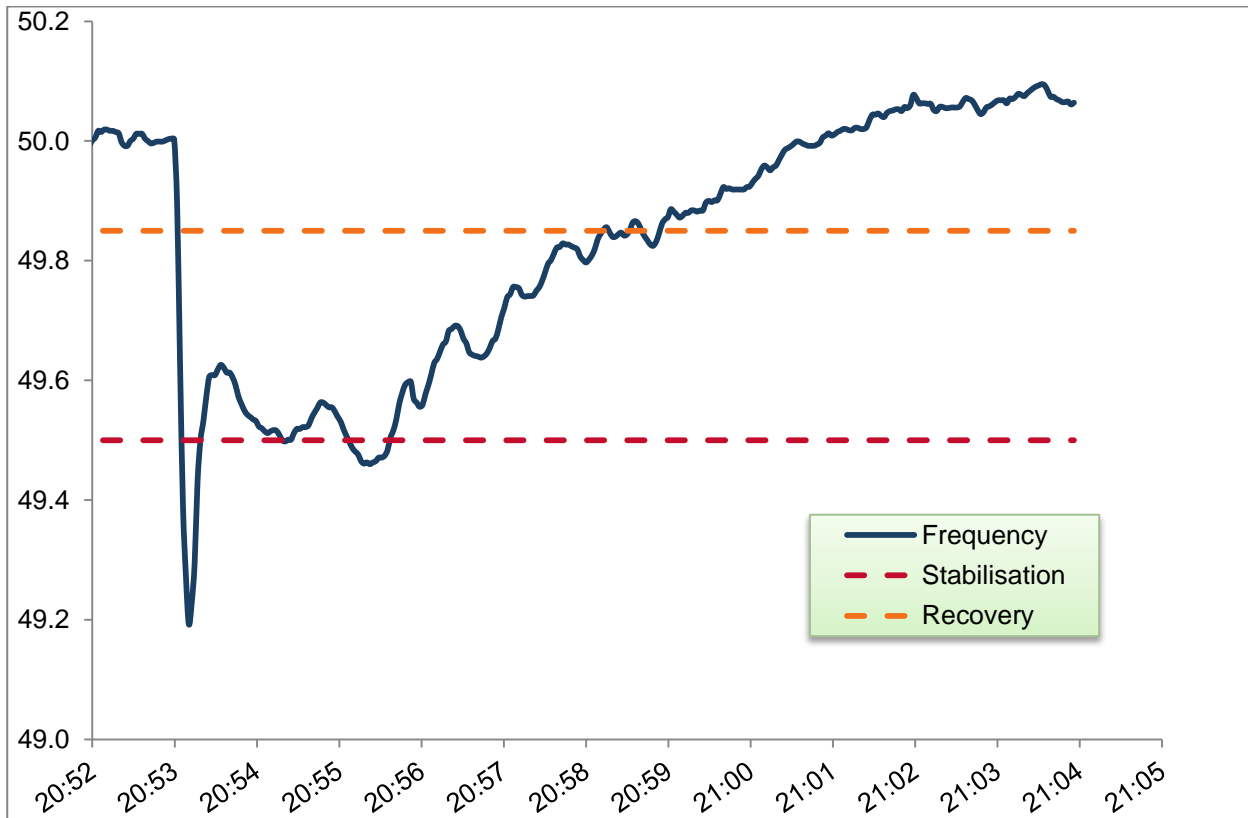
Figure 10 Mainland frequency on 19 June 2012

The power system frequency in the Mainland fell to a minimum of 49.2 Hz at 20:53:54 hrs. The power system responded to bring the system frequency back within the stabilisation lower limit in

approximately 14 seconds. However, the system frequency fell below the stabilisation lower limit again after 122 seconds which is in violation of the Mainland FOS.

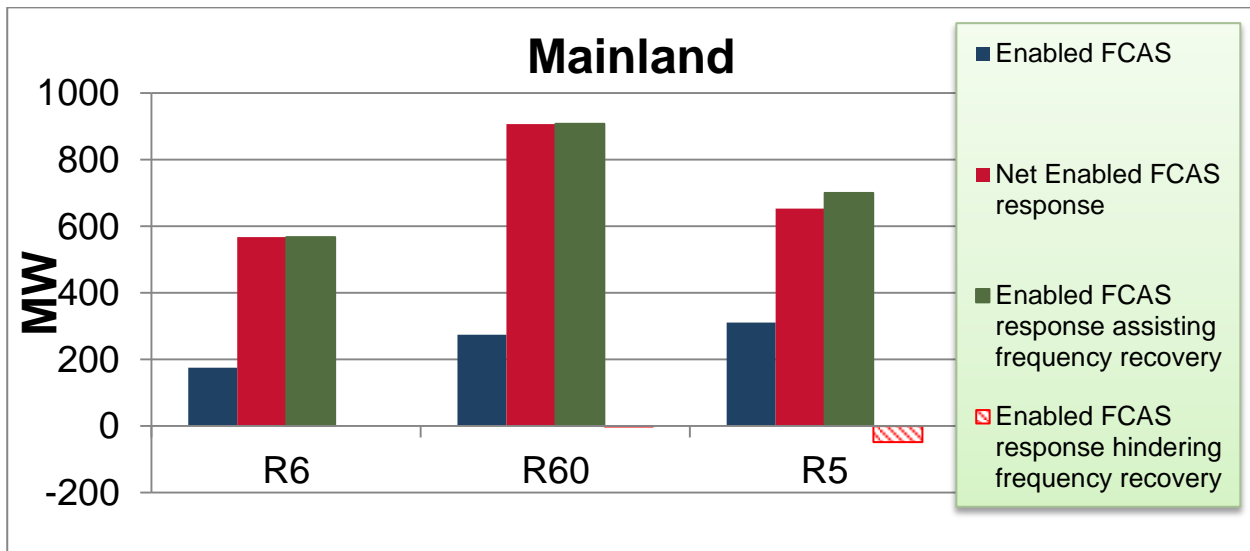
Figure 11 Mainland FCAS raise service enabled on 19 June 2012.

The amount of FCAS that is enabled is only sufficient to cover any single credible contingency event⁷. Approximately 175 MW of R6 was enabled but 568 MW was effectively delivered from the enabled units to assist in frequency recovery. For the R60 service, approximately 275 MW was enabled but 908 MW was delivered from the enabled units. With regards to the R5 service, 311 MW was enabled but 700 MW was delivered from the enabled units to help increase the frequency.

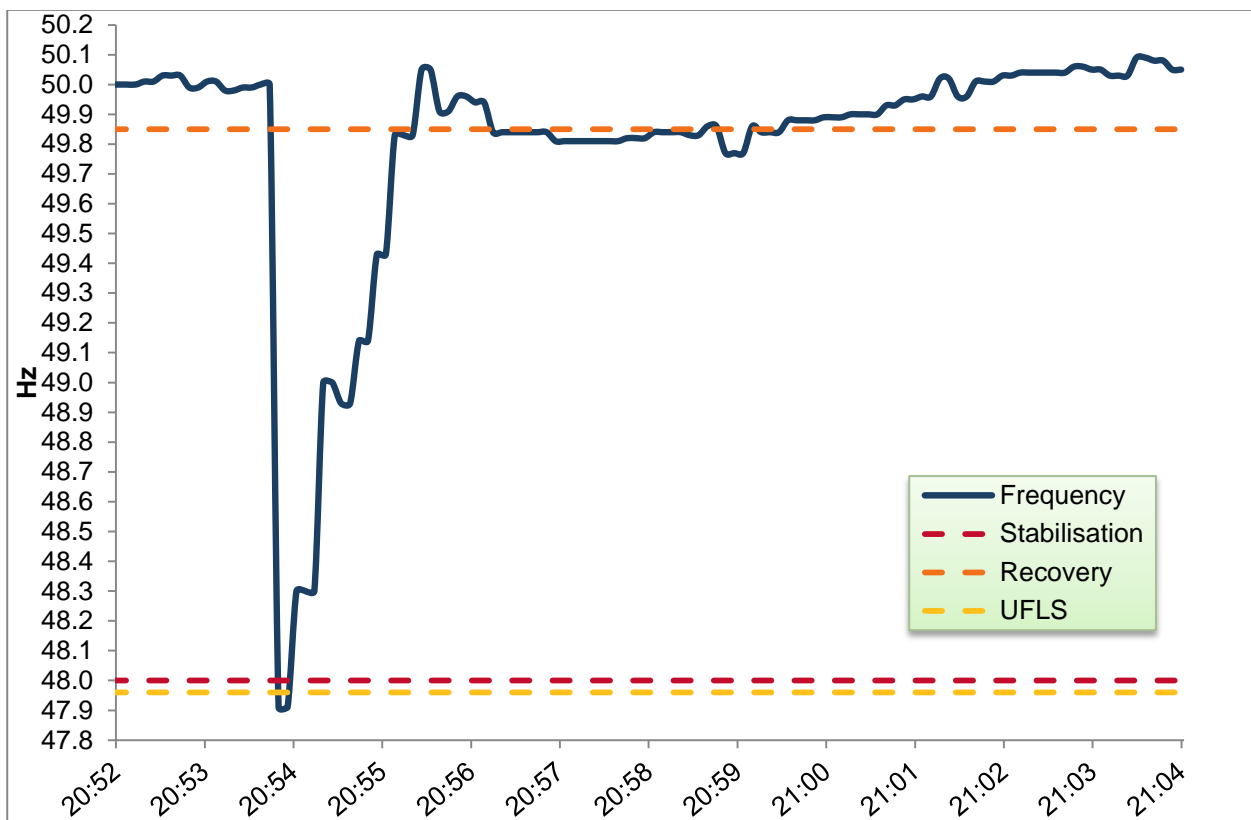
Figure 12 Tasmania frequency on 19 June 2012

The loss of approximately 1955 MW from the Mainland resulted in a drop in Mainland frequency. The Basslink frequency controller responded as expected to increase the export from Tasmania from approximately 130 MW to 580 MW into Victoria. This resulted in a frequency excursion in the Tasmanian frequency from 49.99 to 47.95 Hz.

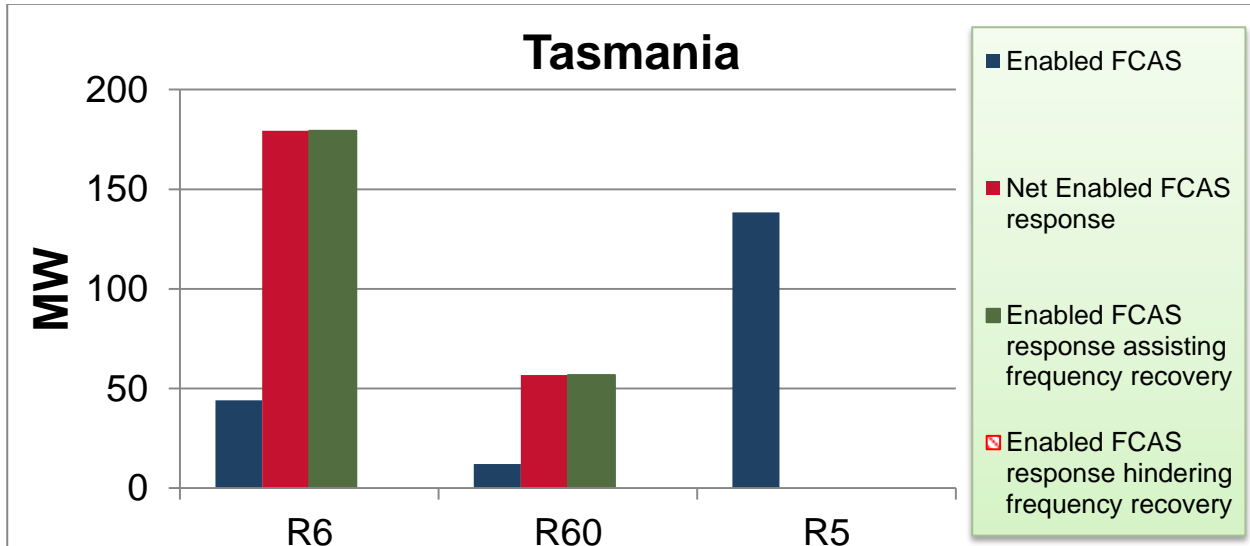
Figure 13 Tasmania FCAS raise service enabled on 19 June 2012

The amount of FCAS that is enabled is only sufficient to cover any single credible contingency event. Approximately 44 MW of R6 was enabled but 179 MW was effectively delivered to assist in frequency recovery. For the R60 service, approximately 12 MW was enabled but 57 MW was delivered. With regards to the R5 service, 138 MW was enabled but none was delivered.
