POWER SYSTEM OPERATING INCIDENT REPORT – SIMULTANEOUS TRIP OF ROWVILLE–YALLOURN NO.5 AND NO.6 220 KV LINES ON 27 NOVEMBER 2012

PREPARED BY: Systems Performance and Commercial

DATE: 10 January 2013

FINAL

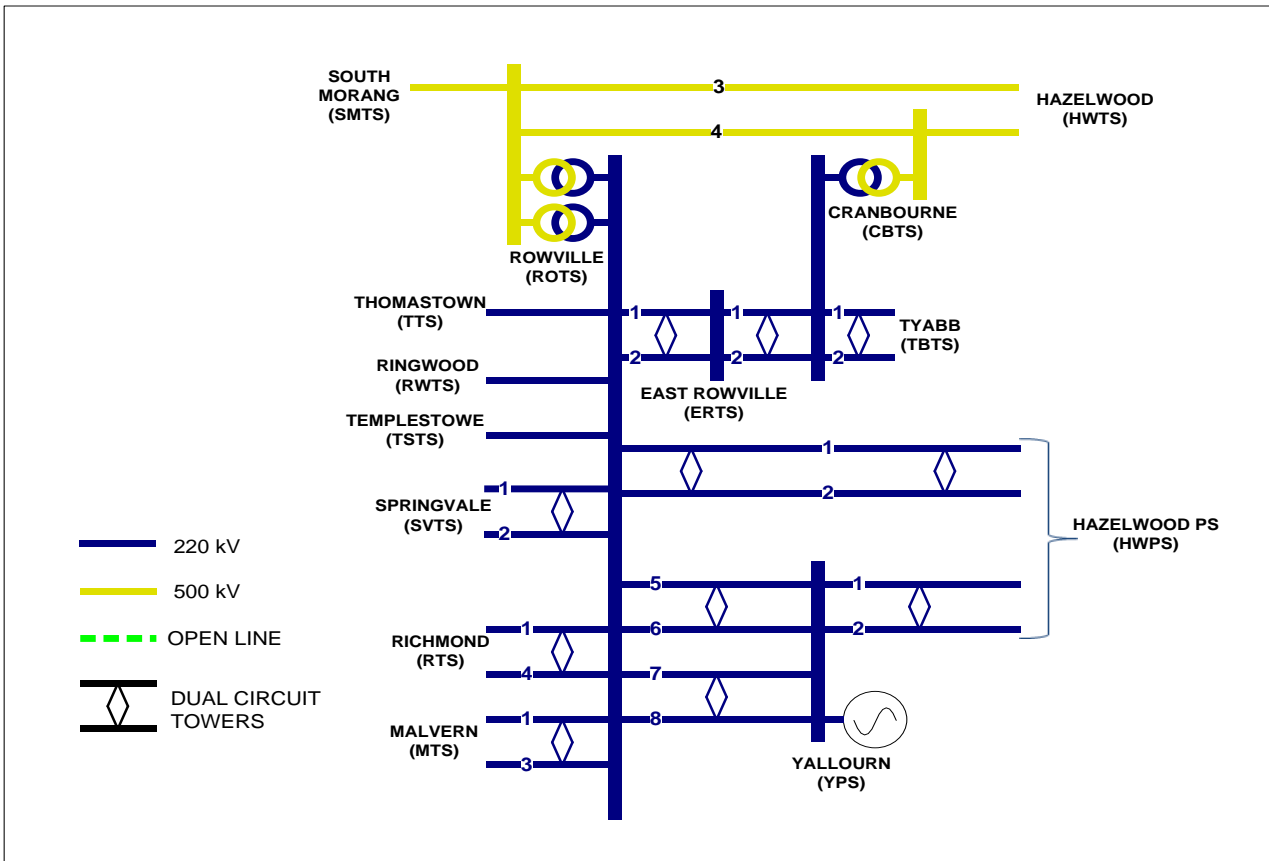
Figure 1 - Status of the power system prior to the incident

The status of the power system prior to the incident is shown in Figure 1. For clarity only equipment relevant to this incident has been included in the diagram.

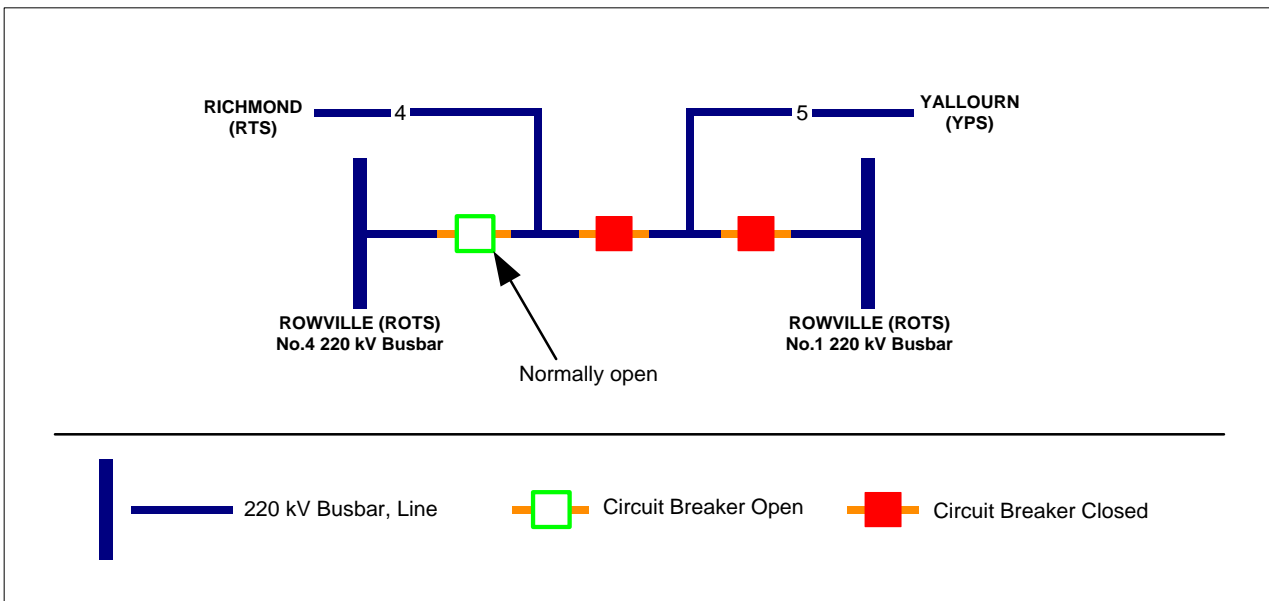
Figure 2 – Circuit breaker status at Rowville Terminal Station

Figure 2 shows the switching configuration of Rowville-Richmond No.4 220 kV line and Rowville-Yallourn No.5 220 kV line at Rowville Terminal Station prior to the incident.

The switching configuration of Rowville Terminal Station shown in Figure 2 shows that prior to the incident the Rowville-Richmond No.4 220 kV line No.4 Bus circuit breaker was open. This is the normal configuration. Therefore under this switching configuration Rowville-Richmond No.4 220 kV line offloaded at Rowville end when the Rowville-Yallourn No.5 220 kV line tripped.

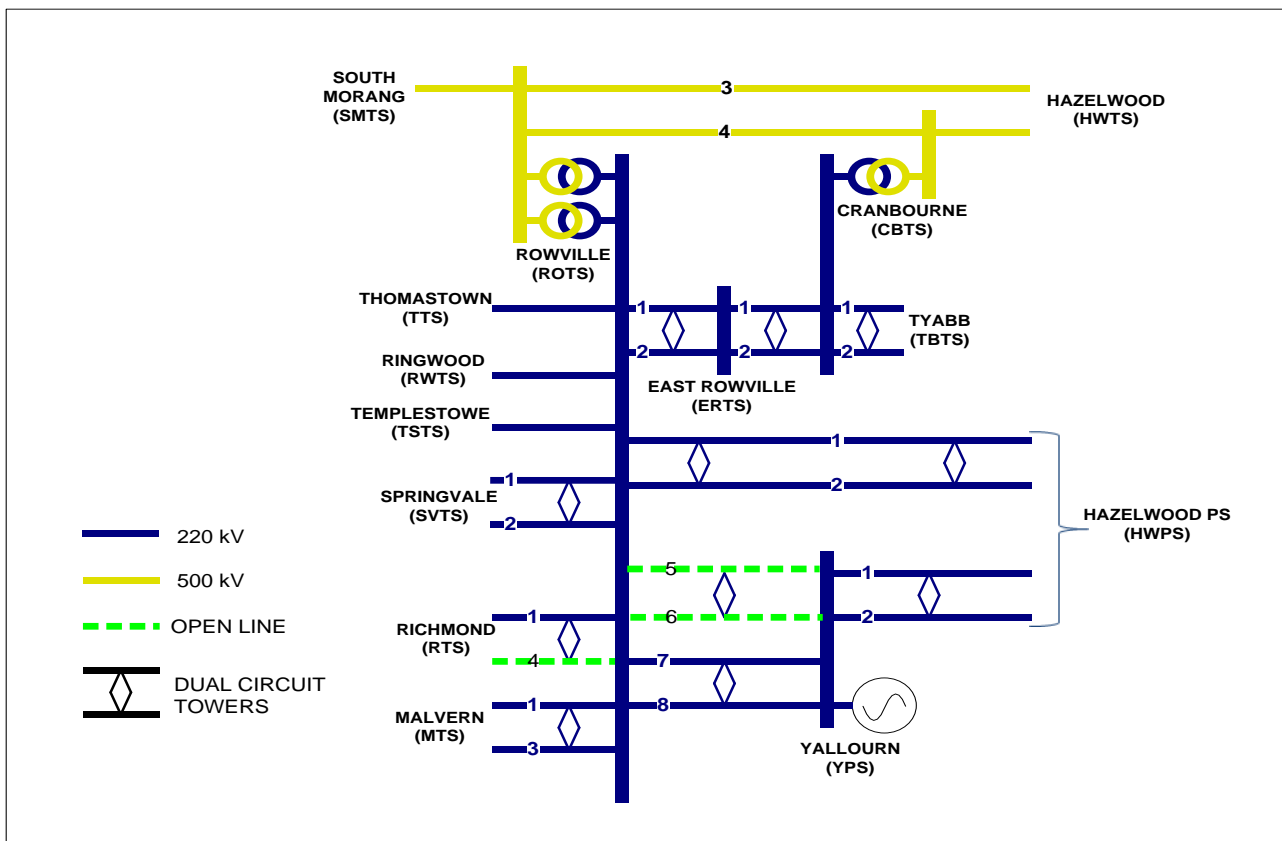
Figure 3 - Status of the power system immediately after the incident

The status of the power system immediately after the incident is shown in Figure 3.

At 04:41 hours on 27 November 2012, the Rowville-Yallourn No.5 and No.6 220 kV lines in Victoria simultaneously tripped on protection operation to clear earth faults due to lightning strikes. Rowville-Richmond No.4 220 kV line offloaded at Rowville end as a result of the tripping.
