POWER SYSTEM OPERATING INCIDENT REPORT – MULTI-ELEMENT TRIP AT BRAEMAR ON 18 OCTOBER 2012

PREPARED BY: System Performance & Commercial

DATE: 27 December 2012

FINAL

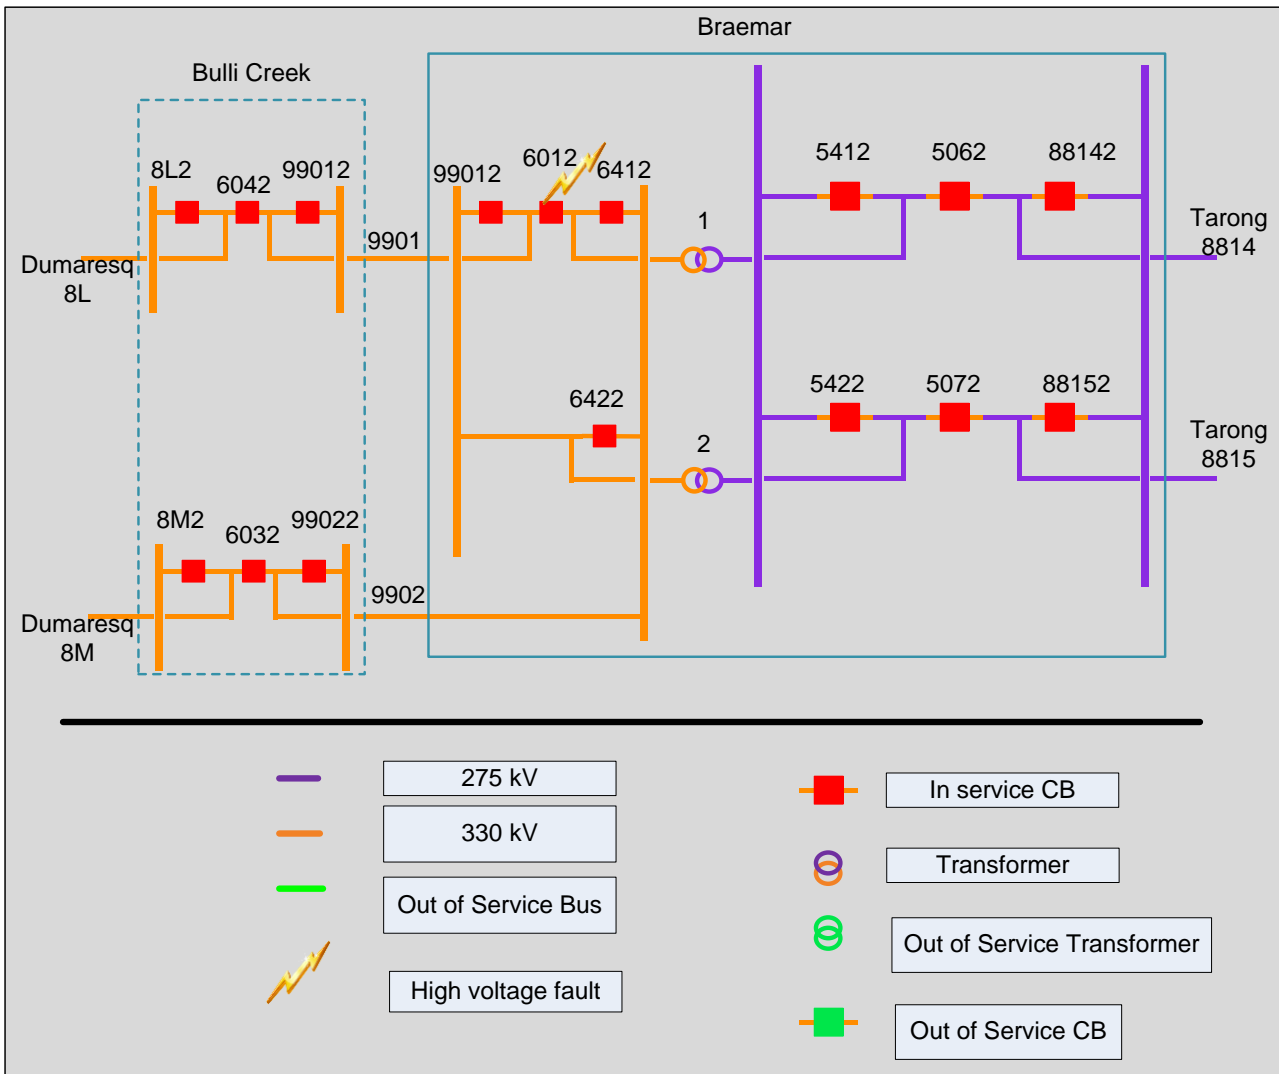
Figure 1 - Status of the power system prior to the incident.

The status of the power system prior to the incident is shown in Figure 1. For clarity, only equipment relevant to this incident has been included in the diagram.

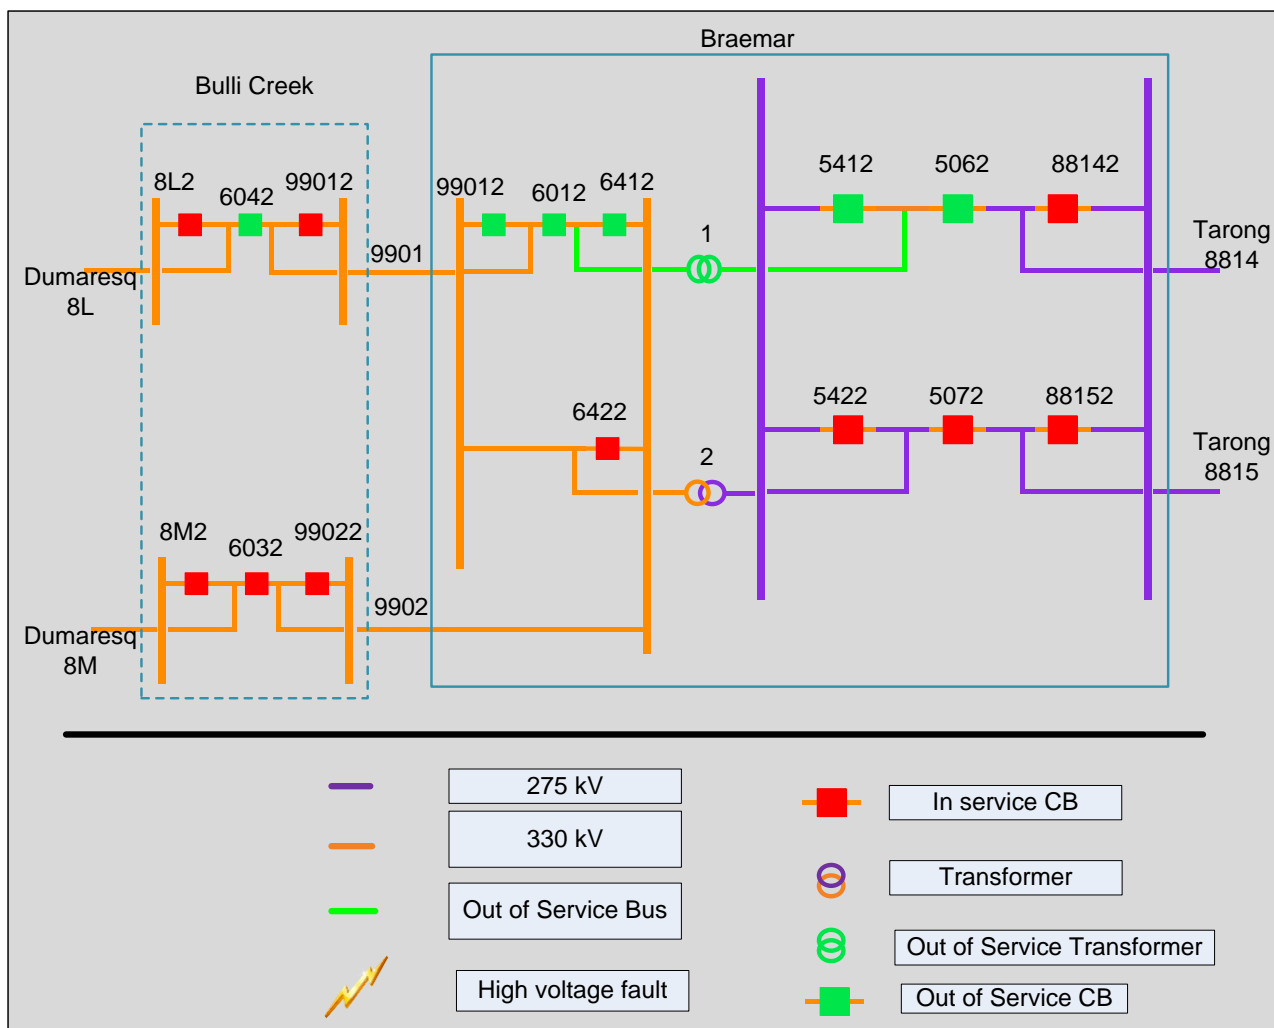
Figure 2 - Status of the power system after incident.

At 20:04:08 hrs on 18 October 2012, the 9901 Braemar – Bulli Creek 330 kV transmission line and the No.1 330/275 kV transformer at Braemar tripped due to a high voltage fault internal to the ‘A’ phase of the 330 kV hybrid switching unit¹ associated with 330 kV CB 6012 at Braemar substation. As per design, only ‘A’ phase of CB 99012 at Bulli Creek tripped.

The status of the power system immediately after the incident is shown in Figure 2.

On 23 October 2012, the 330 kV CB 6012 at Braemar was returned to service after the 330 kV hybrid switching unit was replaced.
