# MULTIPLE CONTINGENCY EVENT FOLLOWING AN EARTHQUAKE IN VICTORIA ON 19 JUNE 2012

PREPARED BY: Systems Capability

DATE: 3 December 2012

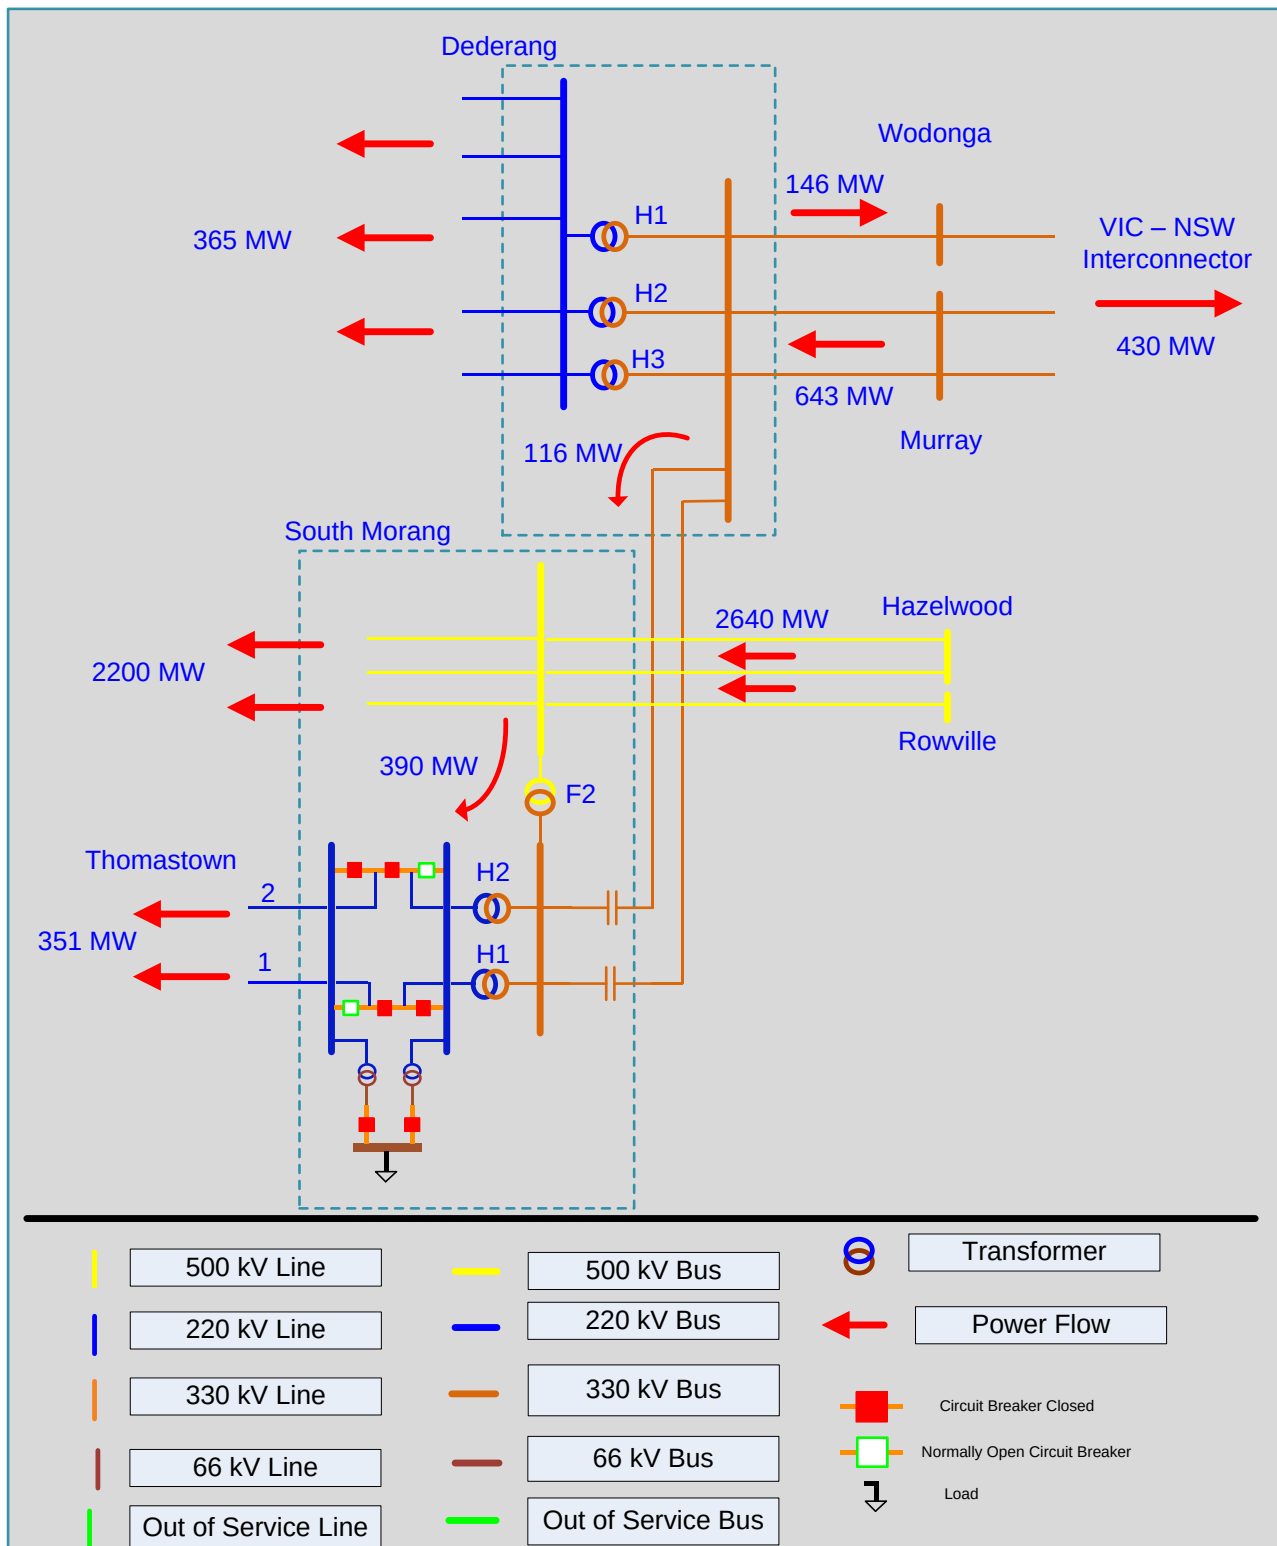
Figure 3 Pre event system conditions

The status of the power system prior to the incident is shown in Figure 3. For clarity, only equipment relevant to this incident has been included in the diagram.

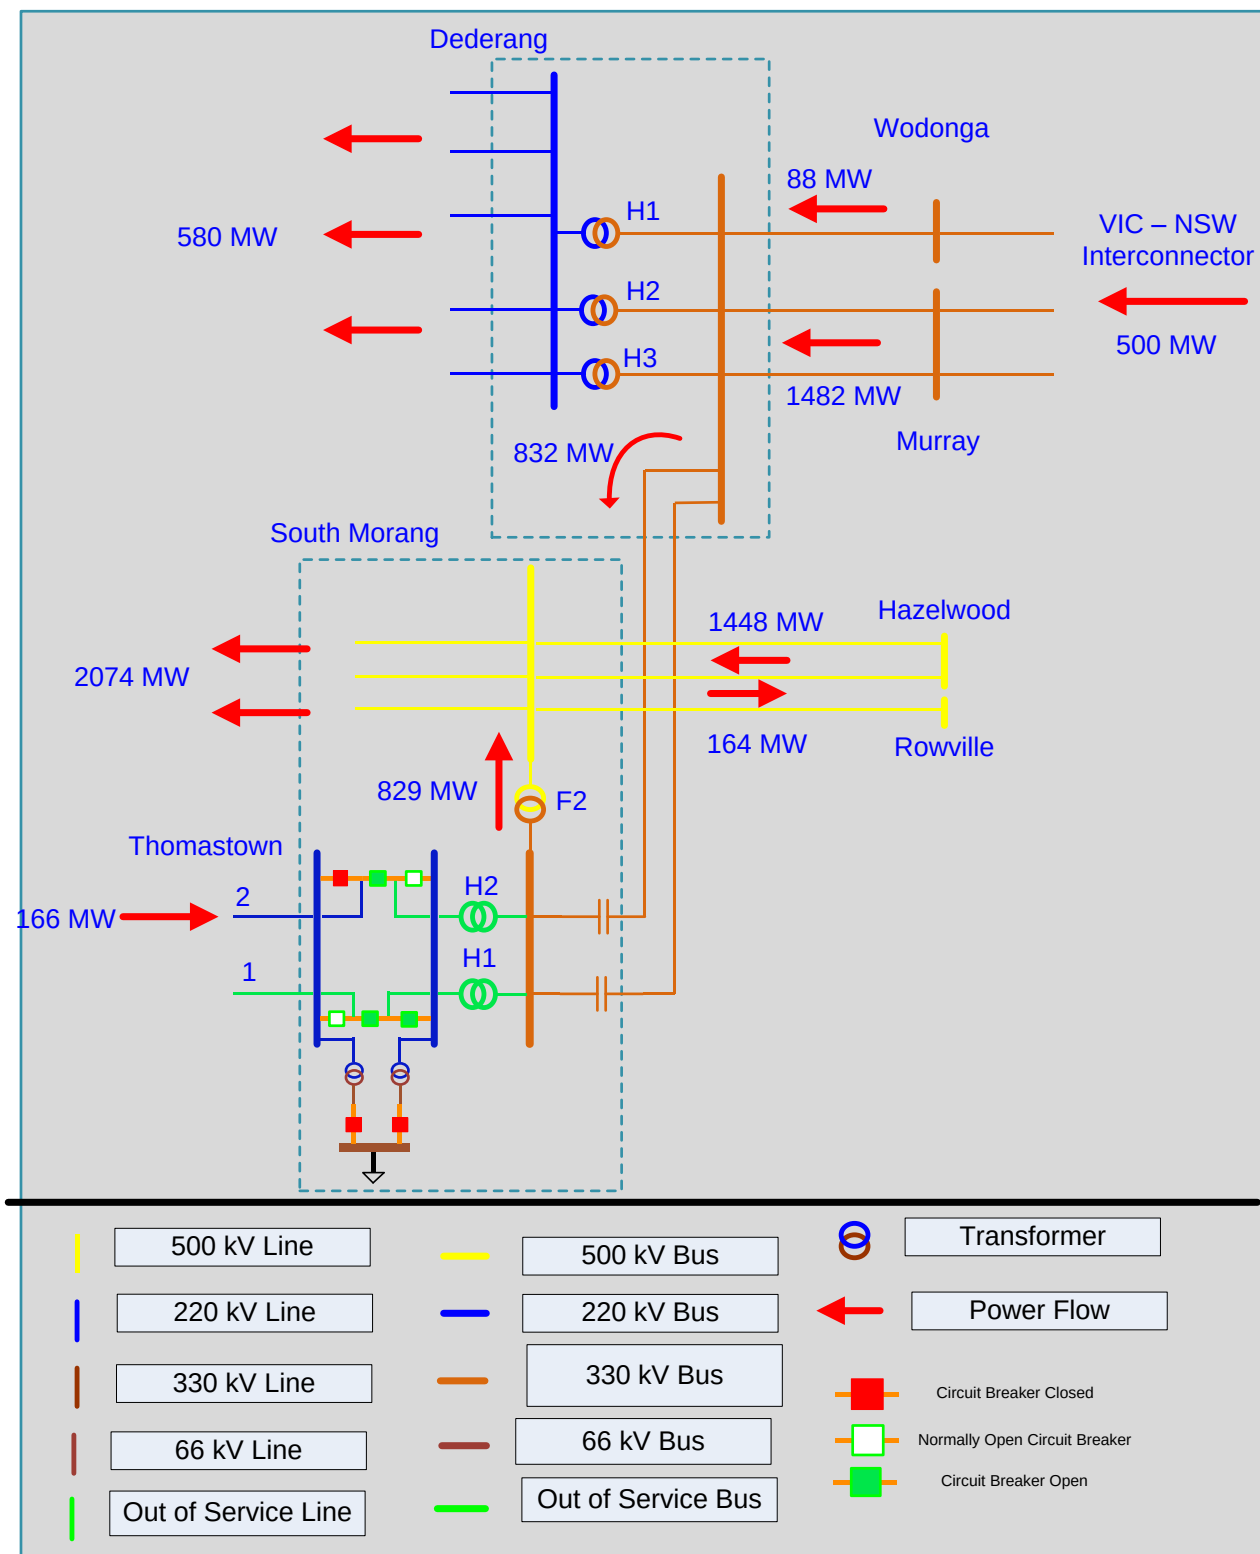
Figure 4 Post event system conditions

The South Morang H1 and H2 transformers tripped at 2054 hrs on Buchholz relay operation. Due to the switching arrangement at the South Morang station, the No.1 South Morang – Thomastown 220 kV transmission line also de-loaded with the H1 transformer. Figure 4 shows the state of the network following the event.

After further investigation, SP AusNet advised that the earth tremors triggered an oil surge within the transformers causing the Buchholz relay operation. SP AusNet has advised that the type of Buchholz relay used at South Morang is exclusive to the South Morang station. SP AusNet found no evidence of damage to the transformers or associated plant. In addition, inspection and checks carried out on the Buchholz relays found the Buchholz relays to be operating correctly.

SP AusNet has advised that due to the low probability of earthquakes in the region and based on its cost/benefit analysis, there are no immediate plans to replace the Buchholz relays. However, the South Morang H1 and H2 transformers are expected to be replaced within the next 10 years subject to regulatory approval.

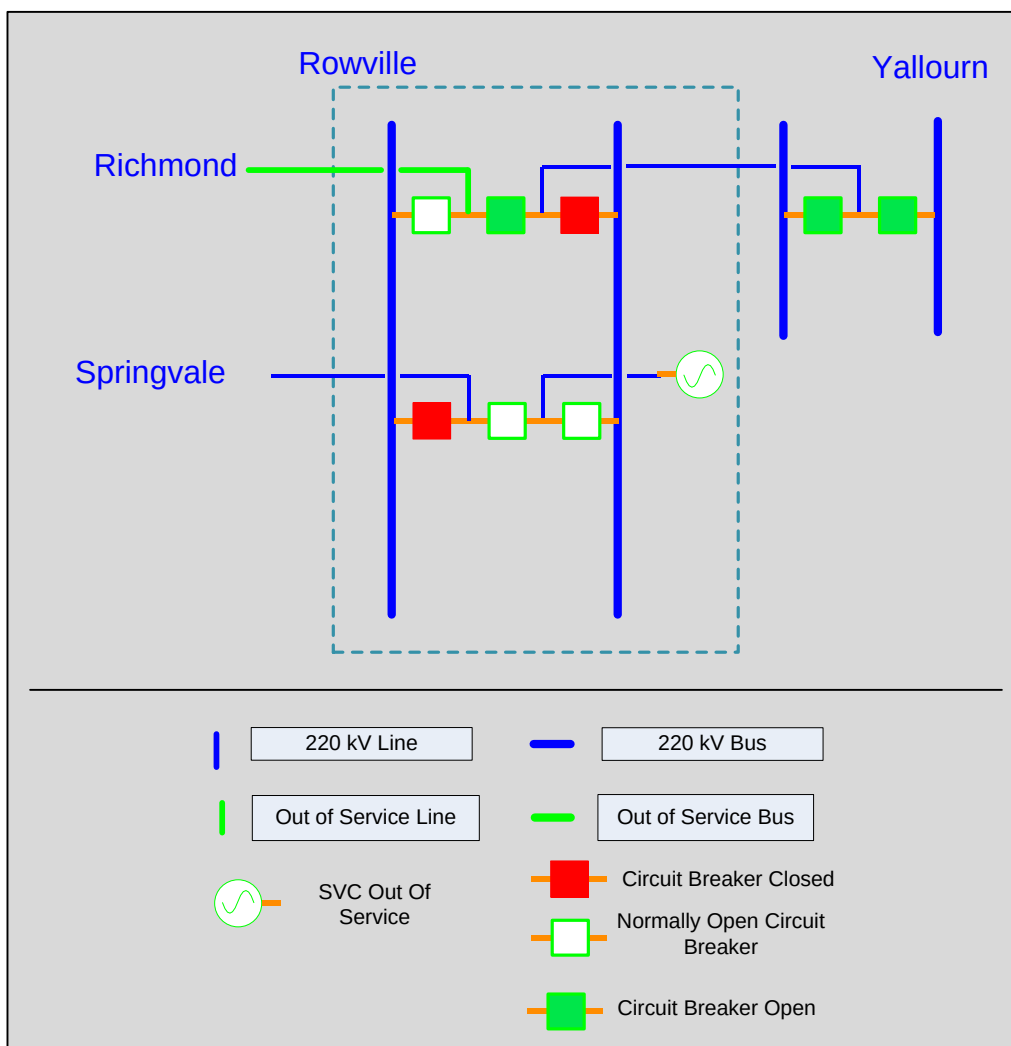
Figure 6 Post event system conditions

At 2118 hrs, approximately 25 minutes after the earthquake, the No.5 Rowville – Yallourn 220 kV transmission line tripped on X and Y protection at both ends of the transmission line. The line auto reclosed at the Rowville end as a result of the Single End Auto Reclose (SEAR) function at Rowville. Due to the switching configuration at Rowville terminal station, the No.4 Rowville - Richmond 220 kV transmission line was also unloaded. The state of the power system following the incident is shown in Figure 6.

At 2125 hrs, the V-ROYP5\_R constraint set was invoked by AEMO. The No.4 Rowville – Richmond 220 kV transmission line was restored at 2152 hrs by closing the CB at the Rowville end. The Yallourn end of the Rowville – Yallourn 220 kV transmission line was restored at 0051 hrs on 20/06/2012 after a line patrol was completed by SP AusNet staff and found no cause of a fault.

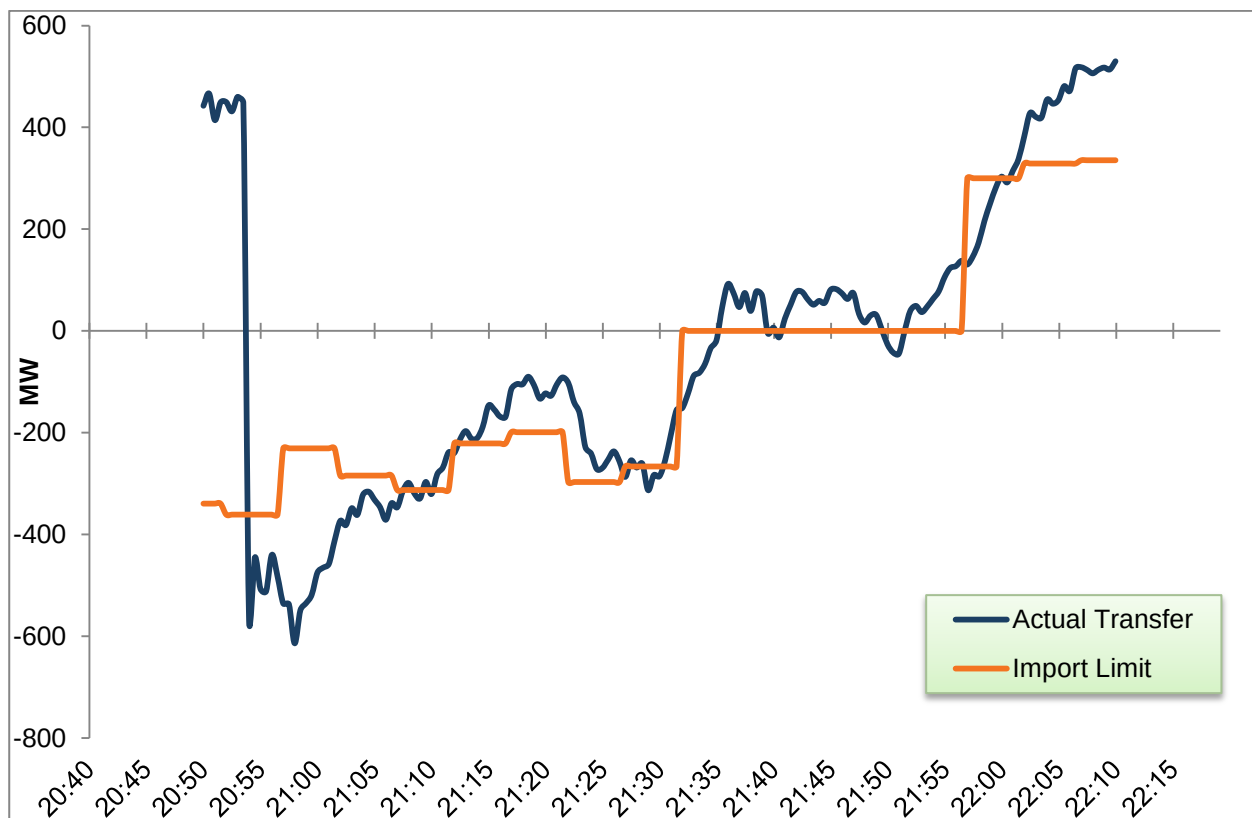
Figure 7 Victoria - New South Wales Interconnector Flows

Prior to the event, Victoria was transferring approximately 430 MW into New South Wales. Following the tripping of the generating units, the interconnector flow reversed with New South Wales transferring approximately 500 MW to Victoria, representing a change of approximately 930 MW. The limit at this time was set by voltage stability constraints for flow out of NSW. Given the revised technical envelope these limits were no longer applicable.

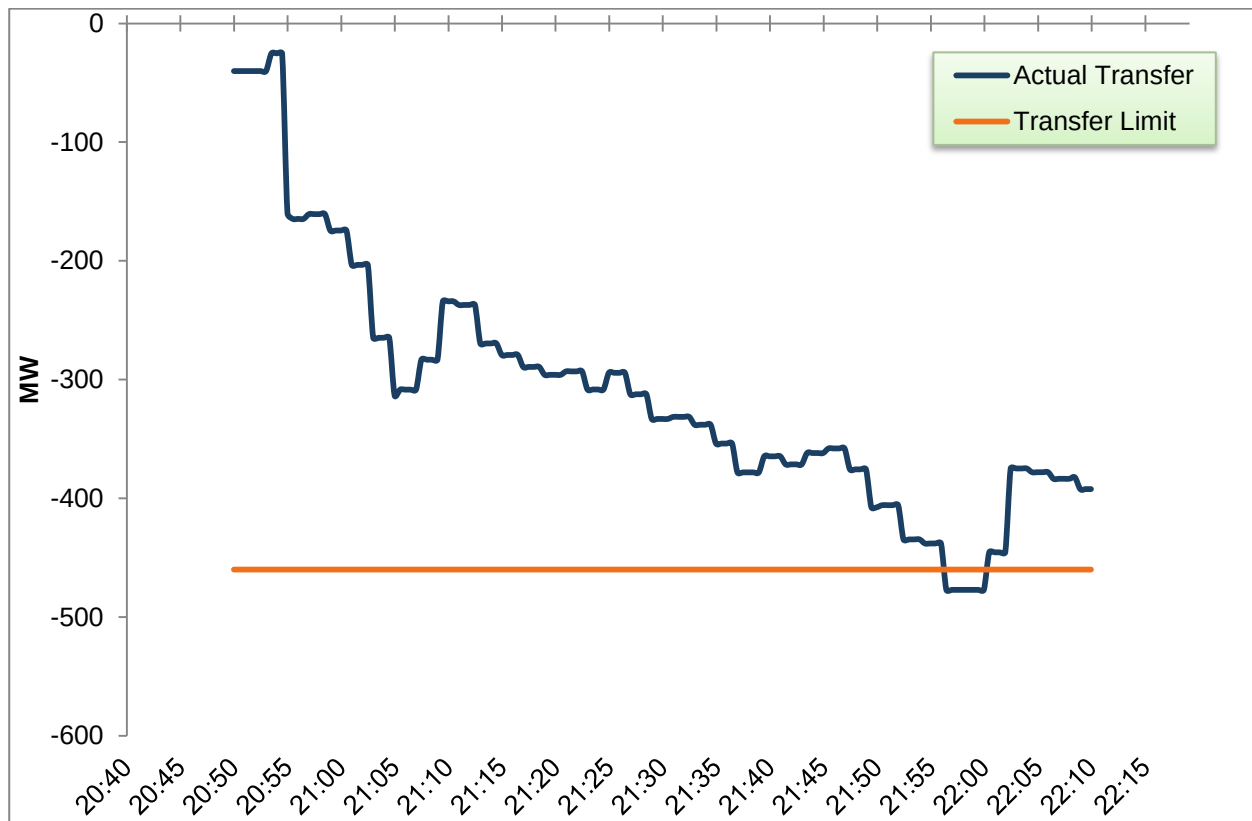
Figure 8 Victoria - South Australia Interconnector Flows

At the time of the event, South Australia was transferring approximately 15 MW to Victoria. The transfer increased to approximately 180 MW immediately following the event, representing a change of approximately 195 MW. The transfer eventually increased up to the transfer limit of 460 MW at 2155 hrs as the transfer from NSW was reduced. The transfer limit was set by the S>V\_NIL\_HYTX\_HYTX thermal constraint equation to avoid overloading the remaining Heywood 275/500 kV transformer for the trip of the other Heywood 275/500 kV transformer.

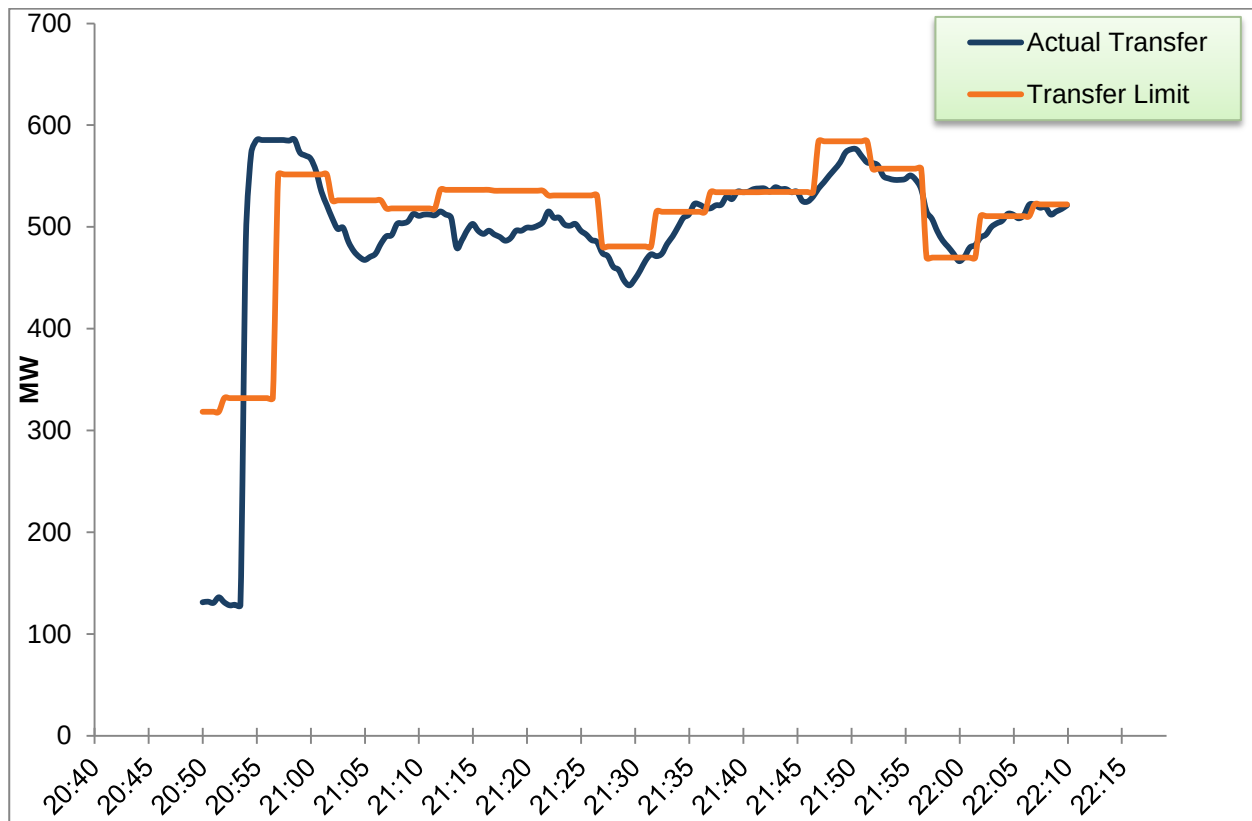
Figure 9 Basslink Flows

Prior to the event, Tasmania was transferring about 130 MW to Victoria. In response to the frequency excursion in Victoria, the interconnector increased power flow into Victoria close to its design limit at approximately 580 MW, representing a change of approximately 450 MW. The transfer exceeded the transfer limits set by FCAS requirements, for short durations due to the normal action of the Basslink frequency controller.

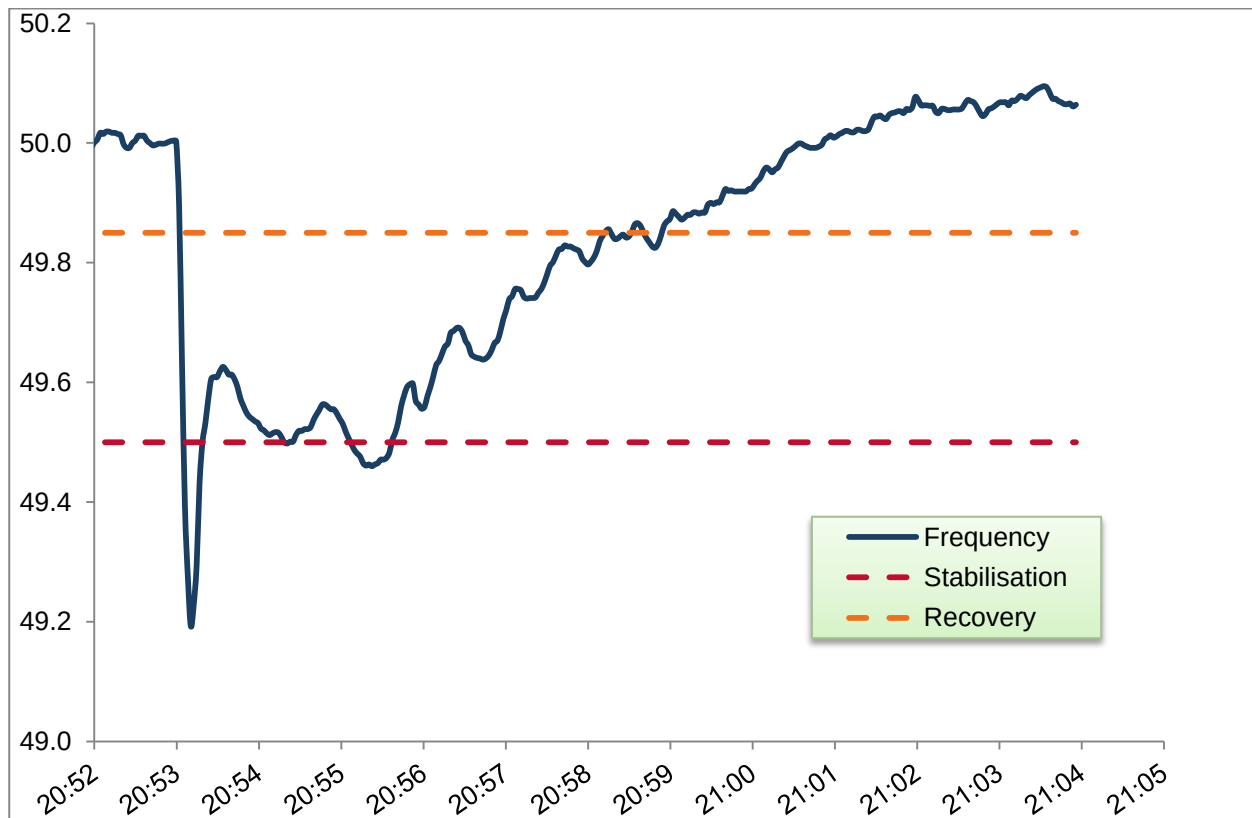
Figure 10 Mainland frequency on 19 June 2012

The power system frequency in the Mainland fell to a minimum of 49.2 Hz at 20:53:54 hrs. The power system responded to bring the system frequency back within the stabilisation lower limit in

approximately 14 seconds. However, the system frequency fell below the stabilisation lower limit again after 122 seconds which is in violation of the Mainland FOS.

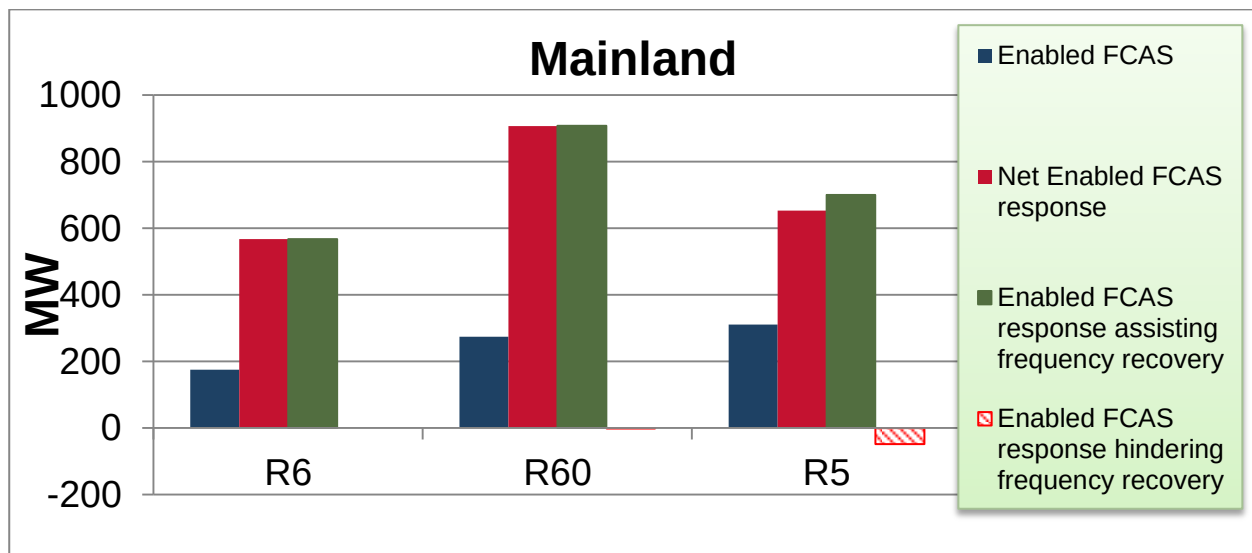
Figure 11 Mainland FCAS raise service enabled on 19 June 2012.

The amount of FCAS that is enabled is only sufficient to cover any single credible contingency event<sup>7</sup>. Approximately 175 MW of R6 was enabled but 568 MW was effectively delivered from the enabled units to assist in frequency recovery. For the R60 service, approximately 275 MW was enabled but 908 MW was delivered from the enabled units. With regards to the R5 service, 311 MW was enabled but 700 MW was delivered from the enabled units to help increase the frequency.

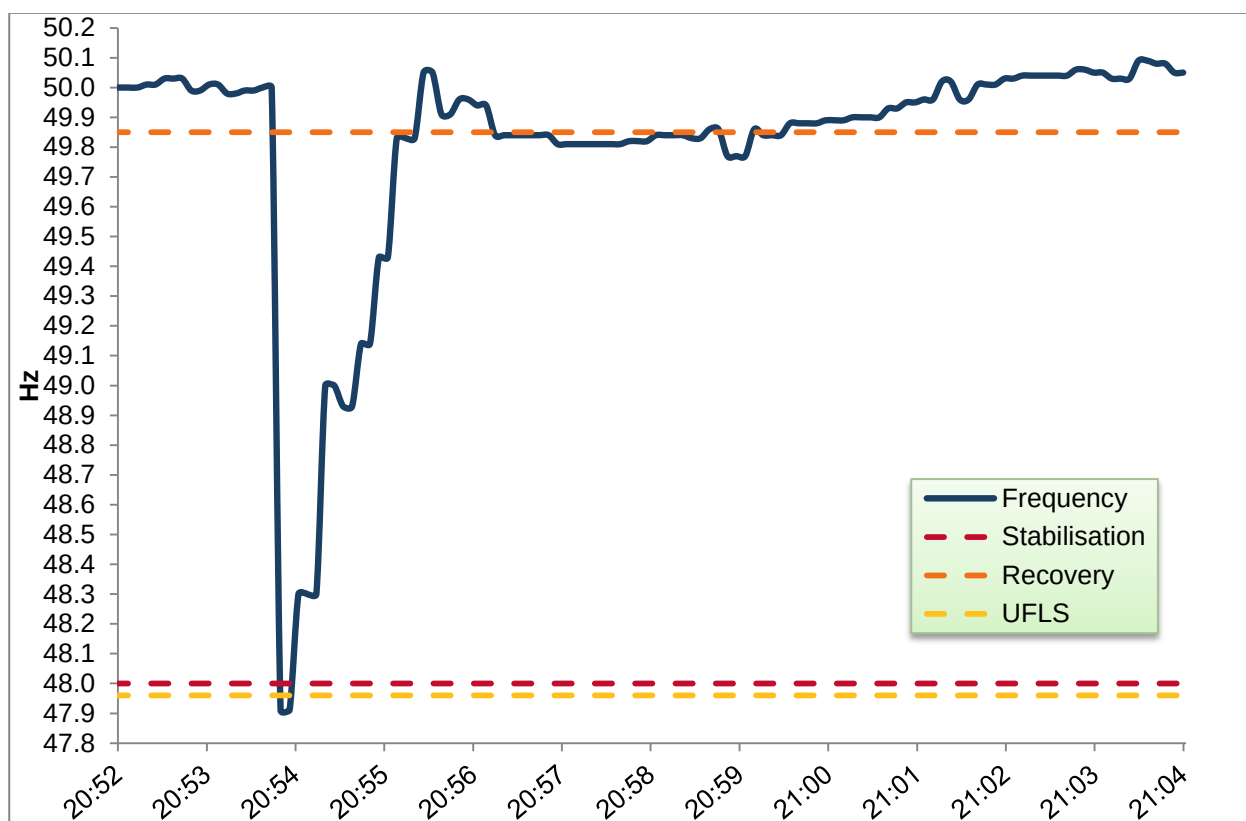
Figure 12 Tasmania frequency on 19 June 2012

The loss of approximately 1955 MW from the Mainland resulted in a drop in Mainland frequency. The Basslink frequency controller responded as expected to increase the export from Tasmania from approximately 130 MW to 580 MW into Victoria. This resulted in a frequency excursion in the Tasmanian frequency from 49.99 to 47.95 Hz.

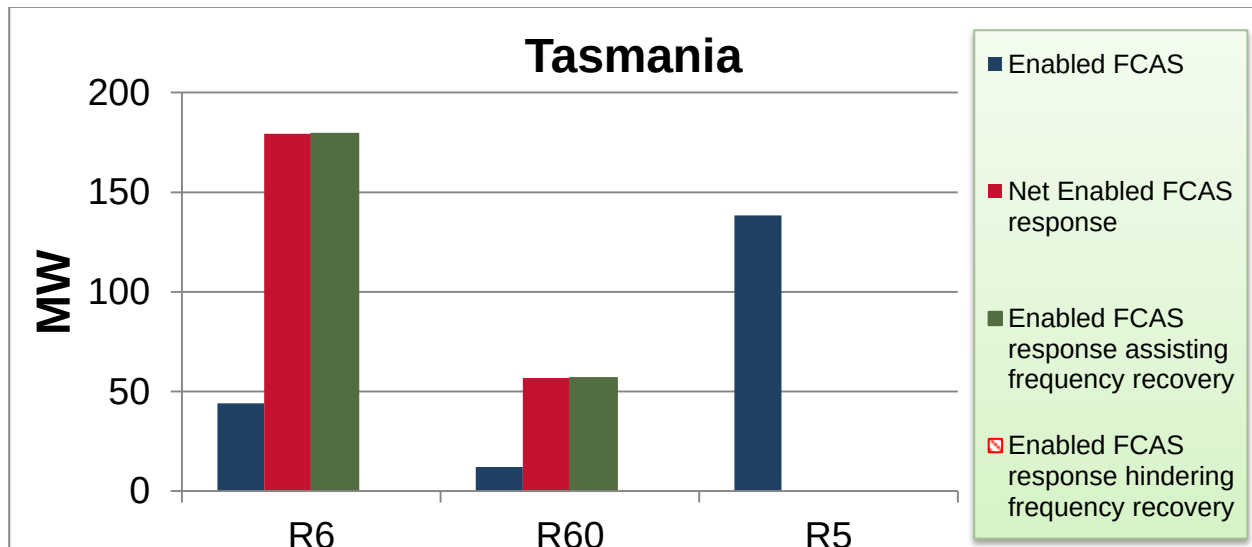
Figure 13 Tasmania FCAS raise service enabled on 19 June 2012

The amount of FCAS that is enabled is only sufficient to cover any single credible contingency event. Approximately 44 MW of R6 was enabled but 179 MW was effectively delivered to assist in frequency recovery. For the R60 service, approximately 12 MW was enabled but 57 MW was delivered. With regards to the R5 service, 138 MW was enabled but none was delivered.
