POWER SYSTEM OPERATING INCIDENT REPORT - TRIP OF SOUTH MORANG No.2 500 kV BUSBAR 1 JUNE 2013

PREPARED BY: AEMO - Systems Performance and Commercial

DATE: 19 July 2013

FINAL

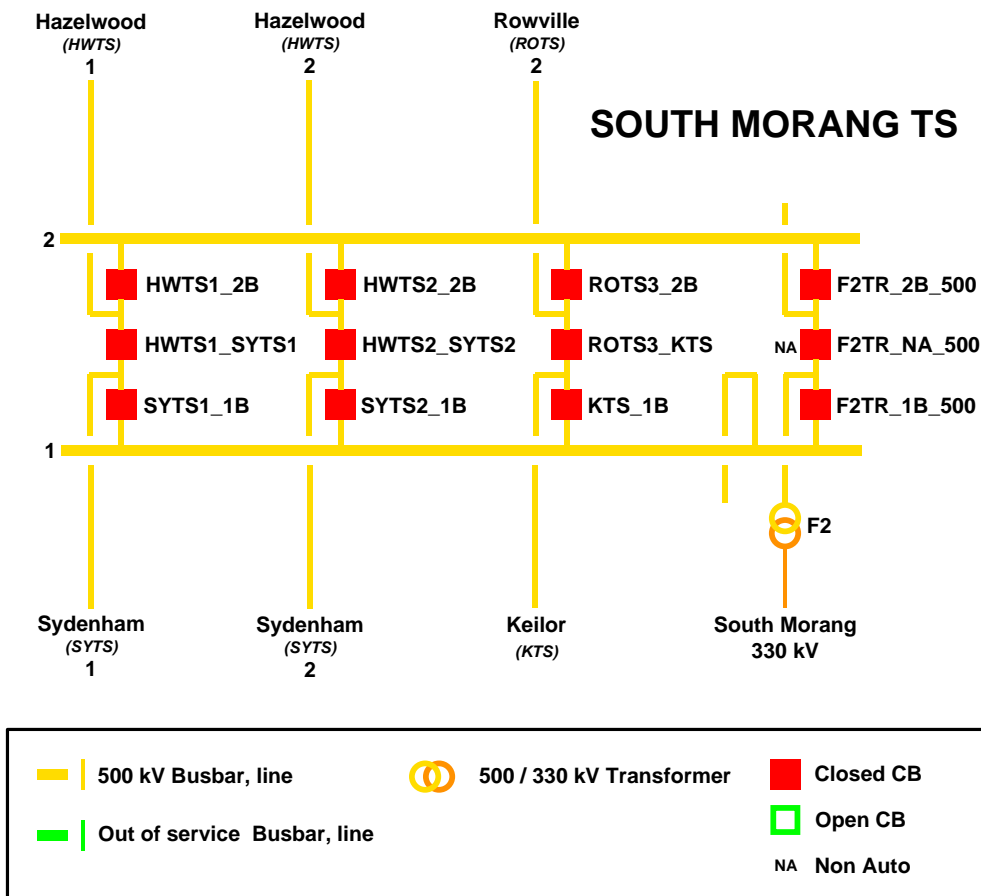
Figure 1 - Status of the power system prior to the incident.

The status of the power system prior to the incident is shown in Figure 1. The diagram shows all circuit breakers connected to the No. 2 500 kV bus bar closed.

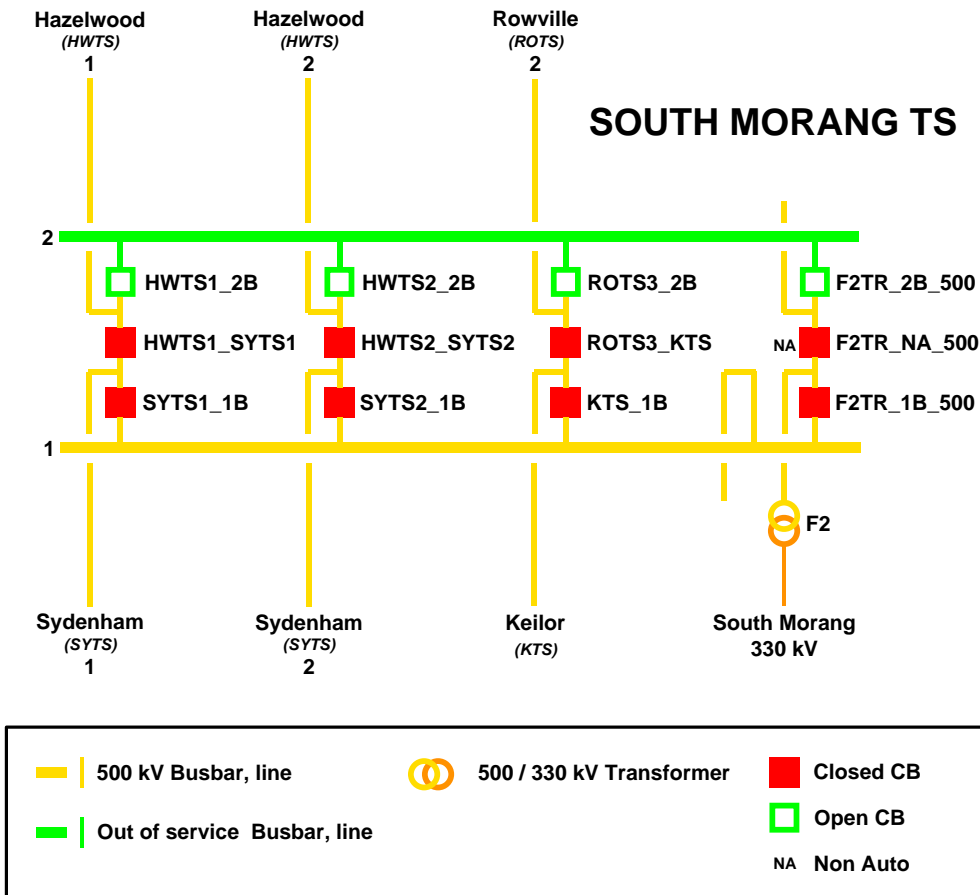
Figure 2 - Status of the power system immediately after the incident

A damaged secondary cable was found to have caused the trip of the busbar. The incident occurred during heavy rainfall in the area of South Morang Terminal Station.

A damaged secondary cable was found to have caused the trip. The cable connected the Blue Phase Gas Density Monitor on the Bay E Zone of No. 2 500 kV Busbar to the SF6 Auto De-Energisation Panel.

The status of the power system immediately after the incident is shown in Figure 2. The diagram shows the out of service No. 2 500 kV Busbar and associated circuit breakers.

SP AusNet response staff isolated the secondary circuit associated with the damaged cable. This enabled the busbar to be returned to service at 0550 hrs, approximately four hours and 45 minutes after the initial event.

Following remedial work, the No. 2 500 kV Busbar SF6 Gas Density Protection trip function for the Blue Phase of Bay E Zone was returned to service 17 days after the incident on 18 June 2013. During this period, the Bay E Blue Phase Gas Density Protection alarm function remained in service.
