# Power System Operating Incident Report – Trip of Bannaby - Mount Piper 500 kV Transmission Line and Bayswater Unit 4 Generator Transformers on 19 March 2014

PREPARED BY:            Systems Capability  
DATE:                      28 May 2014  
STATUS:                  FINAL

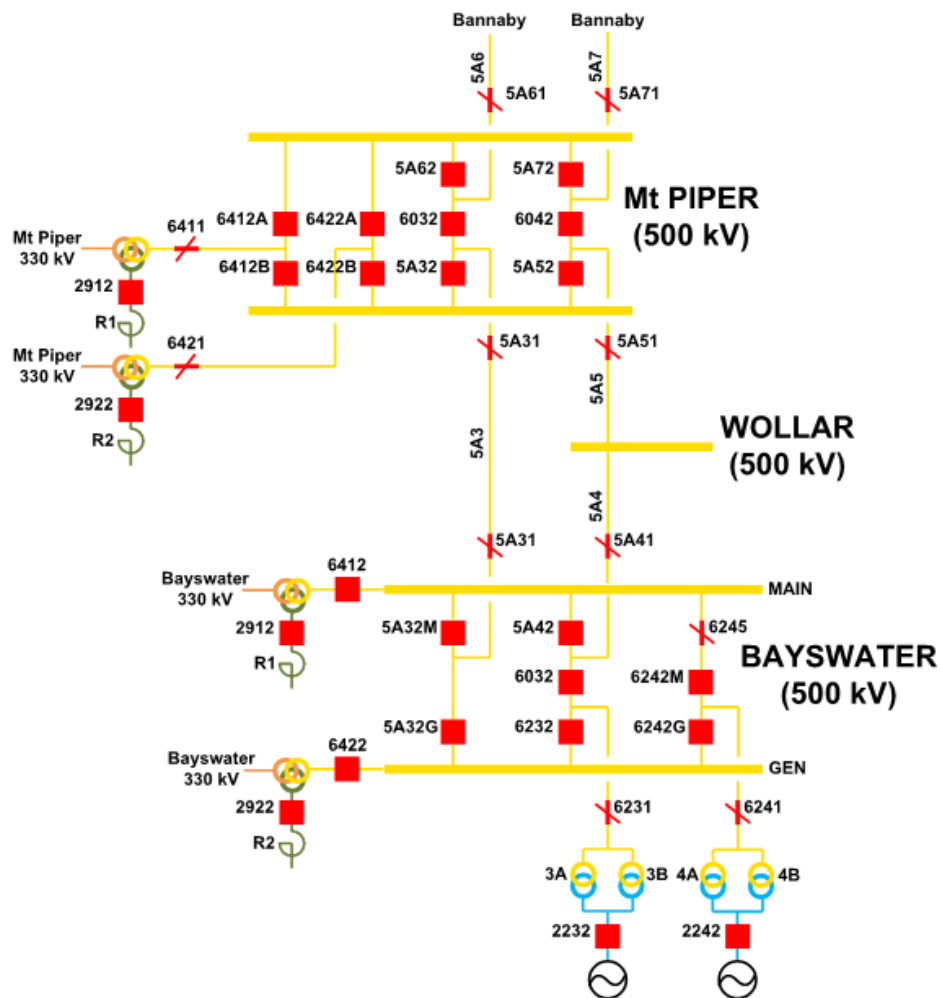
**Figure 1 - Status of the power system prior to the incident**

The status of the power system prior to the incident is shown in Figure 1 and after the incident in Figure 2. For clarity only equipment relevant to this incident, at Mount Piper and Bayswater, has been included in the diagrams. Line 5A7 successfully auto-reclosed shortly after it tripped.

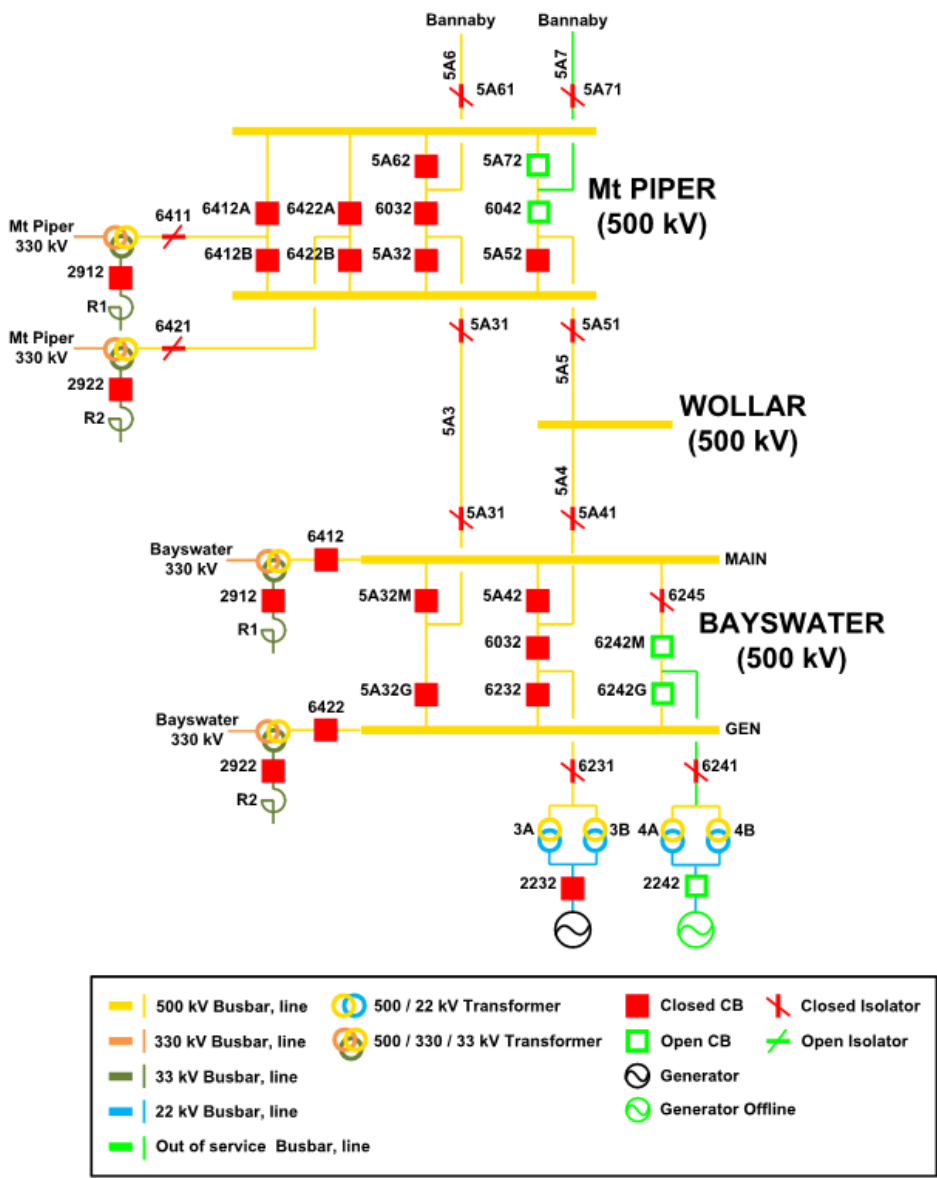
**Figure 2 - Status of the power system immediately after the incident**

On Wednesday 19 March 2014 at 1752 hours, the Bannaby - Mt Piper 5A7 500kV transmission line (Line 5A7) tripped and reclosed. At the same time the Bayswater Unit 4 Generator Transformers 4A and 4B (Unit 4 Transformers) tripped, disconnecting Bayswater Unit 4 (Unit 4) from 625MW.

Macquarie Generation also investigated this incident and found that Unit 4 tripped because of the operation of the X Generator Transformer A and B Differential Protection Relay (X Relay). This relay protects the two parallel 23/500kV generator step up transformers. The duplicate Y Generator Transformer A and B Differential Protection Relay, and the protection on other Bayswater Power Station generating units, did not operate at the time of the incident.

When the X Relay operated it sent an inter-zone trip signal to open the 2 x 500kV TransGrid Circuit Breakers (CBs 6242M and 6242G) connected to the high voltage side of the transformers. The relay also tripped the 22 kV generator circuit breaker and the auxiliary transformer circuit breaker. These events were expected for an X Relay operation.
