Trip of Mullumbimby-Dunoon-Lismore 132 kV transmission lines on 11 Dec 2014

AN AEMO POWER SYSTEM OPERATING INCIDENT REPORT FOR THE NATIONAL ELECTRICITY MARKET

PUBLISHED MARCH 2015

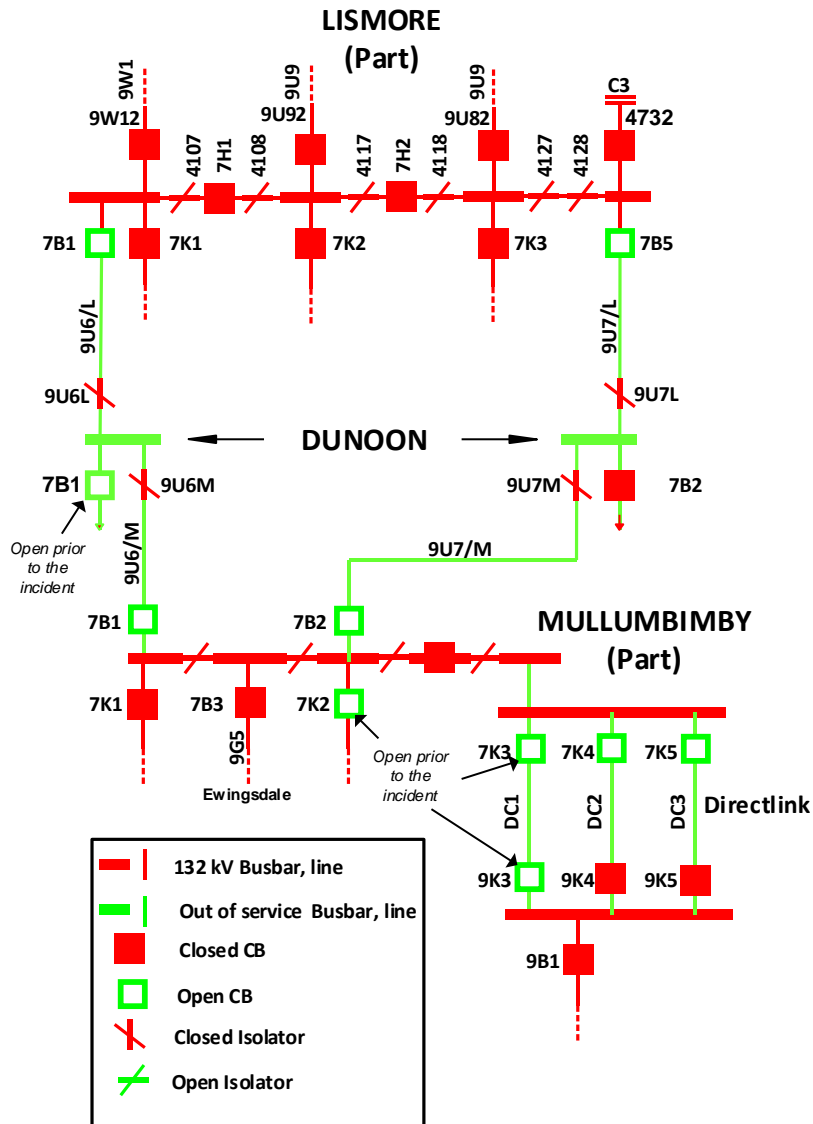
APPENDIX 1 – POWER SYSTEM DIAGRAM

On Thursday 11 December 2014 at 1734 hrs, 132 kV transmission line 9U6 tripped and auto-reclosed. At 1735 hrs, line 9U6 tripped again and then remained out of service. At 1740 hrs, 132 kV transmission line 9U7 tripped and remained out of service. As a result of both 9U6 and 9U7 lines being out of service Directlink tripped via a tripping scheme operation. The operation of the tripping scheme was an expected outcome.

Protection information identified phase-to-phase and phase-to-earth faults on both 9U6 and 9U7 lines at approximately 6 KM from Mullumbimby. The two circuits are on the same double circuit towers in this region. Essential Energy patrolled both lines but found no evidence of a fault.

At 22:59 hrs Essential Energy attempted to re-energise line 9U6. The attempt was unsuccessful but staff in the area heard and observed a flash. A piece of bark was then found hanging from the line. The bark was removed and lines 9U6 and 9U7 were returned to service at 00:55 hrs on 12 Dec 2014.

The power system after the trip of lines 9U6 and 9U7
