TRIP OF BAYSWATER – REGENTVILLE AND BAYSWATER – SYDNEY WEST 330 KV TRANSMISSION LINES ON 24 JANUARY 2015

AN AEMO POWER SYSTEM OPERATING INCIDENT REPORT FOR THE NATIONAL ELECTRICTY MARKET

Published: June 2015

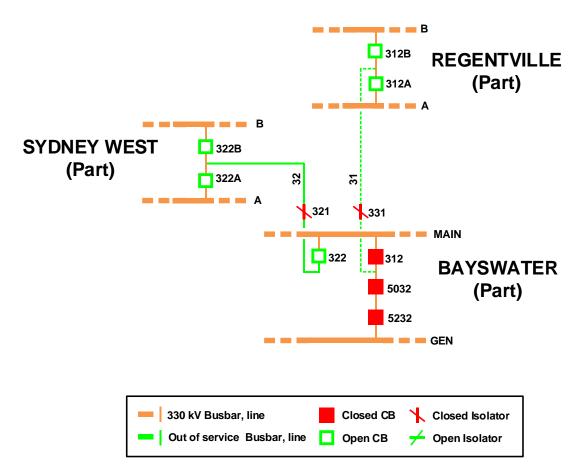
Figure 1 Status of the power system immediately after the incident

The status of the power system after the incident is shown below. The two circuit breakers at Regentville end of the Bayswater – Regentville 31 330 kV transmission line opened and reclosed. The two circuit breakers at Sydney West end and a circuit breaker at Bayswater end of the Bayswater – Sydney West 32 330 kV transmission line opened.
