TRIP OF RICHMOND No.2 & No.4 220kV BUSBARS ON 7 JUNE 2016

AN AEMO POWER SYSTEM OPERATING INCIDENT REPORT
FOR THE NATIONAL ELECTRICITY MARKET

Published: **August 2016**

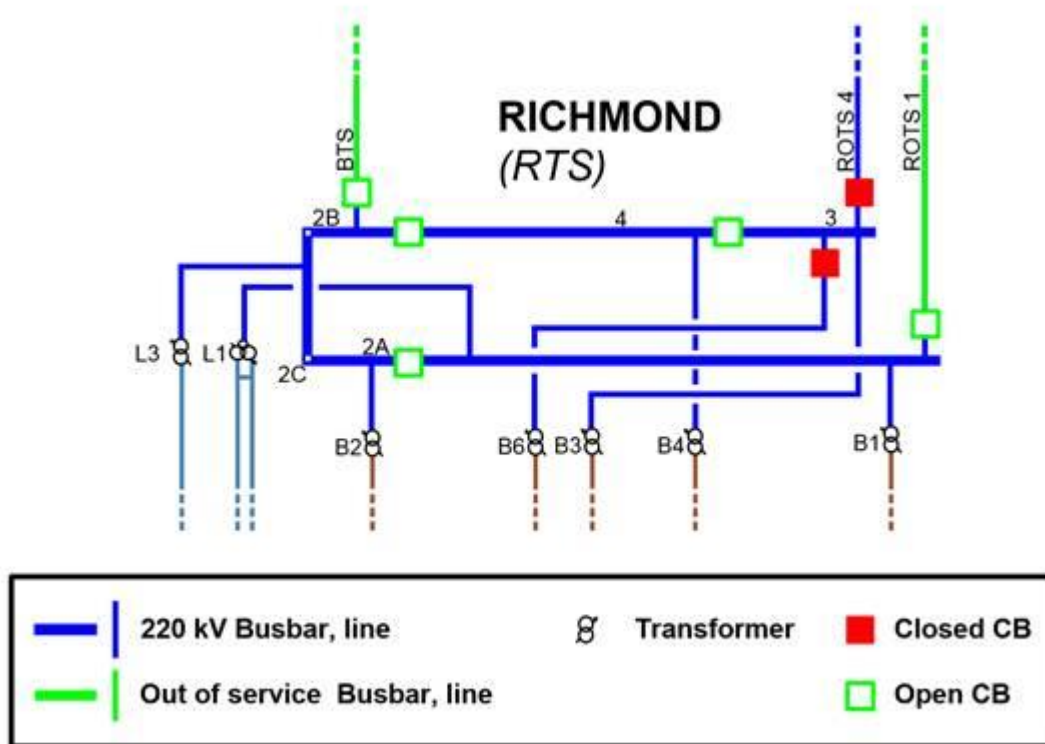
APPENDIX A. – POWER SYSTEM DIAGRAM

The diagram below shows the status of the 220kV switchgear at Richmond Terminal Station immediately after the event.
