# TRIP OF SOUTH EAST – TAILEM BEND NO.1 275KV LINE AND SOUTH EAST NO.1 SVC ON 26 MAY 2016

REVIEWABLE OPERATING INCIDENT REPORT UNDER THE  
NATIONAL ELECTRICITY RULES

Published: **August 2016**

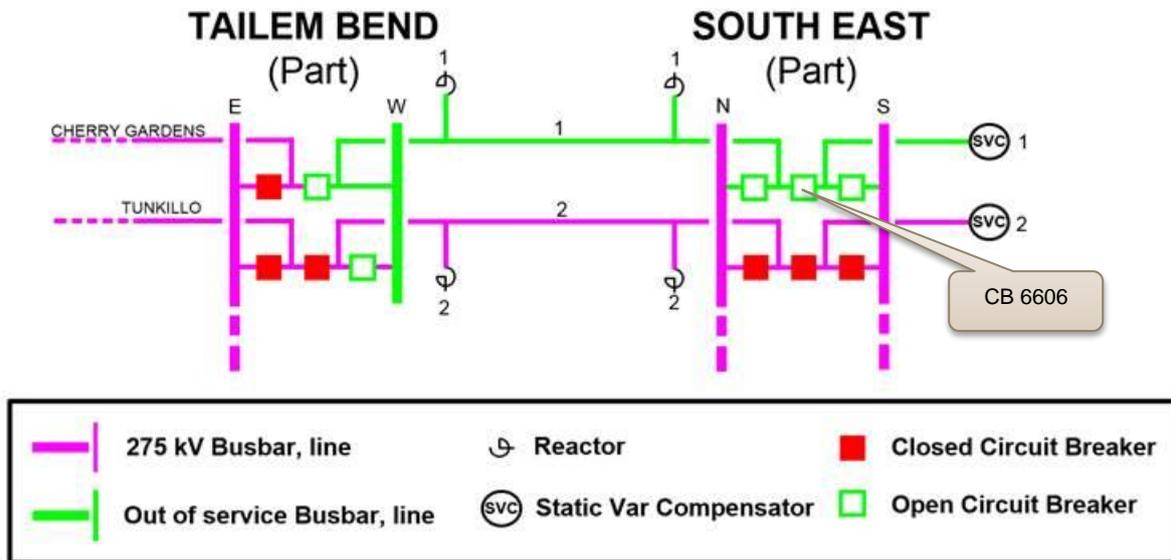
The trip of the No.1 Line and No.1 SVC resulted from the unexpected operation of the circuit breaker (CB) fail protection associated with CB 6606 at South East substation. While the trip of No.1 Line and No.1 SVC is a correct outcome for this protection operation, the protection should not have operated as there was no fault on the power system.

Investigation of the protection system wiring for CB 6606 revealed a damaged cable associated with No.1 SVC protection. The cable was shorted to earth resulting in an inadvertent CB Fail initiate signal being generated and tripping the No.1 Line and No.1 SVC. The damaged cable was replaced and CB 6606 returned to service.

Figure 1 shows the status of the power system immediately after the event.
