TRIP OF YALLOURN POWER STATION NO.2 220 KV BUSBAR ON 8 JUNE 2016

AN AEMO POWER SYSTEM OPERATING INCIDENT REPORT
FOR THE NATIONAL ELECTRICITY MARKET

Published: August 2016

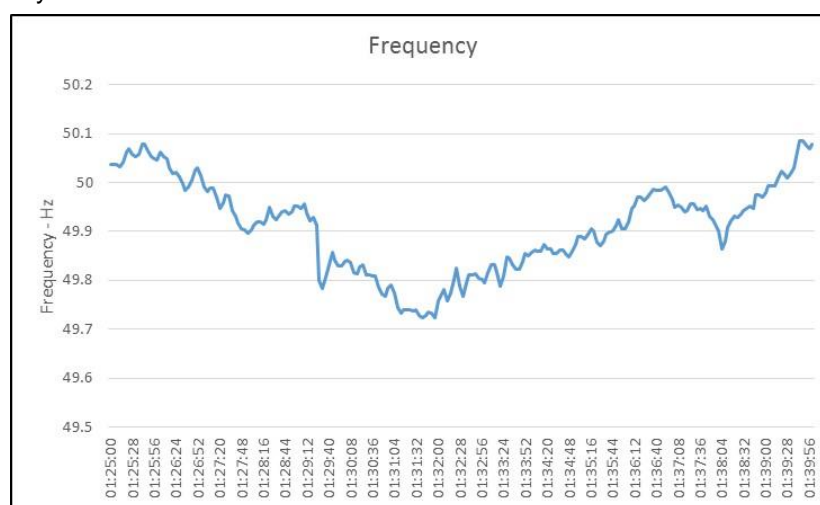
Figure 1: Frequency

For multiple contingency events,¹² the frequency operating standards require the frequency to remain above 47 Hz, return to above 49.5 Hz within two minutes and to above 48.85 Hz within ten minutes. The frequency standard was met for this incident. Figure 1 shows the frequency during this incident.

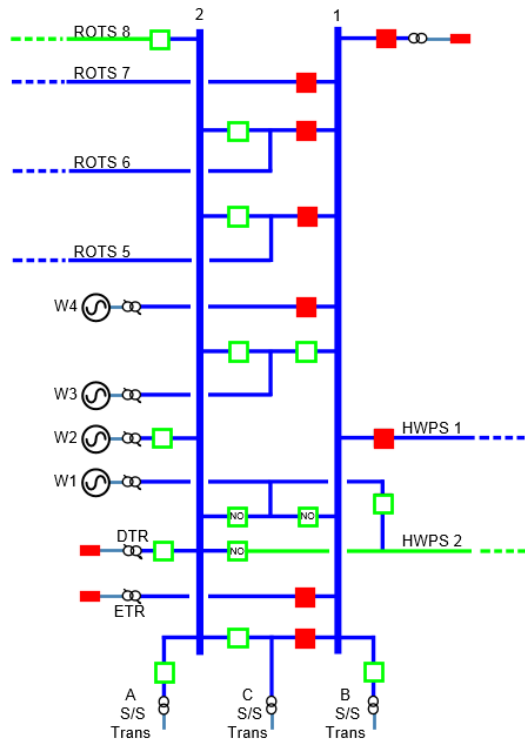
APPENDIX A. – POWER SYSTEM DIAGRAM

On Wednesday 8 June 2016 at 0129 hrs, the YPS No.2 220kV busbar (No. 2 busbar) tripped. This resulted in the islanding and subsequent trip of YWPS unit 2, off-loading of the Yallourn to Rowville No.8 220kV transmission line (No. 8 Line), the Yallourn to Hazelwood No.2 220kV transmission line (No.2 Line), and disconnection of the 'A' and 'D' auxiliary supply transformers. Two minutes later, at 0131 hrs, YWPS generating unit 1 tripped.

The power system immediately after the incident
