# TRIP OF DAVENPORT 275 KV WEST BUS ON 9 OCTOBER 2017

REVIEWABLE OPERATING INCIDENT REPORT UNDER THE  
NATIONAL ELECTRICITY RULES

Published: **26 March 2018**

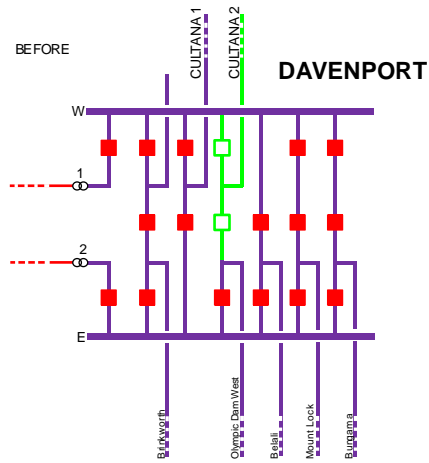
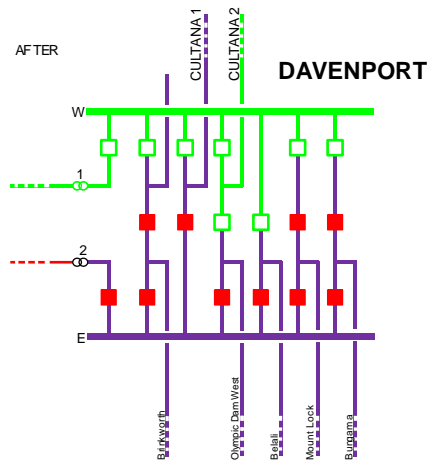
# APPENDIX A. POWER SYSTEM DIAGRAM

On Monday 9 October 2017 at 1153 hrs, the West 275 kV busbar at Davenport Substation tripped during Primary Injection testing of the current transformers (CTs) associated with the Cultana No. 1 line. No transmission lines were offloaded as a result. Refer to Appendix A for a diagram of Davenport Substation before and immediately after the event.

Prior to the incident, the Davenport – Cultana No. 2 line was isolated for replacement of the CTs associated with circuit breaker (CB) 6590 at Davenport. As part of the commissioning process for these new CTs, field crews were carrying out Primary Injection testing. As the test current was increased, the 275 kV West Bus Zone protection operated and all ‘in service’ 275 kV CBs connected to the 275 kV West Bus tripped.

The reason for the trip of the West 275 kV bus was identified as the secondary systems not being isolated correctly. The reason for the incorrect isolation was identified as a failure to correctly follow established procedures.

The diagrams below show the status at Davenport Substation before and immediately after the event.
