# TRIP OF KEILOR NO. 3 220 KV BUSBAR ON 18 MAY 2017

REVIEWABLE OPERATING INCIDENT REPORT UNDER THE  
NATIONAL ELECTRICITY RULES

Published: **1 September 2017**

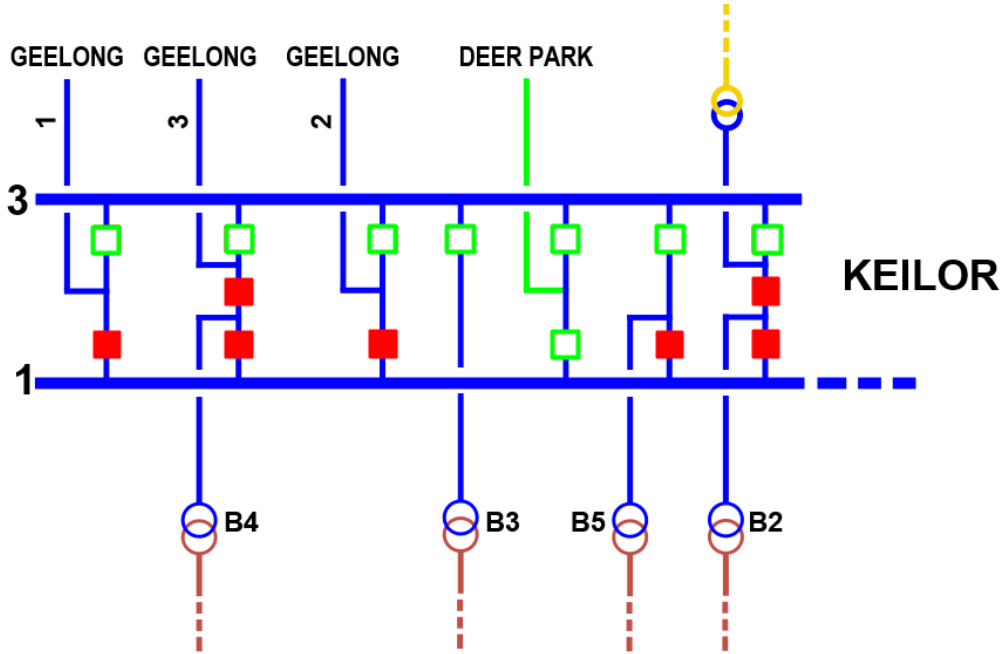
# APPENDIX A. – POWER SYSTEM DIAGRAM

The diagram below shows the status of KTS immediately after the event. Note that the line to Deer Park and the B3 220/66 kV transformer were out of service prior to the event.
