TRIP OF ERARING POWER STATION No. 1 GENERATOR TRANSFORMER AND ERARING – VALES POINT 330 KV LINE ON 31 JANUARY 2018

REVIEWABLE OPERATING INCIDENT REPORT UNDER THE
NATIONAL ELECTRICITY RULES

Published: **May 2018**

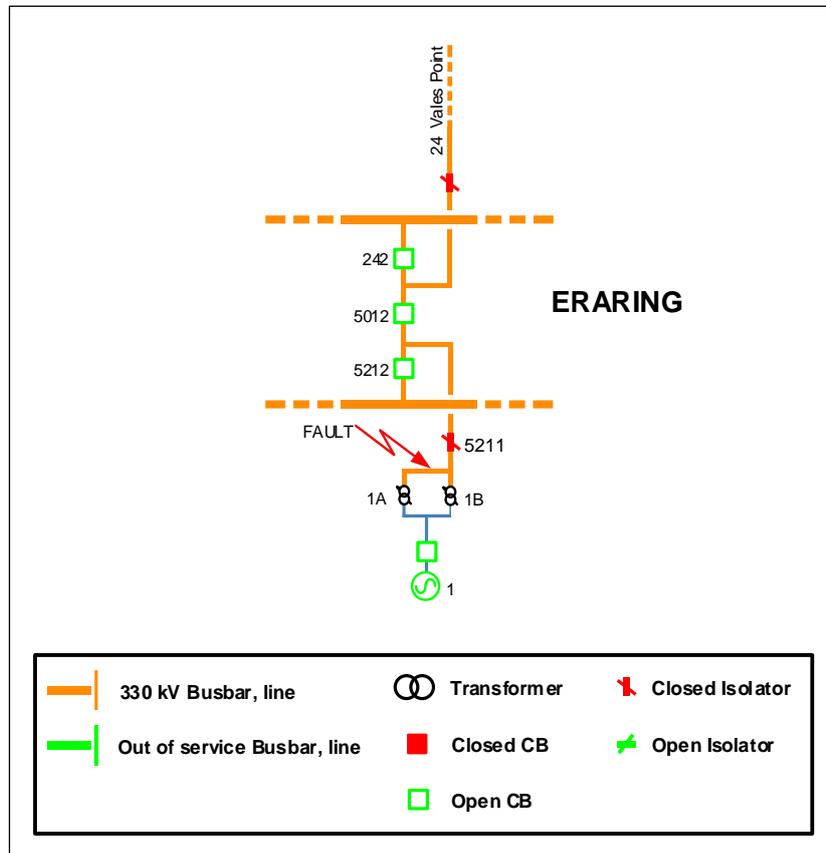
APPENDIX A. SYSTEM DIAGRAM

At 0539 hrs on 31 January 2018, circuit breakers (CBs) 5212, 5012, and 242 tripped at the 330 kV Eraring switchyard, disconnecting the unit 1 transformer and offloading 24 line. There was no loss of generation, as Eraring Power Station unit 1 was out of service at the time. Refer to Appendix A for a diagram of the power system immediately after this incident.

The diagram below shows the affected part of the power system immediately after the incident.
