Trip of South East – Taillem Bend No. 1 275 kV Line and South East No. 1 Static Var Compensator on 26 and 27 April 2018

November 2018

Reviewable operating incident report under the
National Electricity Rules

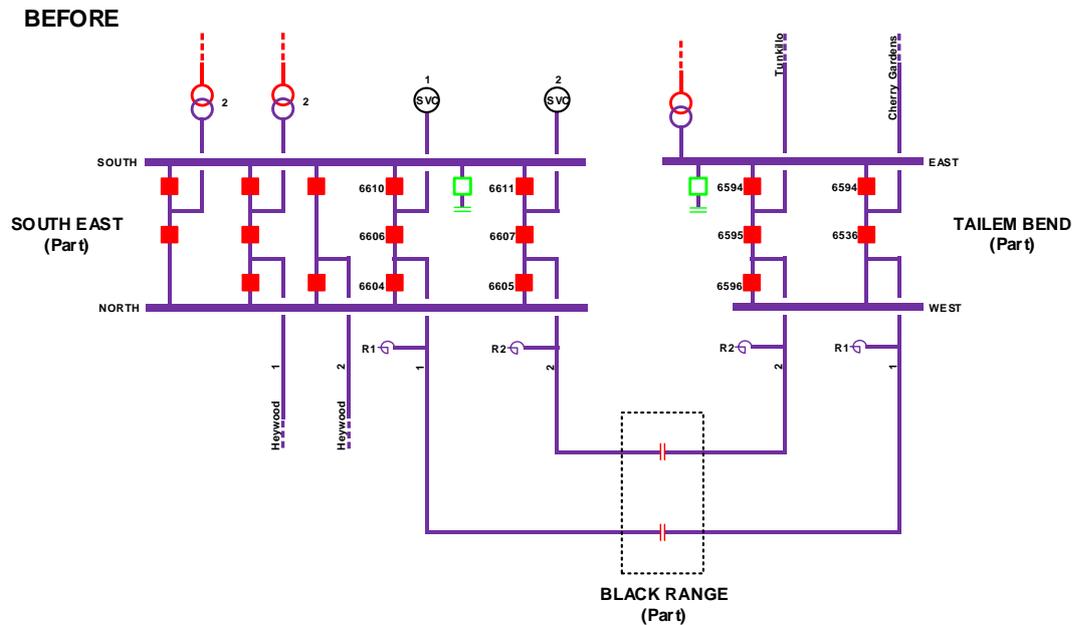
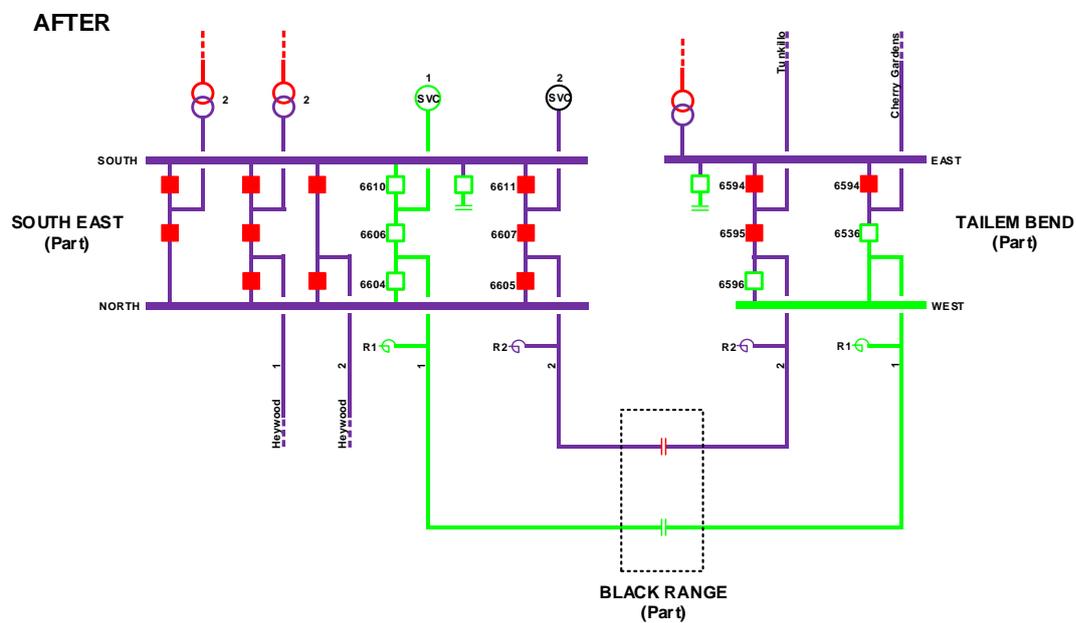
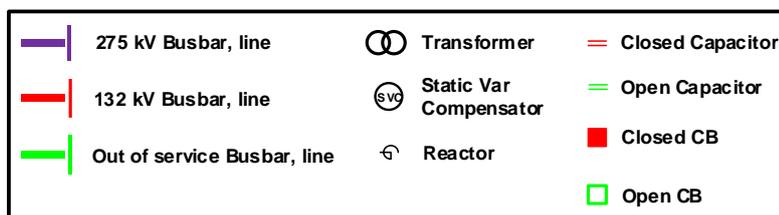
A1. Power system diagram

The diagrams below show the power system before and immediately after the incident on 26 April 2018.
