TRIP OF JEERALANG (JLTS) NO.2 220 KV BUSBAR ON 22 MARCH 2016

AN AEMO POWER SYSTEM OPERATING INCIDENT REPORT
FOR THE NATIONAL ELECTRICITY MARKET

Published: June 2016

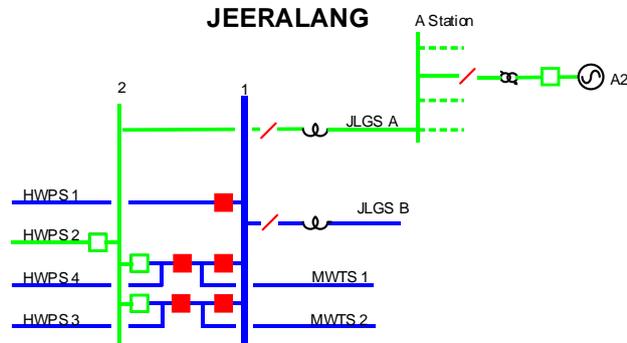
APPENDIX A. – POWER SYSTEM DIAGRAM

This report reviews a power system operating incident that occurred on 22 March 2016 at Jeeralang 220kV terminal station (JLTS) in Victoria. This incident involved the trip of the No.2 220kV busbar and Jeeralang – Hazelwood (JLTS-HWPS) No.2 220kV transmission line.

The trip of the JLTS No.2 220k busbar was the result of a failed surge diverter (blue phase) on the Jeeralang Power Station A2 unit transformer. The trip of the busbar resulted in the de-loading of the JLTS-HWPS No.2 transmission line. This is an expected outcome for this type of fault.

The power system immediately after the incident
