POWER SYSTEM INCIDENT REPORT TRIP OF MULTIPLE TRANSMISSION LINES IN THE VICINITY OF BRAEMAR 275 KV SUBSTATION 13 NOVEMBER 2009

PREPARED BY: Electricity System Operations Planning and Performance

FINAL

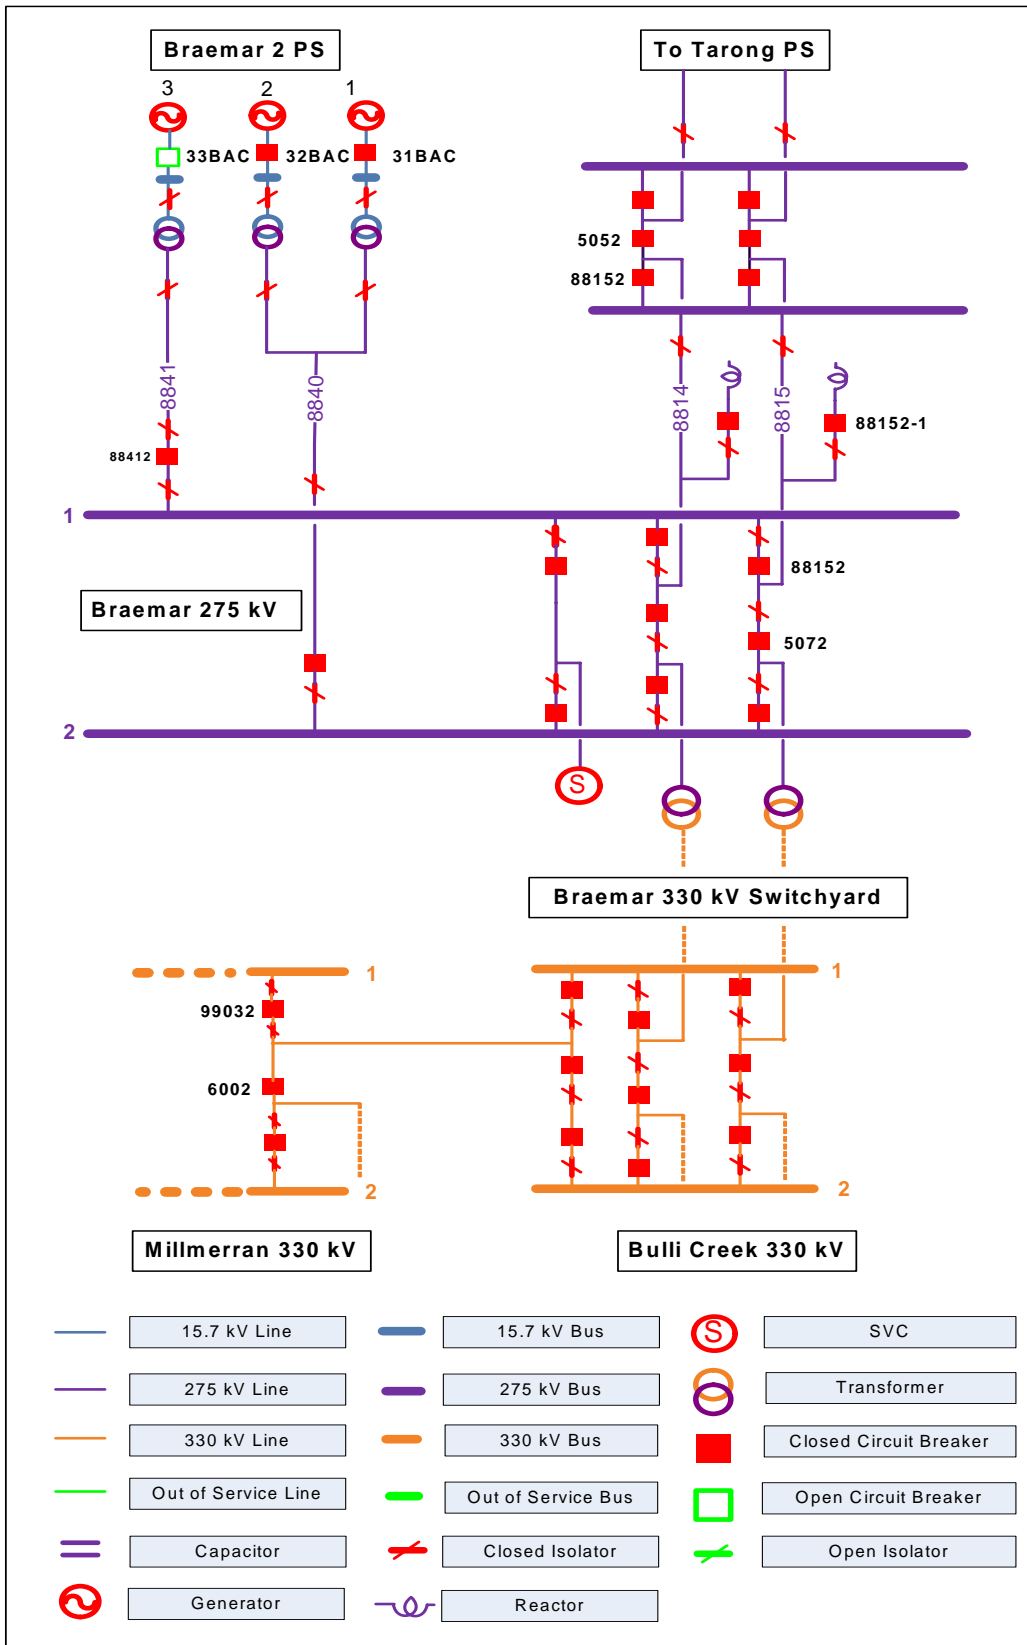
The single line diagram representation of the transmission network relevant to the power system incident is shown in Figure 1. The status of circuit breakers prior to the event is also shown.

Figure 1: Single line diagram showing status of the relevant transmission plant before the event

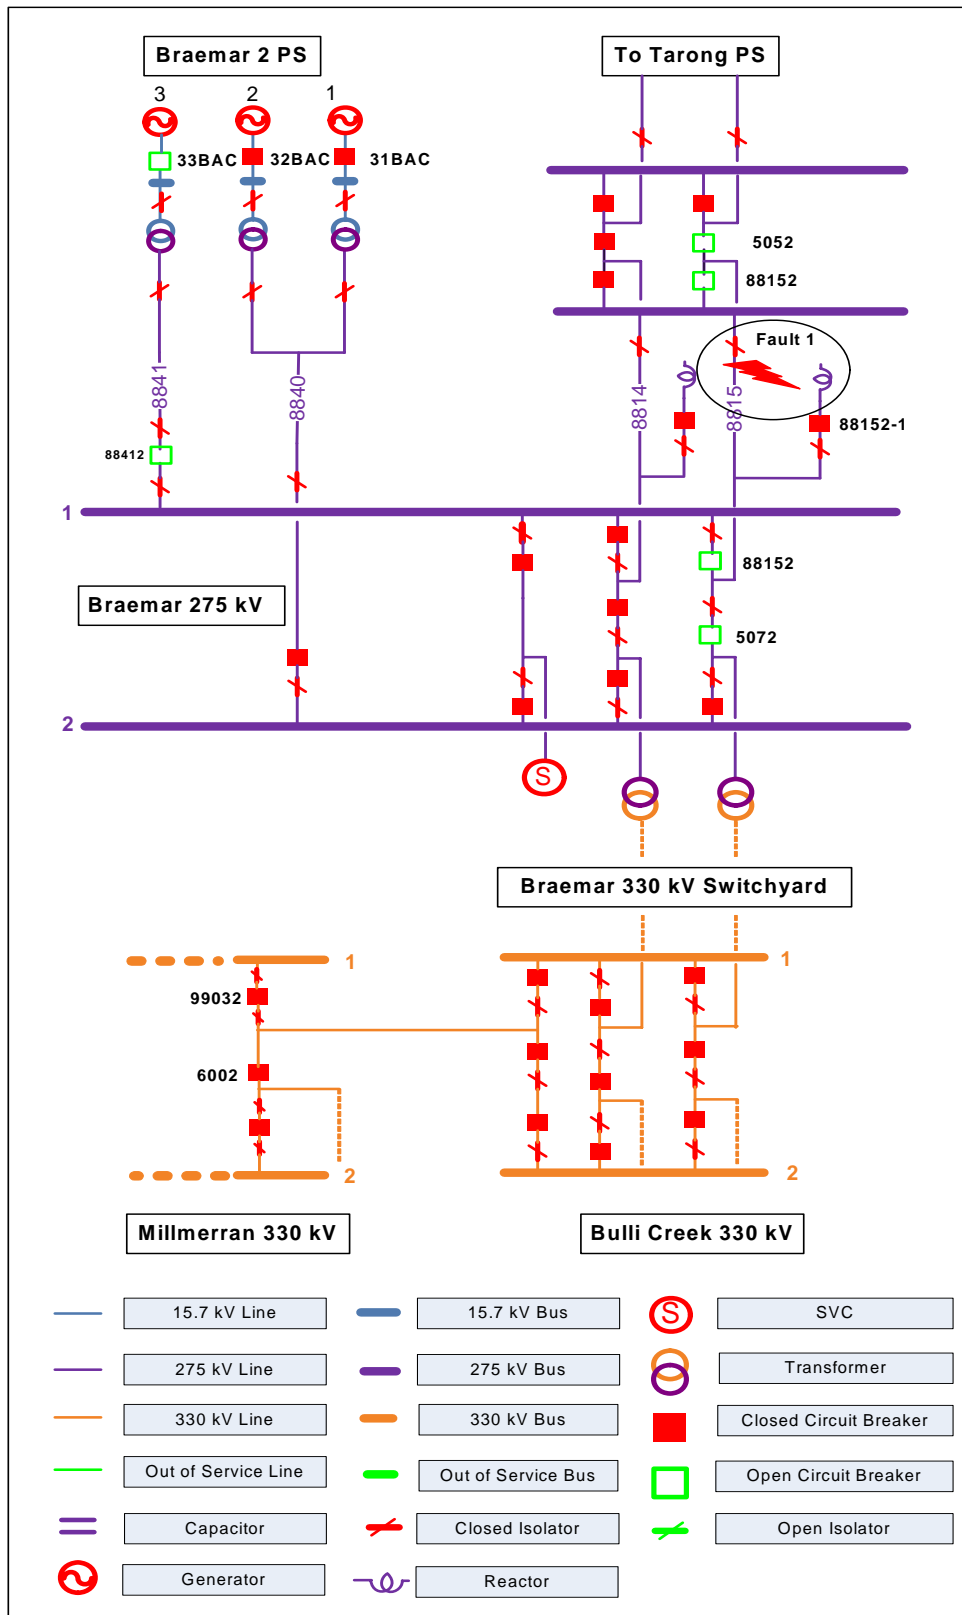
Powerlink advised that at 19:28:54 hours on 13 November 2009, a fault occurred on phase “B” of the Tarong – Braemar (8815) 275 kV transmission line, during a lightning storm. The protection systems operated and performed a single pole trip at both Braemar and Tarong 275 kV substations to successfully clear the fault from the power system.

Coincident with the trip of 8815 transmission line, the Braemar - Braemar 2 Power Station (8841) 275 kV transmission line tripped. The trip of 8841 transmission line was due to the operation of Braemar 2 Power Station protection systems at Braemar 2 Power Station.

ERM Power advised that due to a lightning strike in the immediate vicinity of the Braemar 2 Power Station, the unit 3 transformer protection operated to trip 8841 transmission line by sending a protection inter-trip signal to the Braemar 275 kV substation to open the circuit breakers associated with 8841 transmission line (refer to Figure 2). The Braemar 2 Power Station generating unit 3 was not in service and was on turning gear at the time.

- 88152 - Tarong 275 kV substation;
- 5052 - Tarong 275 kV substation;
- 88152 - Braemar 275 kV substation;
- 5072 - Braemar 275 kV substation; and
- 88412 - Braemar 275 kV substation.

Figure 2 shows the status of relevant circuit breakers at Tarong and Braemar 275 kV substations and Braemar 2 Power Station after the first fault.

Figure 2: Single line diagram showing status of relevant transmission plant after the first fault

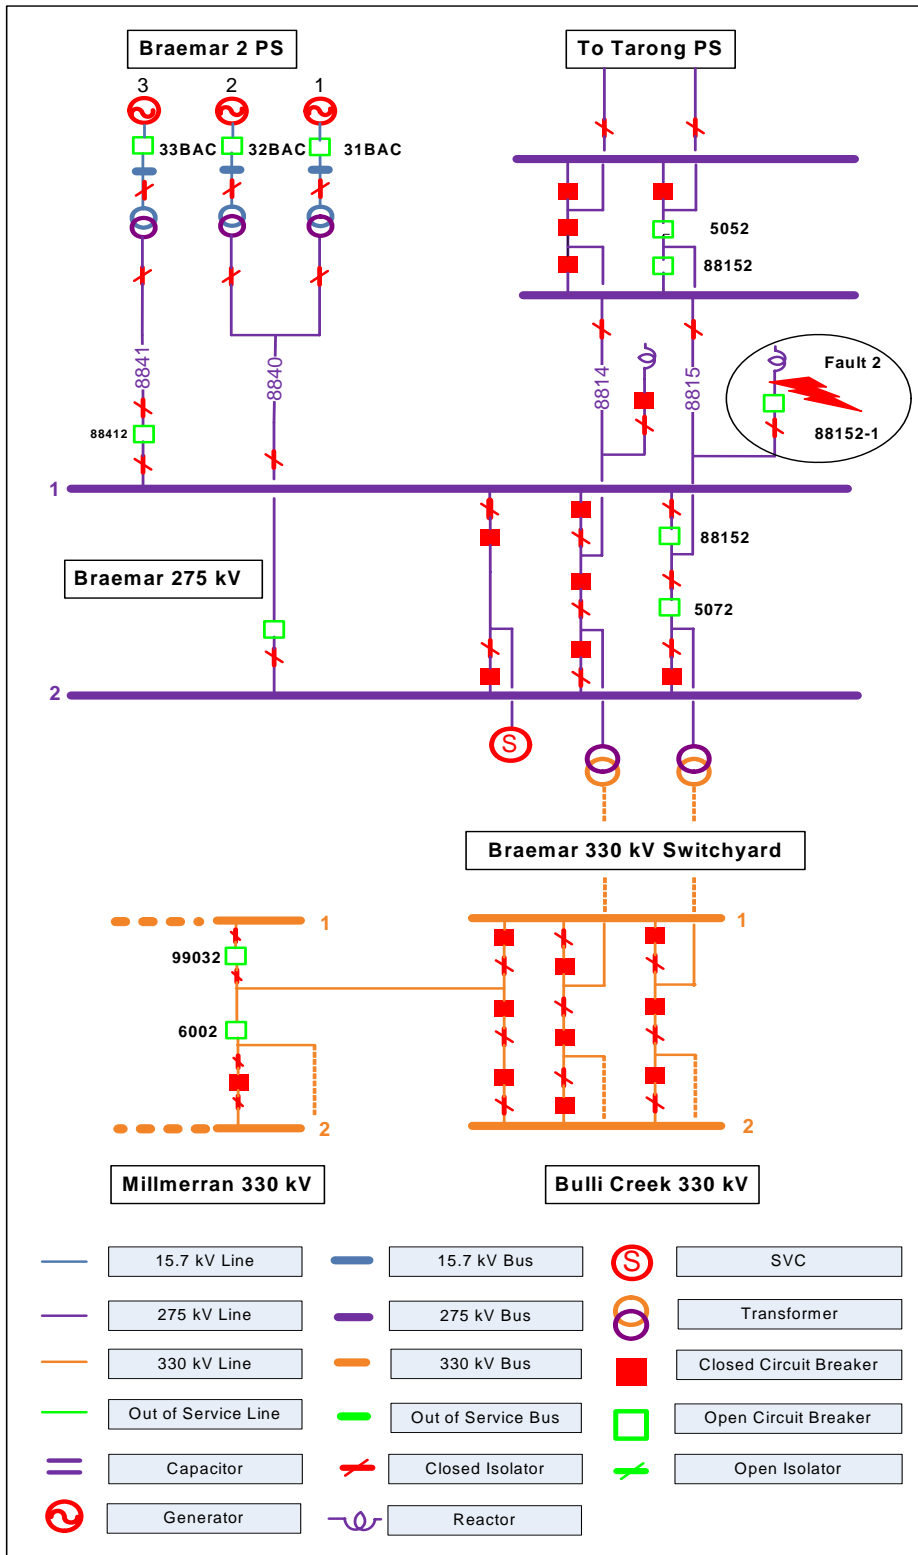
The protection systems operated to trip the 8815 transmission line and 275 kV Reactor successfully clearing the fault from the power system. The cause of the fault was the failure of the 275 kV phase “B” surge arrester associated with the Reactor (refer to Figure 3 for the location of second fault).

Coincident with the trip of the 275 kV Reactor, the Braemar-Braemar 2 Power Station (8840) 275 kV transmission line tripped. The trip of the 8840 transmission line was due to operation of protection systems at Braemar 2 Power Station sending a protection intertrip to Braemar 275 kV substation. The trip of the 8840 transmission line disconnected Braemar 2 Power Station from the transmission network. The combined output from Braemar 2 Power Station generating units 1 and 2 was approximately 305 MW immediately before this event.

Coincident with the trip of the 275 kV Reactor, the Millmerran- Bulli Creek (9903) 330 kV transmission line also tripped at Millmerran end only, off-loading the transmission line. The trip occurred due to operation of the transmission line protection systems at Millmerran.

- 88152 – Braemar 275 kV substation;
- 88152-1 - Braemar 275 kV substation;
- 88402 - Braemar 275 kV substation;
- 31BAC - Braemar 2 Power Station;
- 32BAC – Braemar 2 Power Station;
- 99032 - Millmerran 275 kV substation; and
- 6002 - Millmerran 275 kV substation.

Figure 3 shows the status of relevant circuit breakers at Tarong 275 kV, Braemar 275 kV and Millmerran 330 kV substations.

Figure 3: Single line diagram showing status of the relevant transmission plant after the second fault

The damaged surge arrester associated with phase “B” of the Braemar-Tarong (8815) 275 kV transmission line was replaced.
