# POWER SYSTEM INCIDENT REPORT TRIP OF TOWNSVILLE SOUTH 132 KV BUSBAR ON 13 OCTOBER 2009

PREPARED BY: ESOPP

FINAL

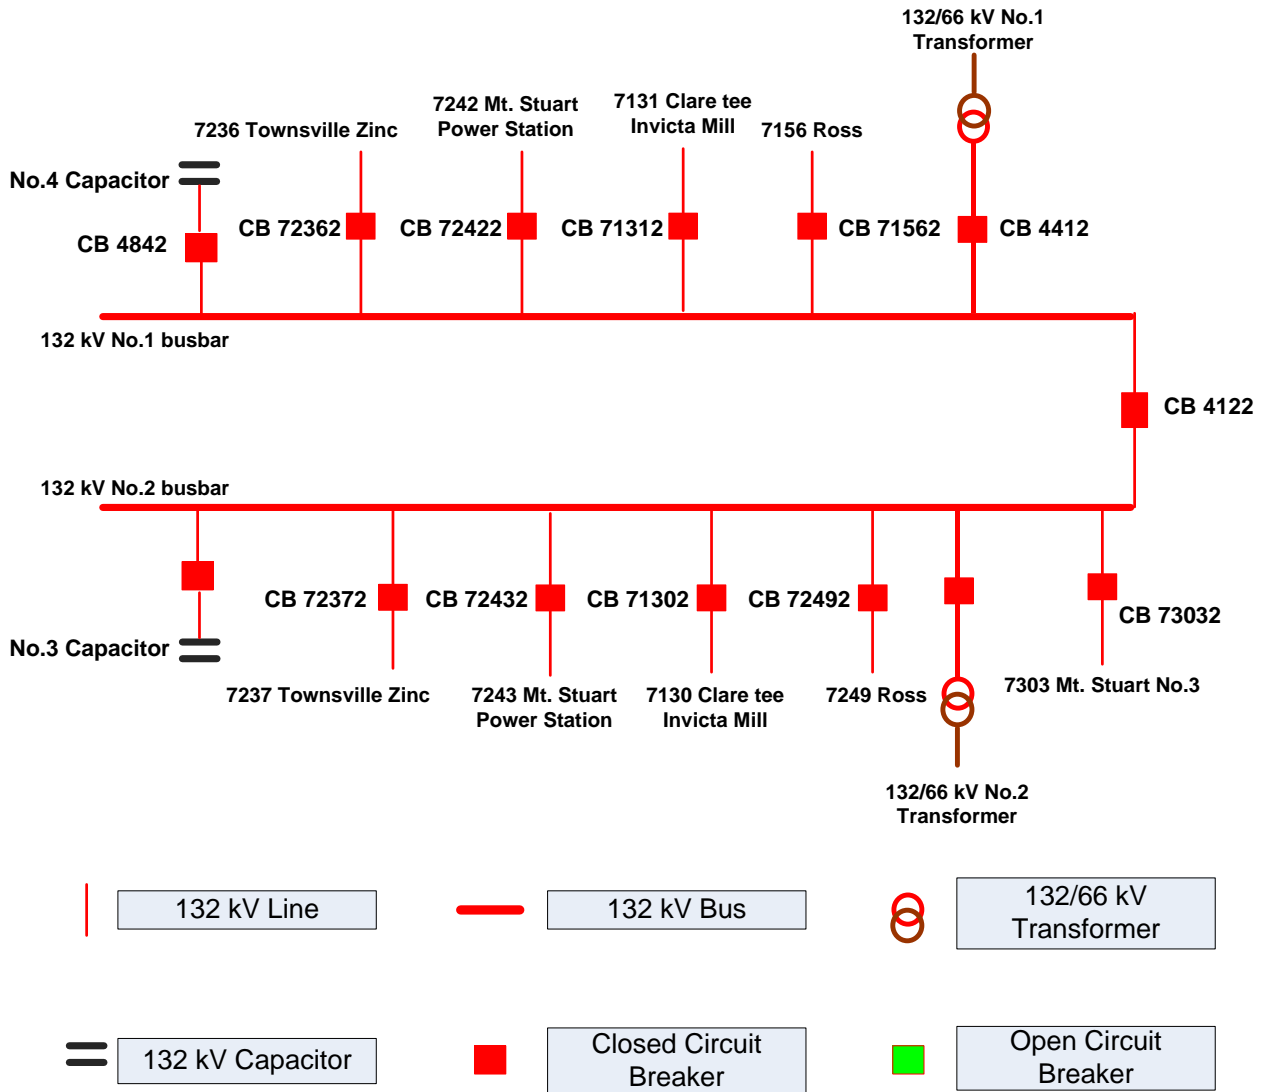
**Figure 1: T56 Townsville South single line diagram prior to the event**

The transmission network configuration at Townsville South substation including the status of circuit breakers prior to the event is shown in Figure 1.

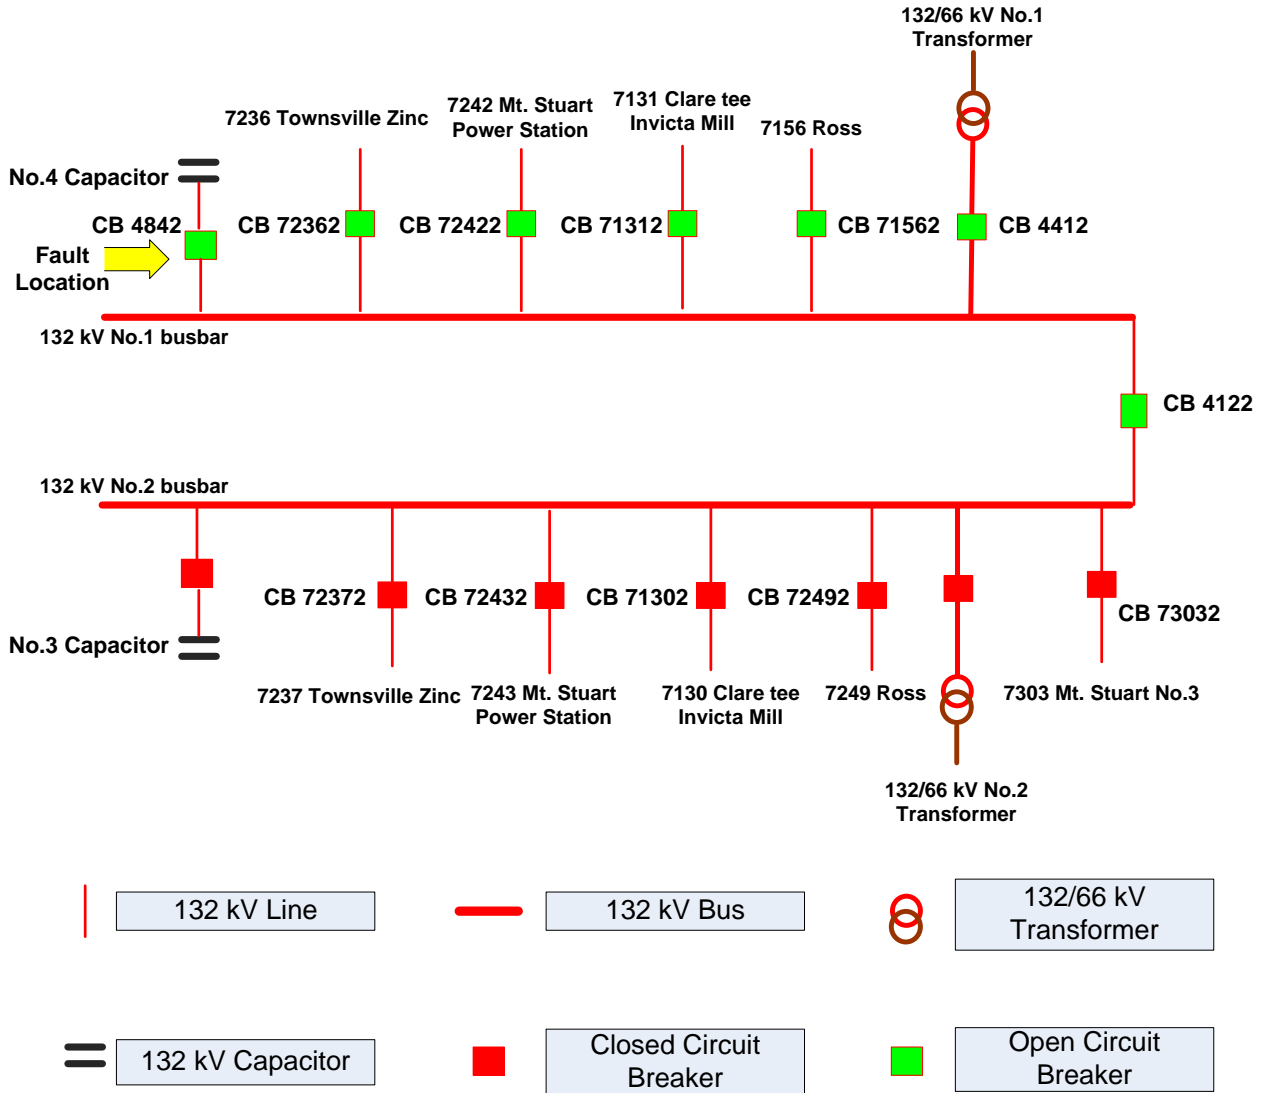
**Figure 2: T56 Townsville South single line diagram after the event**

- Busbar section circuit breaker 4122
- 7131 line circuit breaker 71312
- 7156 line circuit breaker 71562
- No.1 transformer circuit breaker 4412
- 7236 line circuit breaker 72362
- 7242 line circuit breaker 72422
- No.4 capacitor circuit breaker 4842

The transmission network configuration at Townsville South substation including the status of circuit breakers after the event is shown in Figure 2.
