POWER SYSTEM INCIDENT REPORT

TRIP OF NO.1 220KV BUSBAR AT SOUTH MORANG TERMINAL STATION ON 12TH DECEMBER 2009

PREPARED BY: ESOPP

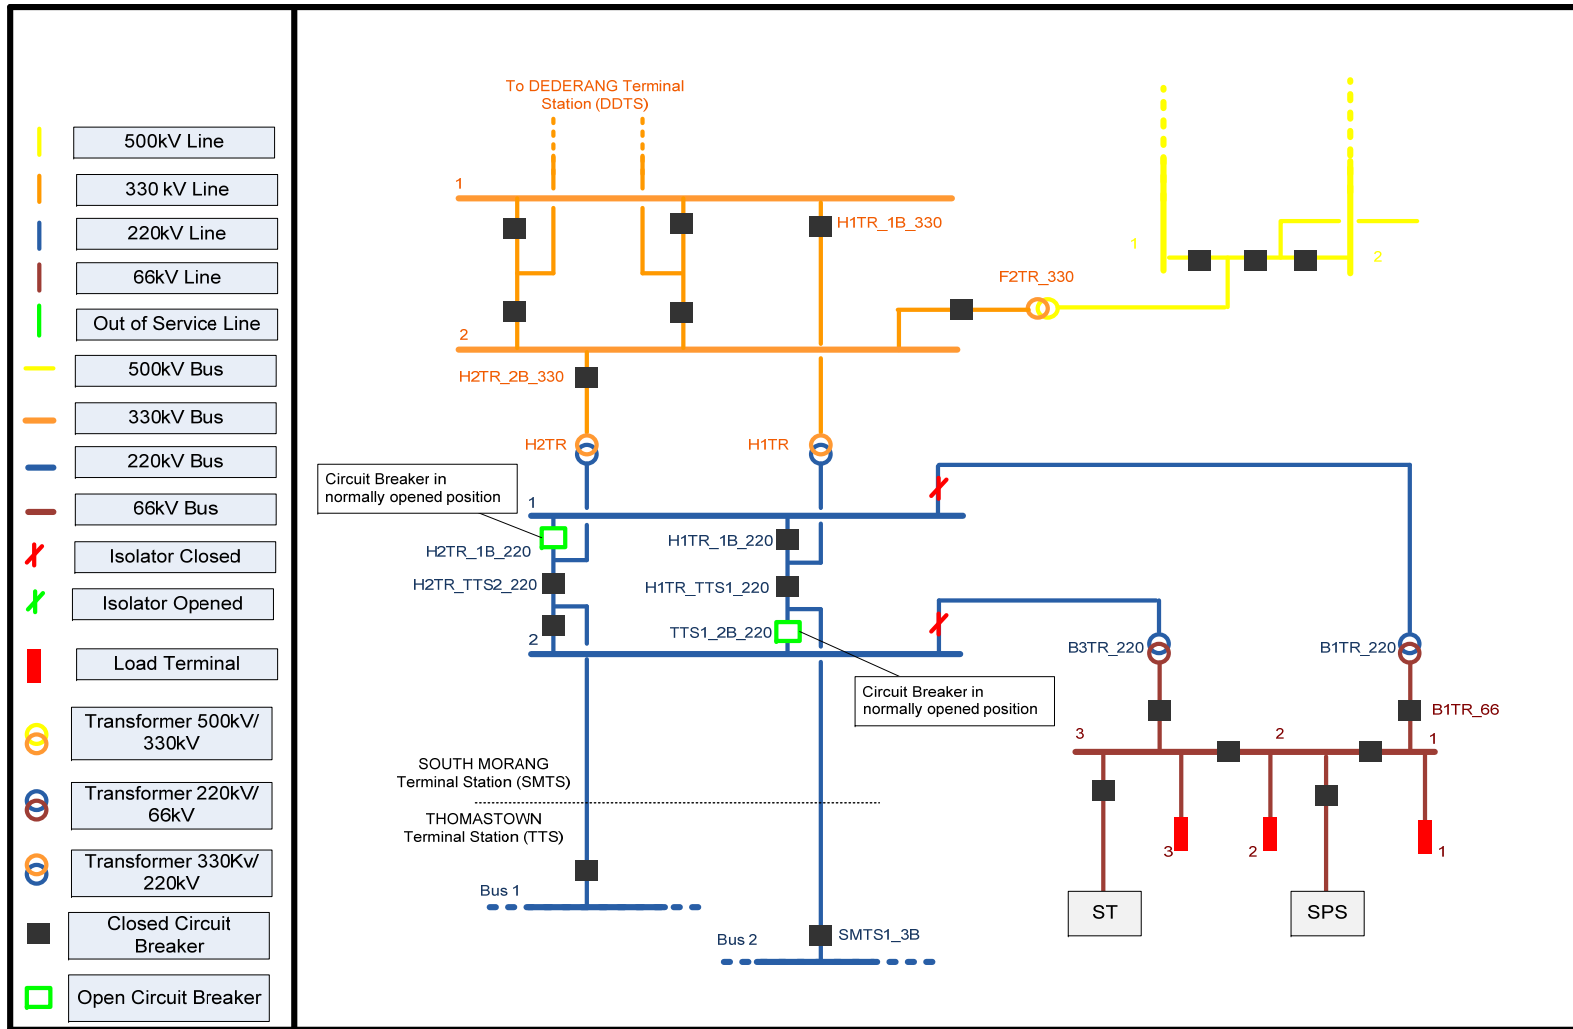
FIGURE 1: STATUS OF SMTS PRIOR TO THE OCCURANCE OF THE INCIDENT

At approximately 23:51 hrs on 12th December 2009, an internal flash over occurred in the H2 transformer 220kV No.1 bus CB. Normally this CB is operated open. As a result of the failure, the No 1 220 kV busbar opened automatically and the H1, H2 and B1 transformers at SMTS were de-energised. This also caused off-loading of the Thomastown No1 220 kV line at SMTS. Figure 1 below illustrates the status of SMTS before the incident and figure 2 outlines the status after the incident.

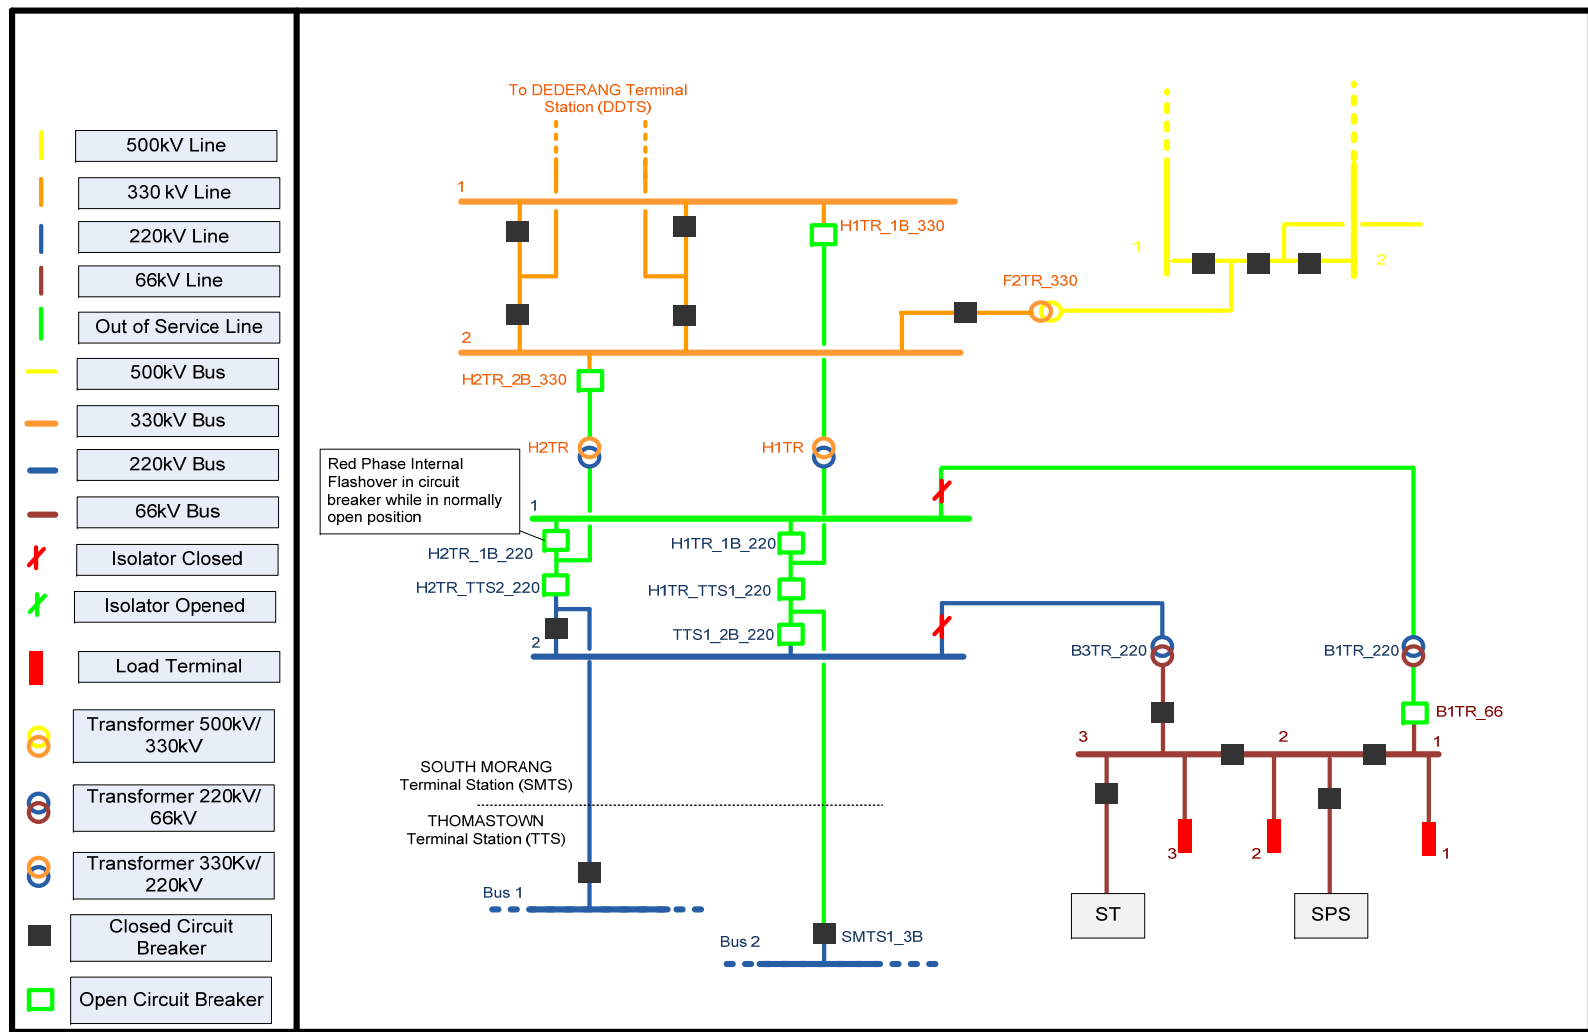
FIGURE 2: STATUS OF SMTS AFTER THE OCCURANCE OF THE INCIDENT

The H2 transformer 220kV No.1 bus CB at SMTS is normally operated open. At approximately 23:51hrs on 12th December 2009, an internal flash over of the red phase of this CB occurred. The X protection of the H2 transformer operated tripping the H2 330/220KV transformer. The protection design at SMTS is such that the B1 220/66 kV transformer zone differential protection is extended to cover the No.1 220kV busbar. Similarly the B3 transformer zone differential protection is extended to cover the No.2 220kV busbar. (Note that B1 and B3 transformers do not have 220kV CBs.) Hence the B1 220/66KV transformer also tripped when the internal flash over was experienced on the H2 transformer 220kV No.1 bus CB.
