# TRIP OF LOWER TUMUT -UPPER TUMUT 64 330 KV LINE AND CANBERRA - LOWER TUMUT 7 330 KV LINE ON 11 JULY 2015

AN AEMO POWER SYSTEM OPERATING INCIDENT REPORT FOR THE NATIONAL ELECTRICTY MARKET

Published: September 2015

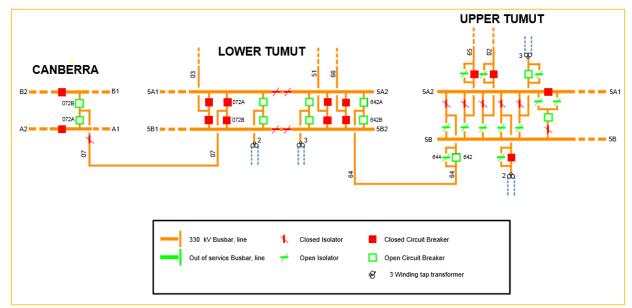
#### APPENDIX A. – POWER SYSTEM DIAGRAM

The power system during the incident – circuit breakers on Line 64 opened, and circuit breakers on Line 07 opened at Canberra end only.
