POWER SYSTEM INCIDENT REPORT TRIP OF MACKAY 'C' 132 KV BUSBAR ON 12 FEBRUARY 2010

PREPARED BY: Electricity System Operations Planning and Performance

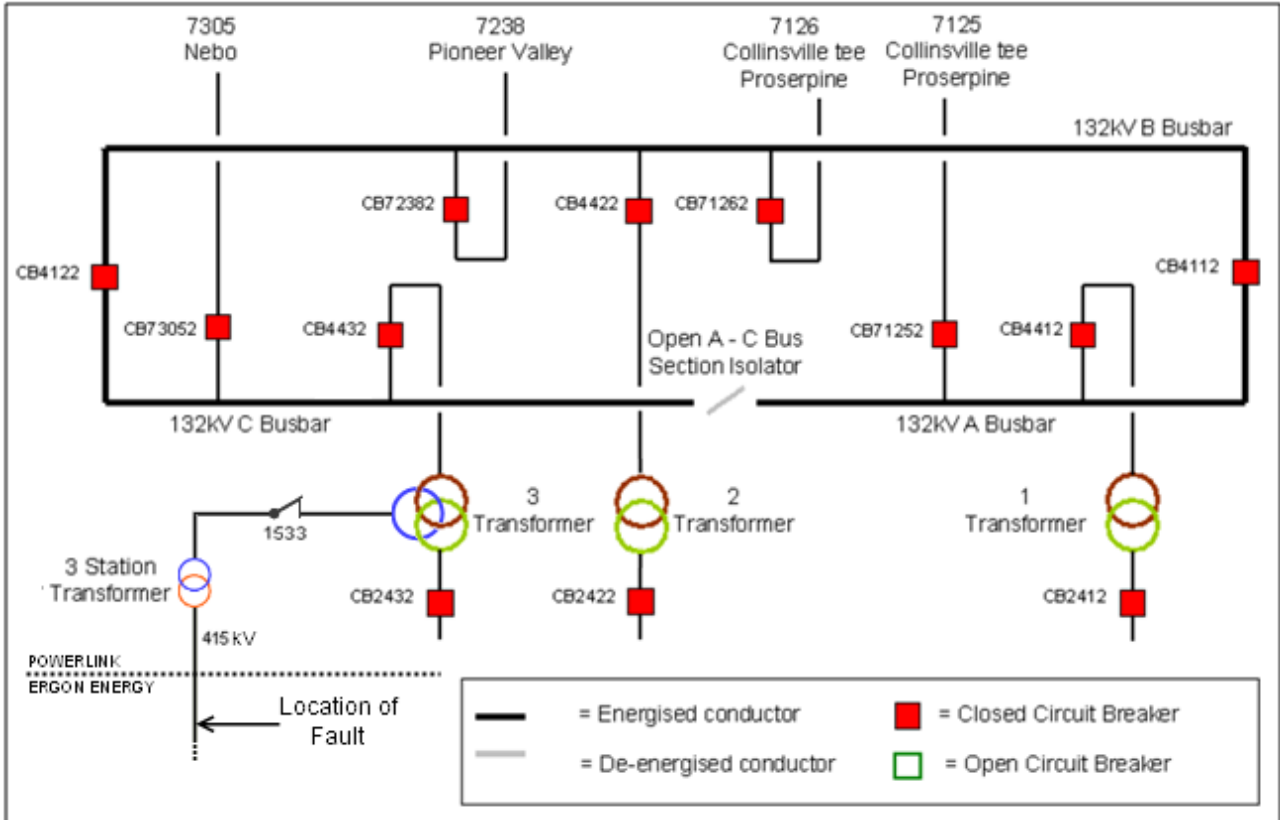
The T38 Mackay 132 kV substation consists of a ring busbar configuration. At the time of the event the 132 kV busbars were setup in a split ring configuration. The Mackay Gas Turbine was not in service during the event.

Figure 1 shows the statuses of relevant circuit breakers at T38 Mackay substation prior to the event.

Figure 1: Status of relevant T38 Mackay substation circuit breakers prior to the event

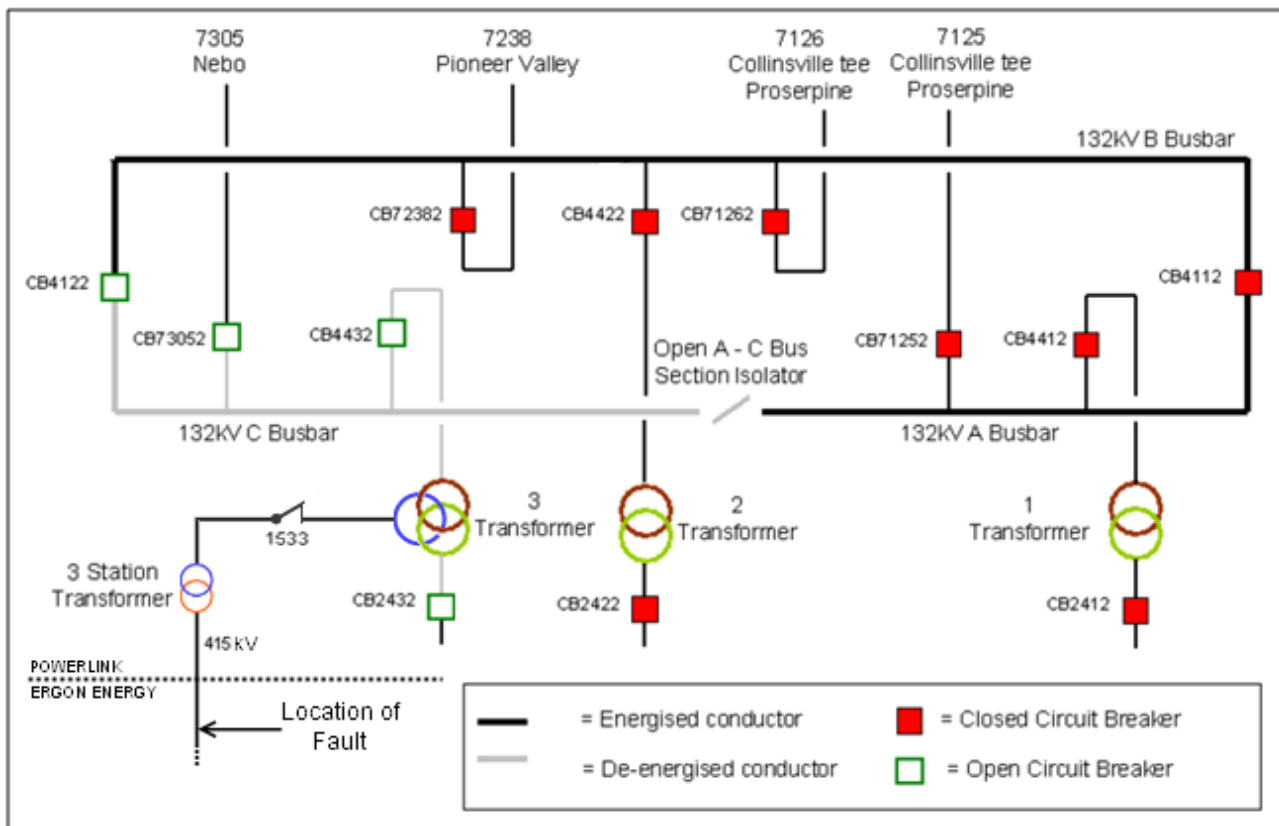
Due to an electrical fault within a relay, circuit breaker 4432 did not open within the required time, which caused the operation of a circuit breaker fail protection scheme to trip the 132kV 'C' busbar by opening the following circuit breakers:

- 132 kV "B" – 'C' busbar section circuit breaker 4122
- Mackay to Nebo (7305) 132 kV line circuit breaker 73052

Figure 2: Status of relevant T38 Mackay substation circuit breaker after the busbar trip

The trip of Mackay 132/33 kV 3 transformer occurred on the operation of the transformer protection system. This protection system was triggered due to a phase to ground fault on the 415 volt network supplied by the 11 kV tertiary winding of the transformer. The Mackay 'C' 132 kV busbar then tripped due to the subsequent operation of the circuit breaker fail system when circuit breaker 4432 did not open within the required time.

A fault in the tripping relay associated with the No.3 transformer protection system caused the delayed opening of 132 kV circuit breaker 4432. This triggered the circuit breaker fail protection to trip the 'C' busbar. The faulty tripping relay has since been replaced.
