POWER SYSTEM INCIDENT REPORT

MULTIPLE CONTINGENCIES IN NORTH QUEENSLAND ON 16TH AND 17TH FEBRUARY 2010

PREPARED BY: ESOPP

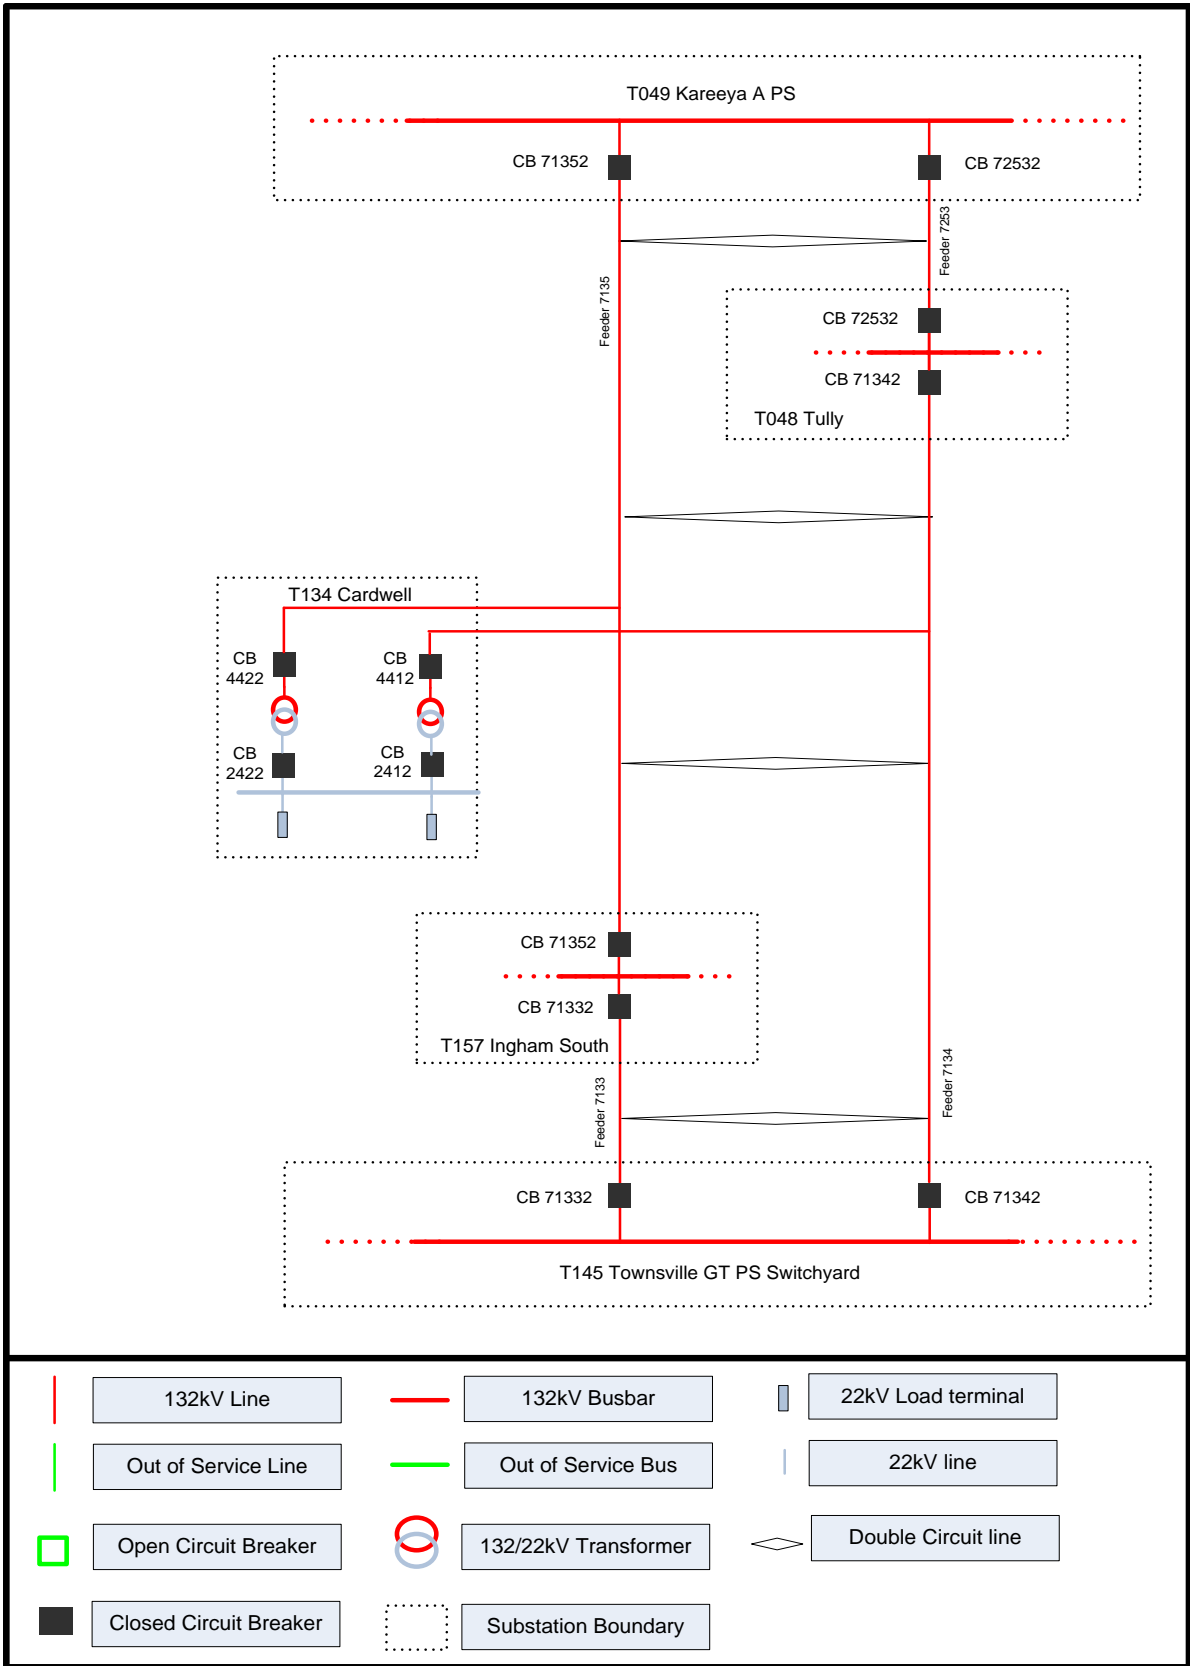
FIGURE 1: STATUS OF 132KV SUBSTATIONS INVOLVED IN BOTH CONTINGENCY EVENTS BEFORE THE TRIPS HAVE OCCURRED

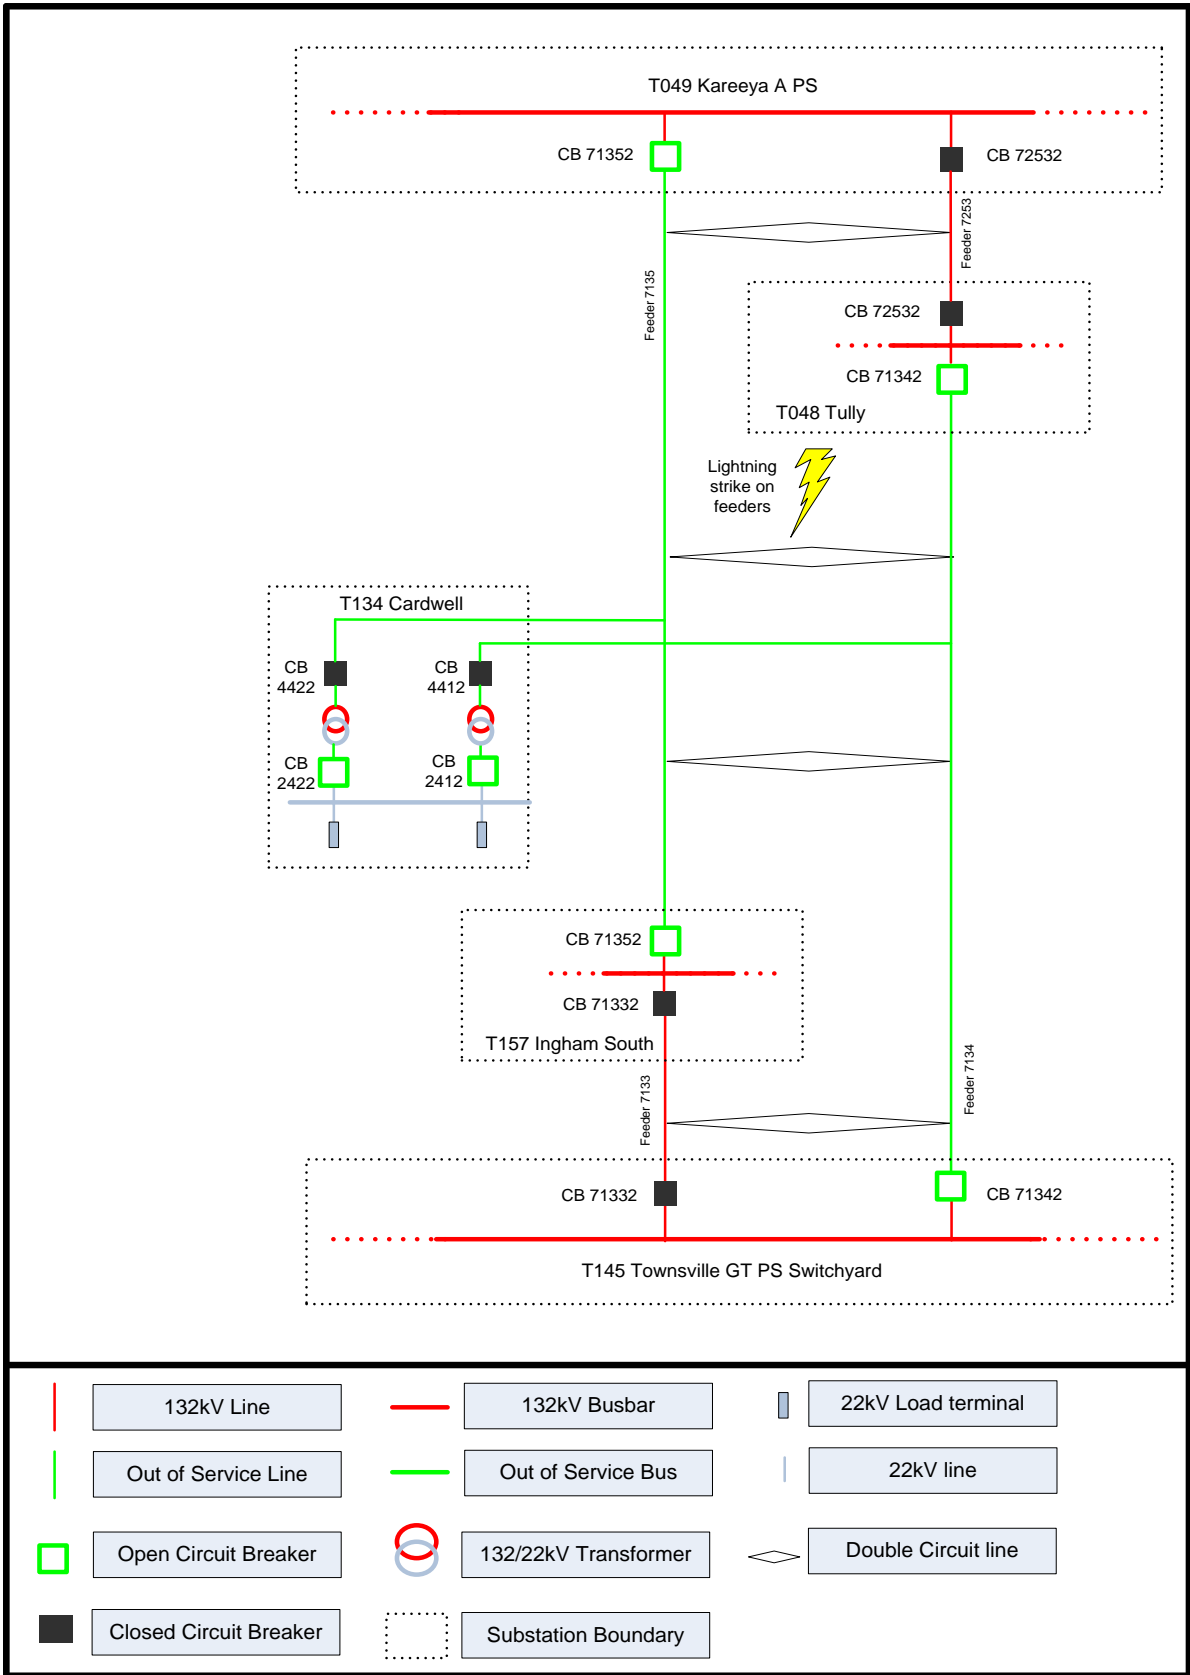
The incident on the 16th February resulted in both lines supplying Cardwell substation tripping, causing a 3MW load interruption. Both lines returned to service at 17:52hrs restoring the load at Cardwell.

7134 line was returned to service at 16:55hrs on 18 February 2010 after the replacement of a damaged surge arrester on this line at Ingham East substation.

FIGURE 2: STATUS OF 132KV SUBSTATIONS INVOLVED IN BOTH CONTINGENCY EVENTS AFTER THE TRIPS HAVE OCCURRED
