POWER SYSTEM INCIDENT REPORT TRIP OF KURRI TO ROTHBURY 132 KV LINE AND THE HYDRO ALUMINIUM POTLINES ON 24 OCTOBER 2010

PREPARED BY: ESOPP
VERSION: 1.0
DATE: 17 February 2011
FINAL

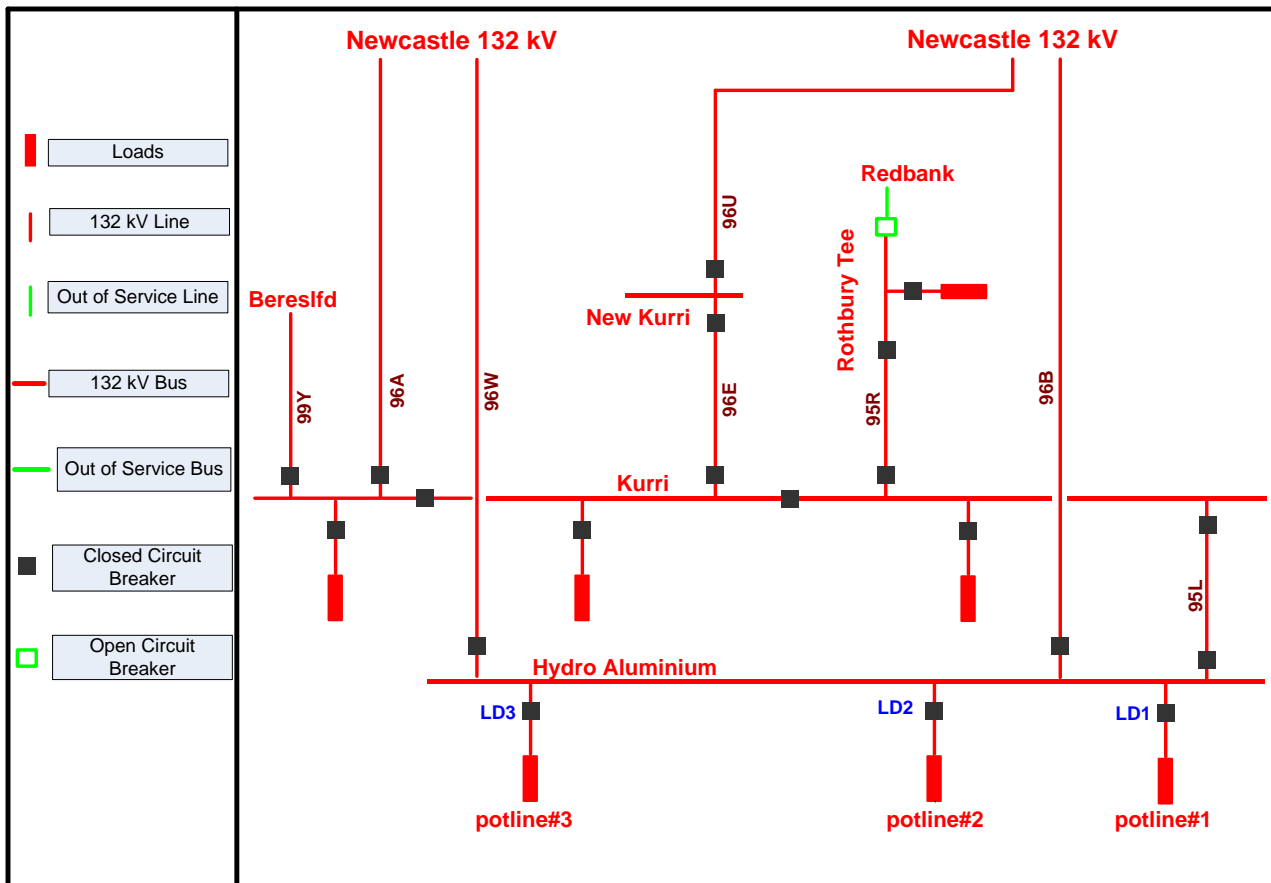
Figure 1 –Network in the vicinity of Energy Australia’s Kurri substation switchyard before the event

On 24 October 2010, the Kurri 132 kV substation was operating in the system normal configuration. Refer to Figure 1 for the network configuration in the vicinity of Kurri 132 kV substation and the connections to Hydro Aluminium, before the event took place. Note that all the transmission lines in Figure 1 belong to Energy Australia. All these transmission lines are treated as a part of the NEM transmission network.

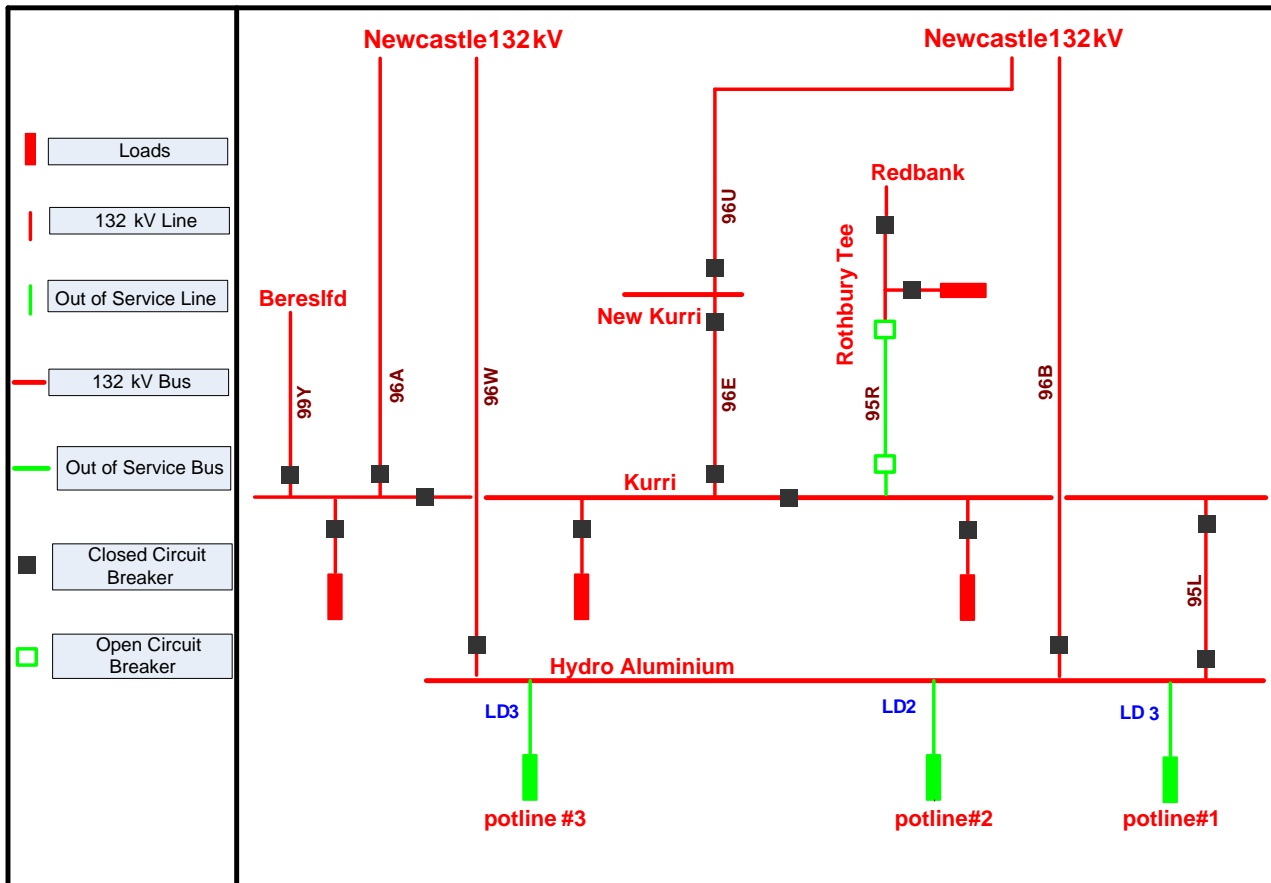
Figure 2 – Network in the vicinity of Energy Australia’s Kurri substation switchyard after the event

At 0758 hrs, the protection systems of 95R Kurri – Rothbury 132 kV line operated for a phase to ground fault and the transmission line tripped. This fault was caused by the failure of an overhead earth wire which came into contact with the C phase conductor of the line. The fault recorder indicated that the distance to fault was approximately 190 meters from the Kurri substation.

Immediately after the trip of the 95R line, all three potlines of Hydro Aluminium tripped on the operation of their internal protections, interrupting approximately 300 MW of load.

Refer to Figure 2 for an overview of Kurri 132 kV substation and connections to Hydro Aluminium immediately after the event.
