POWER SYSTEM INCIDENT REPORT

TRIP OF UPPER TUMUT TO CANBERRA AND UPPER TUMUT TO LOWER TUMUT 330KV LINES ON 27 MARCH 2010

PREPARED BY: Electricity System Operations Planning and Performance

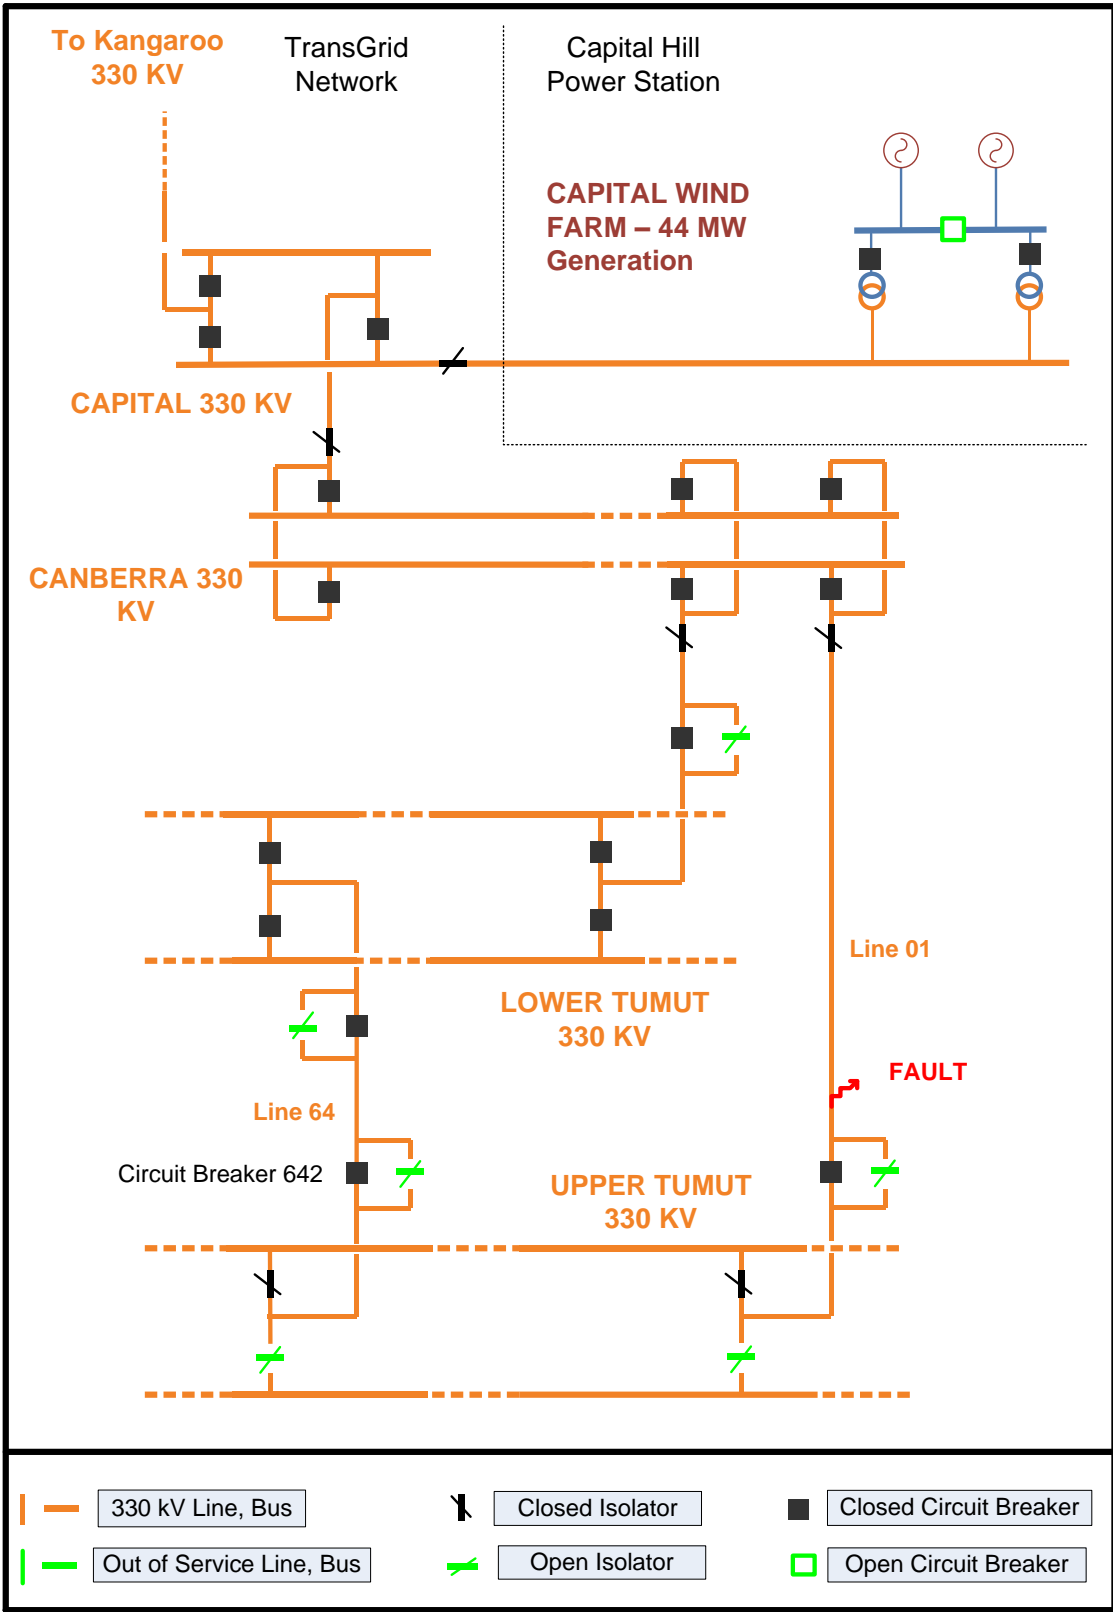
FIGURE 1 – POWER SYSTEM CONFIGURATION AT THE TIME OF FAULT AT 07:18 ON 27 MARCH 2010

At 18:18 hours on 27 March 2010, a mid-span joint failed on Line 01 causing one of the three phase conductors (white phase) to fall to the ground. The mid span failure occurred approximately 20 km from the Upper Tumut substation. The grounding of the phase conductor produced a fault that caused Line 01 to trip, auto-reclose, trip and lock out. The configuration of the power system at the time of the fault can be seen in Figure 1.

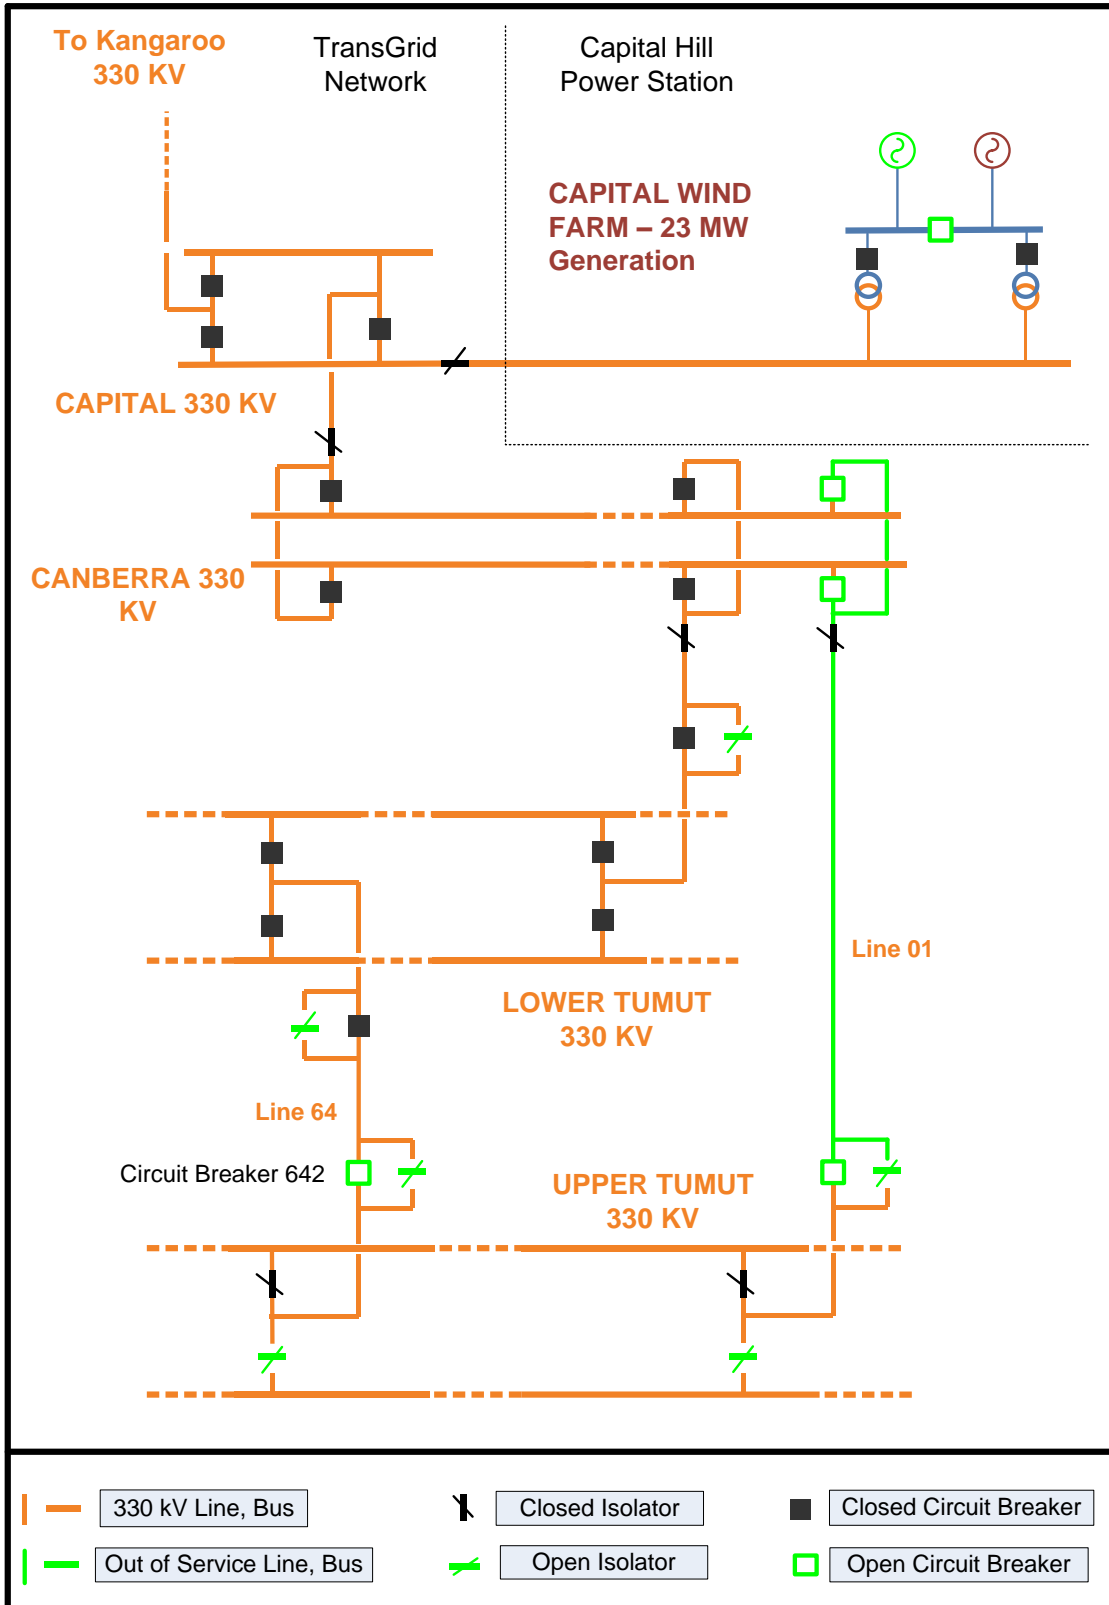
FIGURE 2 – POWER SYSTEM CONFIGURATION AFTER LINE 01 AUTO-RECLOSED AND LOCKED-OUT AT 07:18 ON 27 MARCH 2010

Coincident to the trip of Line 01 were the opening of Line 64 at the Upper Tumut substation and the loss of 21 MW of generation (27 wind turbine generating units) at Capital Hill Wind Farm. The configuration of the power system immediately following the fault is shown in Figure 2.
