# POWER SYSTEM INCIDENT REPORT SIMULTANEOUS TRIP OF BRAEMAR POWER STATION UNITS 1 AND 2 ON 10 JANUARY 2011

PREPARED BY: ESOPP  
VERSION: 1.0  
DATE: 27 April 2011  
FINAL

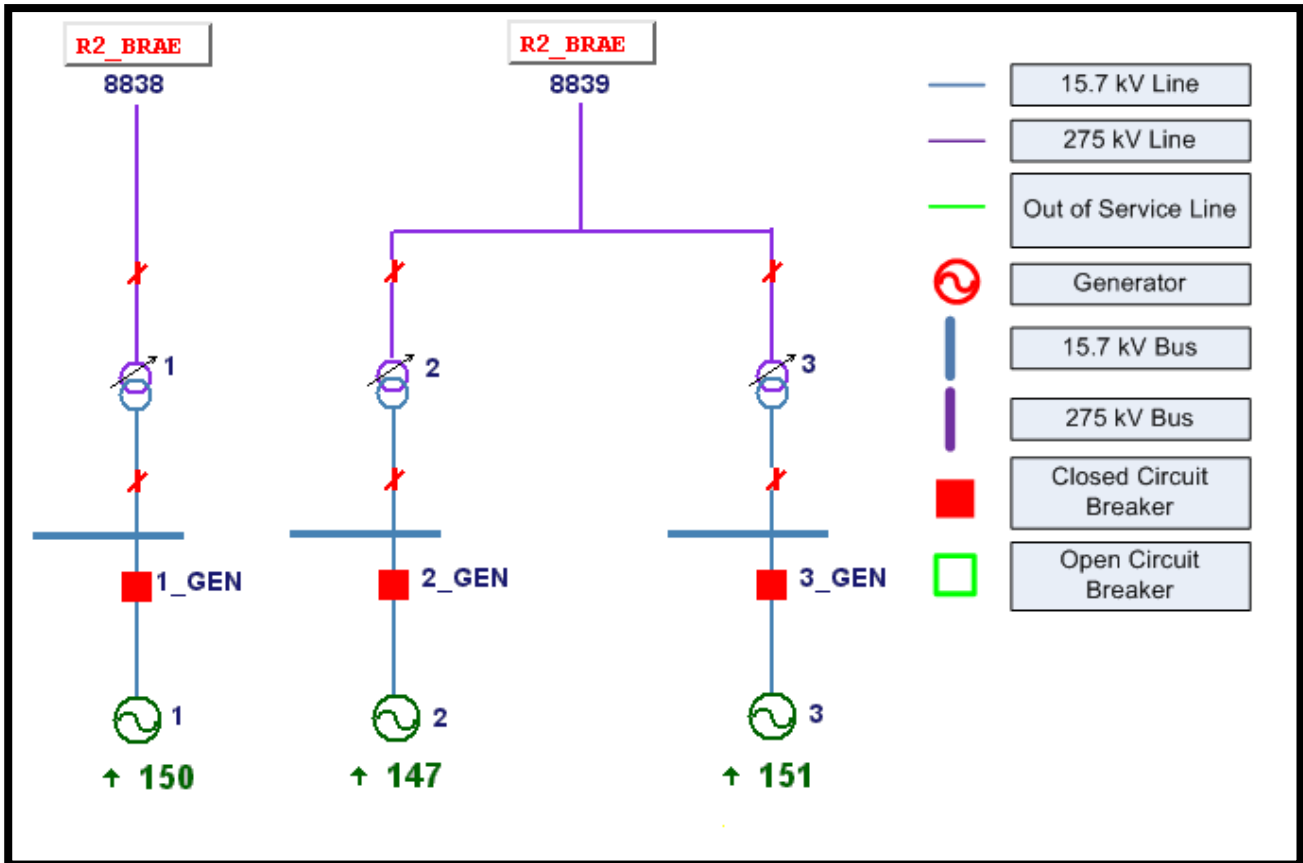
Figure 1 – Braemar Power Station before the event

At 1708 hrs on 10 January 2011, generating units 1 and 2 at Braemar Power Station tripped resulting in a loss of 300 MW of generation in Queensland. Prior to the event, unit 1 was at 151 MW and unit 2 was at 149 MW.

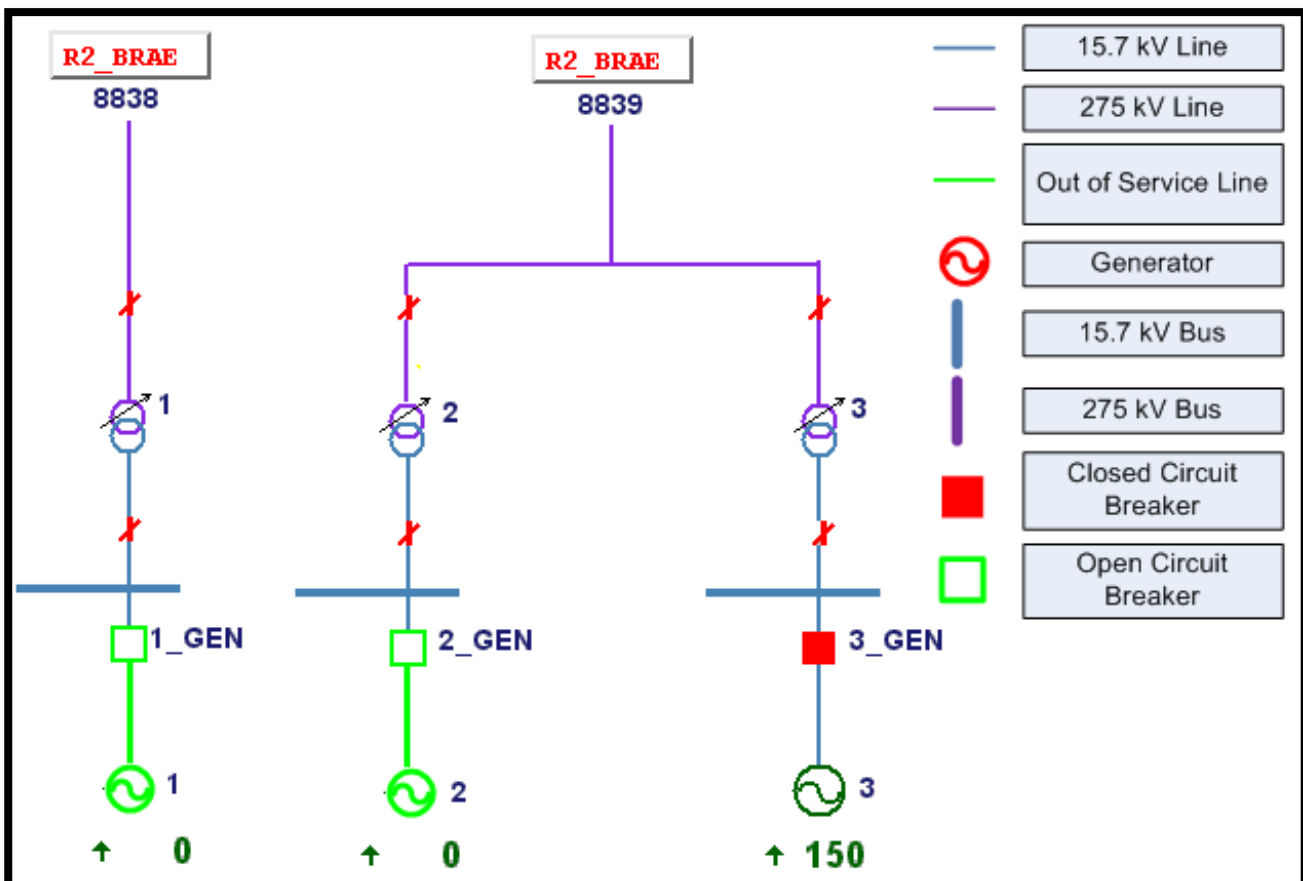
Figure 2 – Braemar Power Station immediately after the event

Generating units 1 and 2 at Braemar are fed off a common gas supply system, with two parallel supply paths in the gas supply system. The high gas pressure protection operated on one supply path, closing that gas supply path due to sensing a high gas pressure. As a result, both 1 and 2 generating units continued to draw gas from the remaining supply path. A single gas supply path only has the capacity to supply a single unit. This led to insufficient fuel supply and combustion failure which caused both units to trip.

An incorrect operation of high gas pressure protection caused the trip of generating units 1 and 2 at Braemar Power Station. It has not been able to establish the exact cause of this protection operation. Alinta Energy has undertaken suitable actions to minimise similar occurrence in the future.

- Pressure reducing regulators were tested by independent consultants and found to operate successfully under test conditions
- The over pressure protection device was tested and found to be slightly low in calibration. This device was re-set and tested

- Engineering review of the system indicated that the settings of the high pressure shut down valves were low and these devices have since been reset
- Pressure transmitters were tested and found to be within calibration

- As a precautionary measure, all the related gas pressure reducing regulator valves were inspected and overhauled
- After subsequent investigations, Alinta Energy plans to install a cross over connection between the gas supply system feeding 1 and 2 generating units and the gas supply system feeding the 3 generating unit. This will ensure the shutdown of one gas supply path is unlikely to result in tripping of generating units due to insufficient fuel supply.

1. Alinta Energy will investigate whether any improvements can be made to the existing routine test and inspection regime of the gas yard to ensure ongoing reliability.
2. Alinta Energy will investigate options to improve real time data recording for future fault finding.
3. Alinta Energy will install a cross over connection between the gas supply system feeding 1 and 2 generating units and the gas supply system feeding the 3 generating unit.
