# POWER SYSTEM OPERATING INCIDENT REPORT

## SIMULTANEOUS TRIP OF 97K COOMA – MUNYANG AND 97G GUTHEGA – MURRAY 132 KV LINES ON 5 JULY 2011

PREPARED BY: Electricity System Operations Planning and Performance

DATE: 8 December 2011

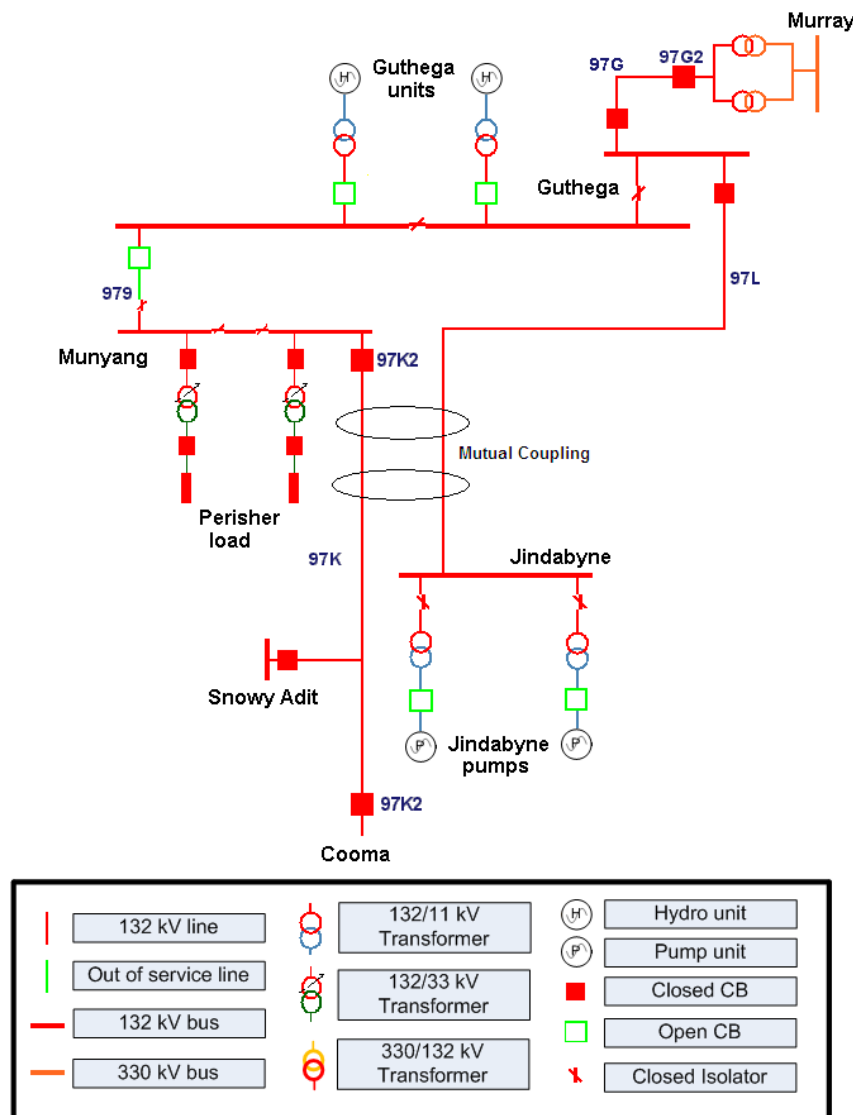
Figure 1 – Status of the power system prior to the incident

The status of the power system prior to the incident is shown in Figure 1. For clarity only equipment relevant to this incident has been included in the diagram.

Note that the two Guthega generating units and two Jindabyne pumps were not in service at the time. As per TransGrid’s normal operating practice, the 979 Guthega – Munyang 132 kV line was open at the Guthega end.

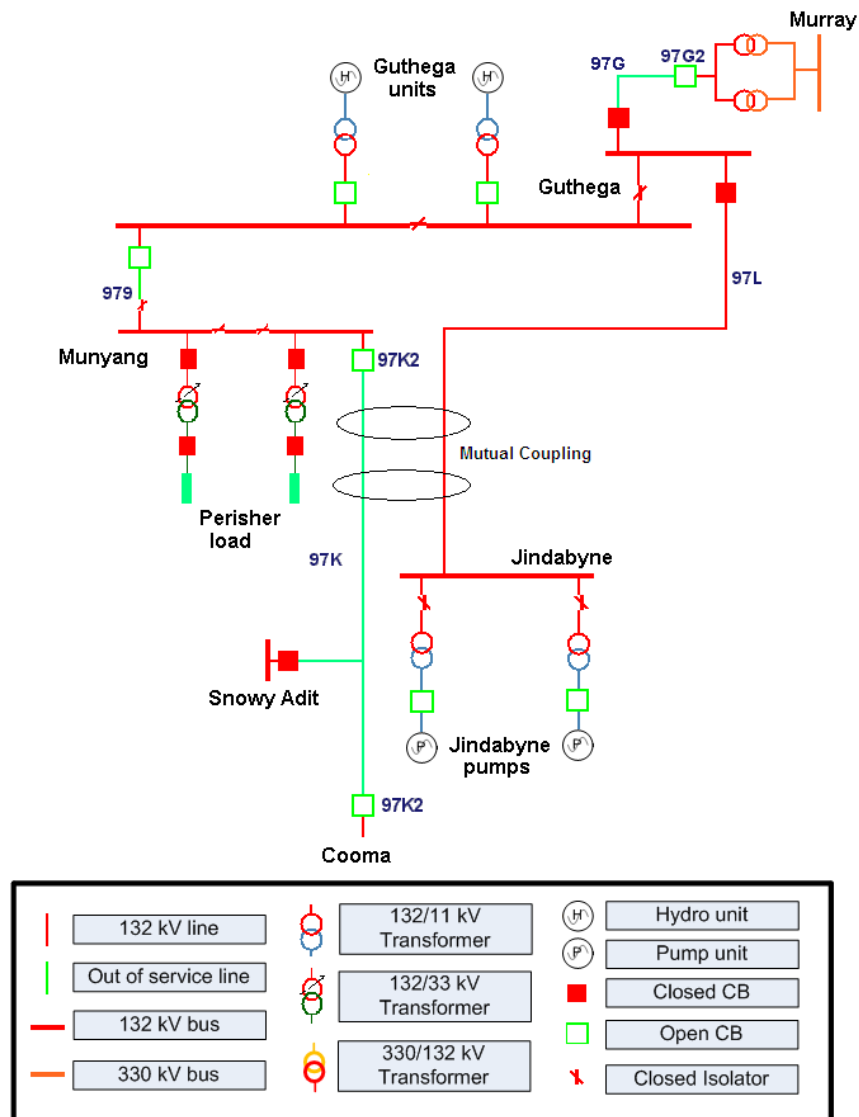
Figure 2 - Status of the power system immediately after the incident

At 1027 hrs on 5 July 2011 the 97K Cooma – Munyang 132 kV line tripped, auto-reclosed, tripped and locked out at both ends. This resulted in the interruption of approximately 18 MW of Perisher load supplied from the Munyang substation. At the same time the 97G Guthega – Murray 132 kV line tripped at the Murray end only, de-energising the 132 kV lines to the Guthega generating units and Jindabyne pumps which were not in service.

The status of the power system immediately after the incident is shown in Figure 2.
