# POWER SYSTEM OPERATING INCIDENT REPORT – OFFLOADING OF BASSLINK AND TRIPPING OF RIO TINTO LOAD ON 5 JULY 2012.

PREPARED BY: Systems Performance and Commercial

DATE: 30 November 2012

FINAL

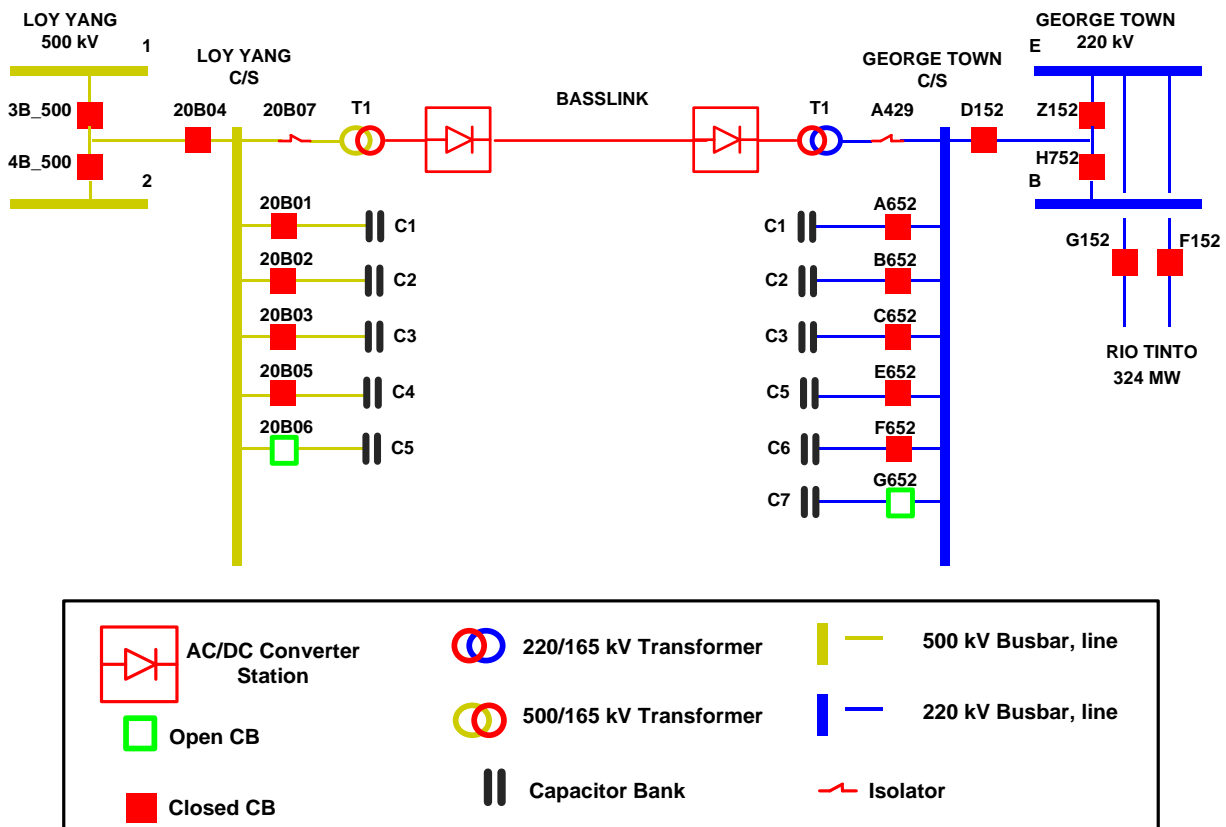
Figure 1 - Status of the power system prior to the incident

The status of the power system prior to the incident is shown in Figure 1. For clarity only equipment relevant to this incident has been included in the diagram.

Prior to the event, flow on Basslink was 597 MW in the Tasmania to Victoria direction and the load at the Rio Tinto aluminium smelter was 324 MW.

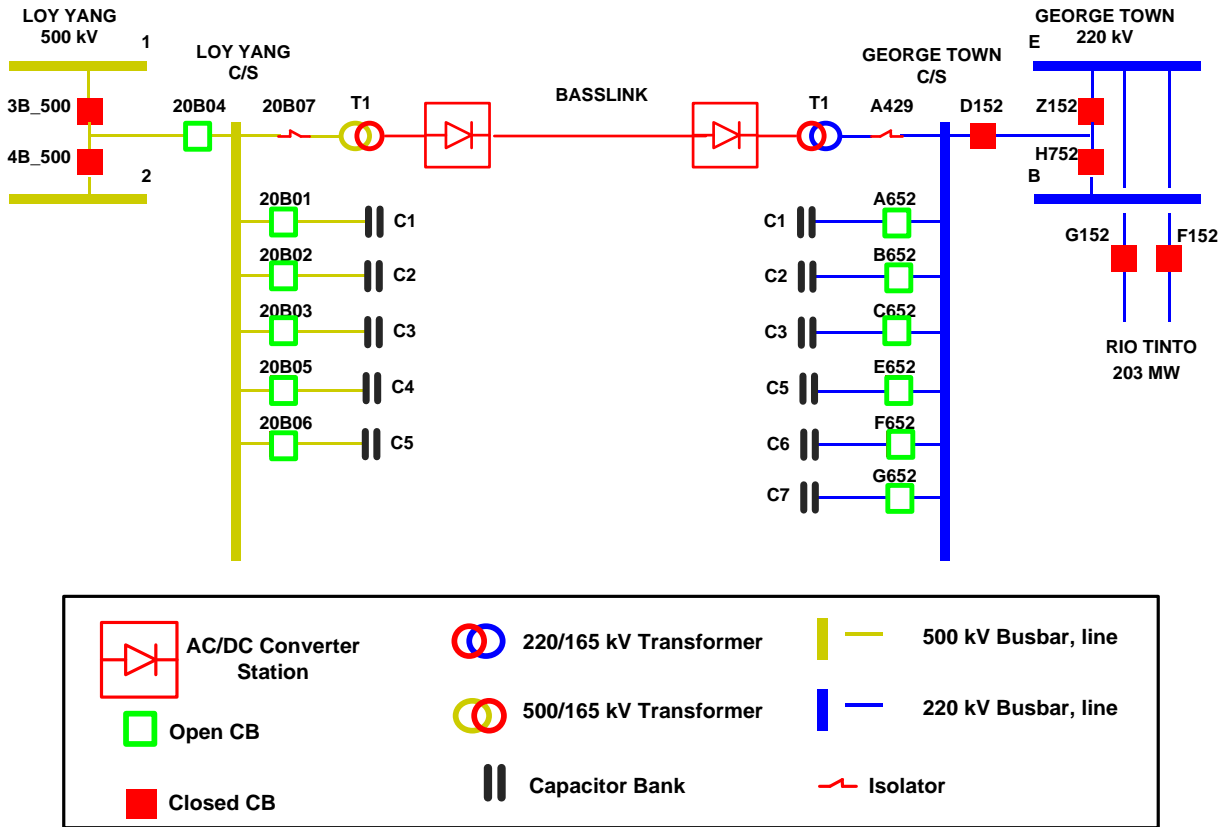
Figure 2 - Status of the power system immediately after the incident

The status of the power system immediately after the incident is shown in Figure 2.

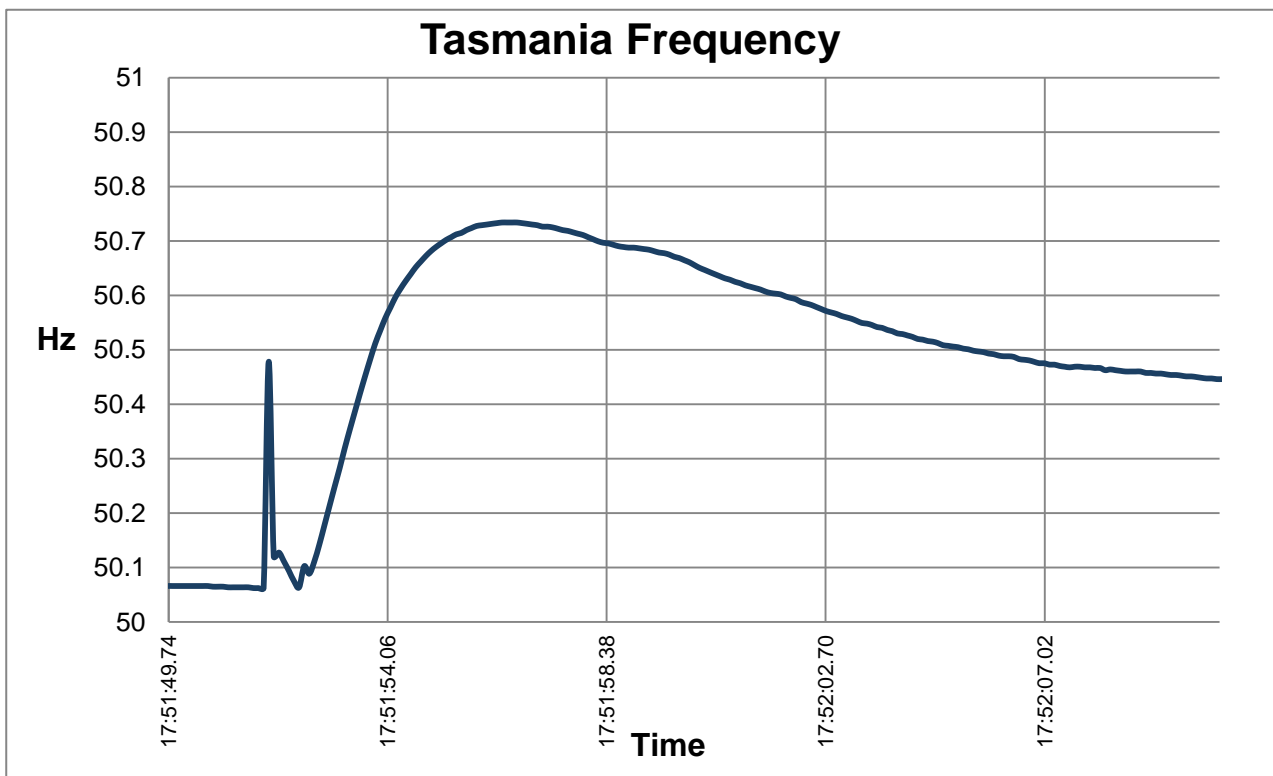
Figure 3 – Tasmania Frequency (high speed data)

The frequency both in Tasmania and in the mainland remained within the frequency operating standards during and after the event. Figure 3 and 4 below show Tasmania frequency during and after the event.

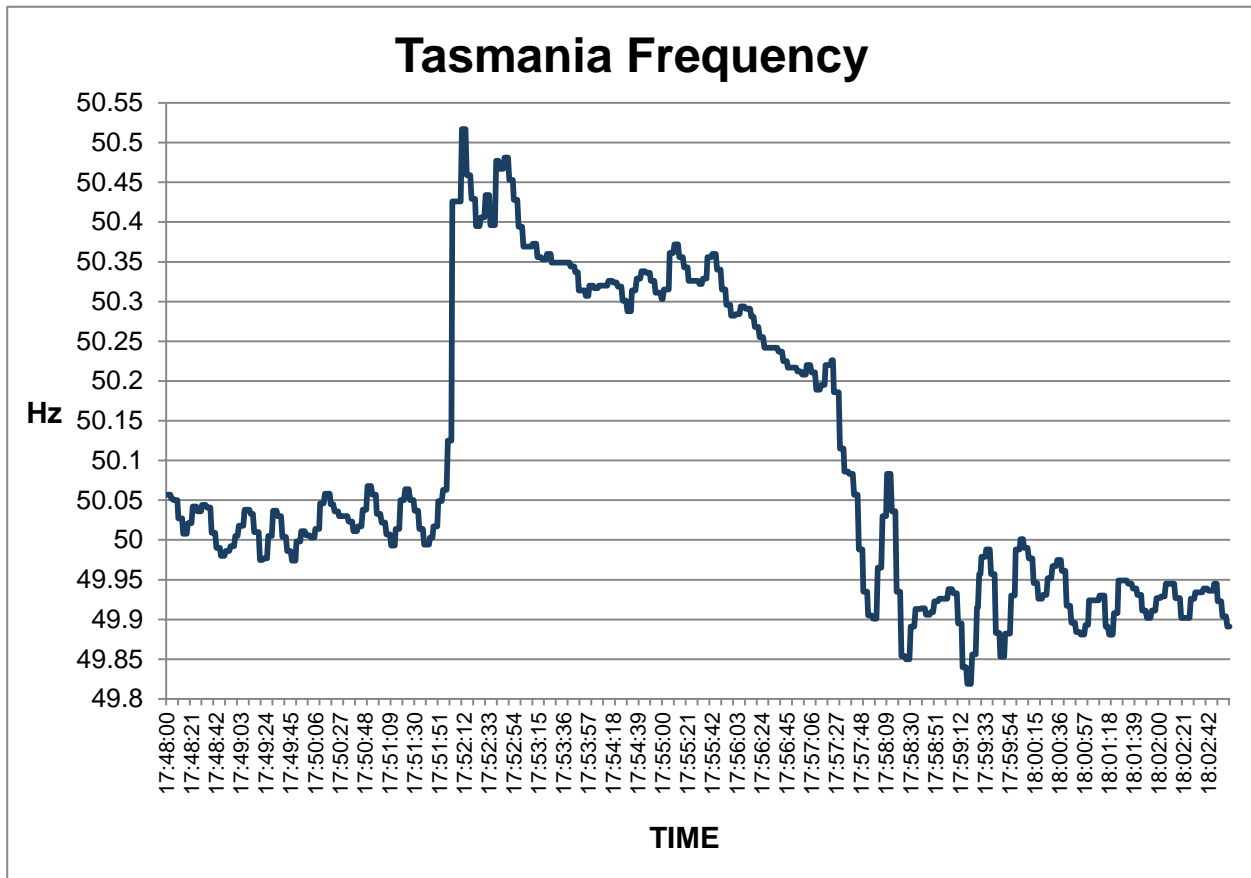
Figure 4 – Tasmania Frequency (1 second data)

Figure 4 above shows that the Tasmania frequency was within the recovery band (49.85 to 50.15 Hz) within 10 minutes of the event.

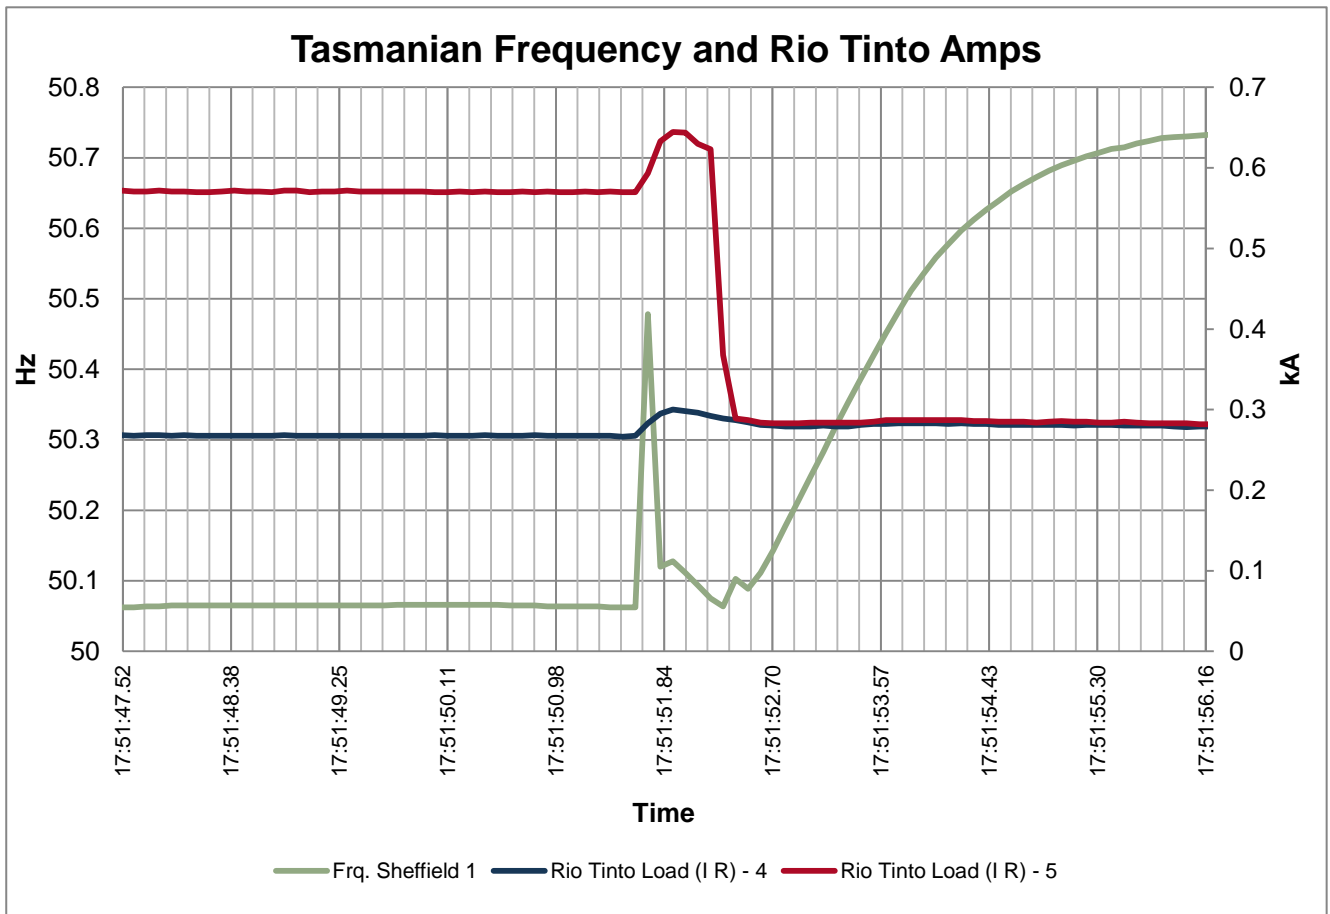
Figure 5 – Tasmania Frequency and Rio Tinto Load

Simultaneously with the trip of Basslink, one of the potlines at the Rio Tinto aluminium smelter tripped from 121 MW. Figure 5 shows the current on each of the lines that supply Rio Tinto’s load and the Tasmania frequency during this event. For clarity of the graphic, only the current of one phase (phase R) of each line is shown in Figure 5.

It can be seen that the load on both lines, that supply the Rio Tinto aluminium smelter from George Town increased as a response to the rise in frequency and voltage (voltage is shown in Figure 6).

Approximately 600 ms after the trip of Basslink, one of the Rio Tinto potlines (supplied by the George Town No 5 220kV line), tripped.

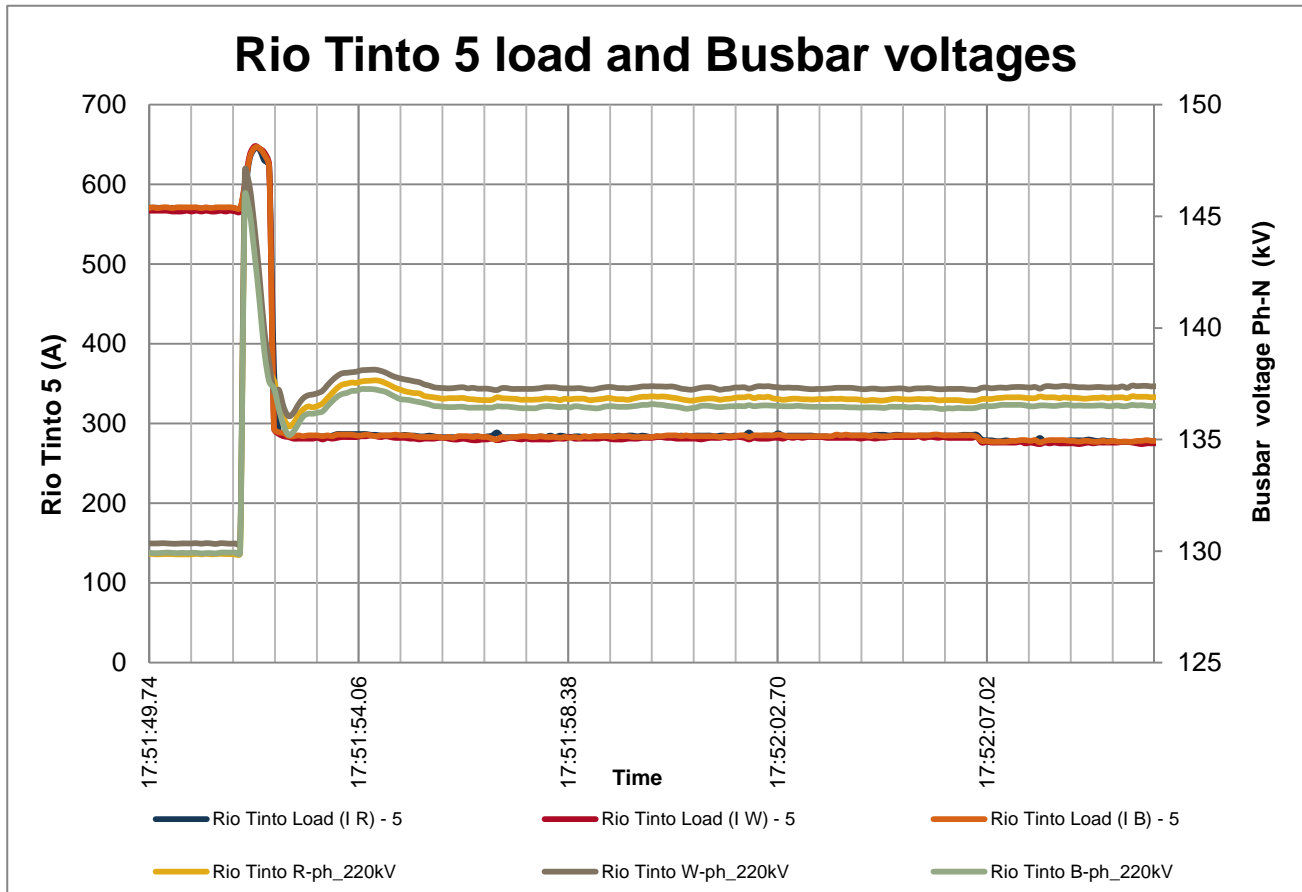
Figure 6 –Rio Tinto Load (5) and Bus Voltages

Figure 6 shows the phase to neutral voltages at Rio Tinto 220 kV busbar, and the current through each one of the three phases of the George Town to Rio Tinto No 5 220kV line.

It can be seen that after the trip of Basslink the voltage at Rio Tinto initially increased from around 223 KV (130 kV Ph-N) to around 254 kV (147 kV Ph-N). The voltage values as shown in Figure 6 are within the limits permitted by the National Electricity Rules (S5.1a.4).

This initial voltage rise is due to the normal delayed trip of the Basslink filters at the George Town converter station after the trip of Basslink.

There is no indication that the trip of the potline was directly caused by this increase in voltage.
