POWER SYSTEM OPERATING INCIDENT REPORT – TRIP OF MULTIPLE TRANSMISSION LINES IN TASMANIA ON 13 MAY 2012

PREPARED BY: Systems Capability

DATE: 26 October 2012

FINAL

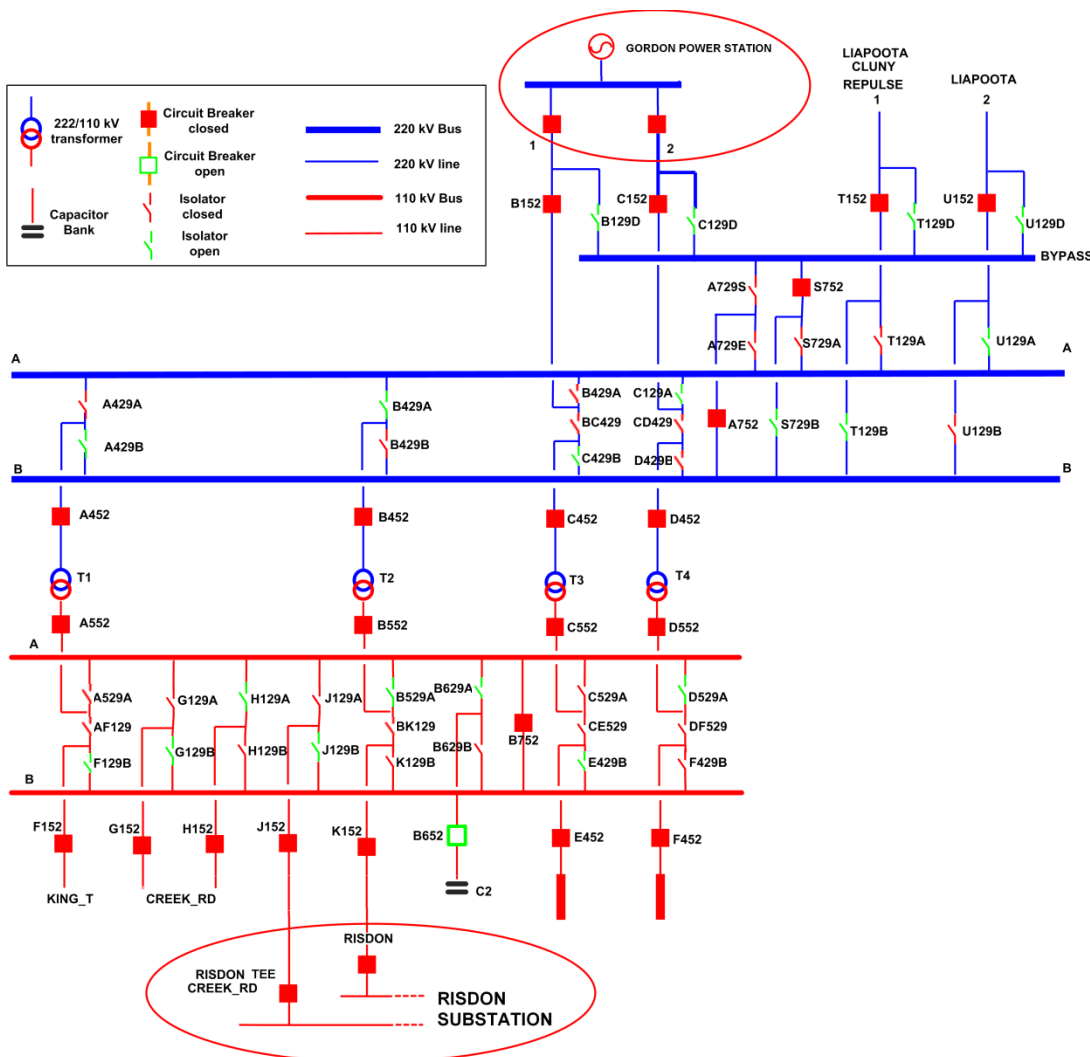
Figure 1 - Status of the Chapel Street substation prior to the incident

The status of the power system prior to the incident is shown in Figure 1. For clarity only equipment relevant to this incident has been included in the diagram.

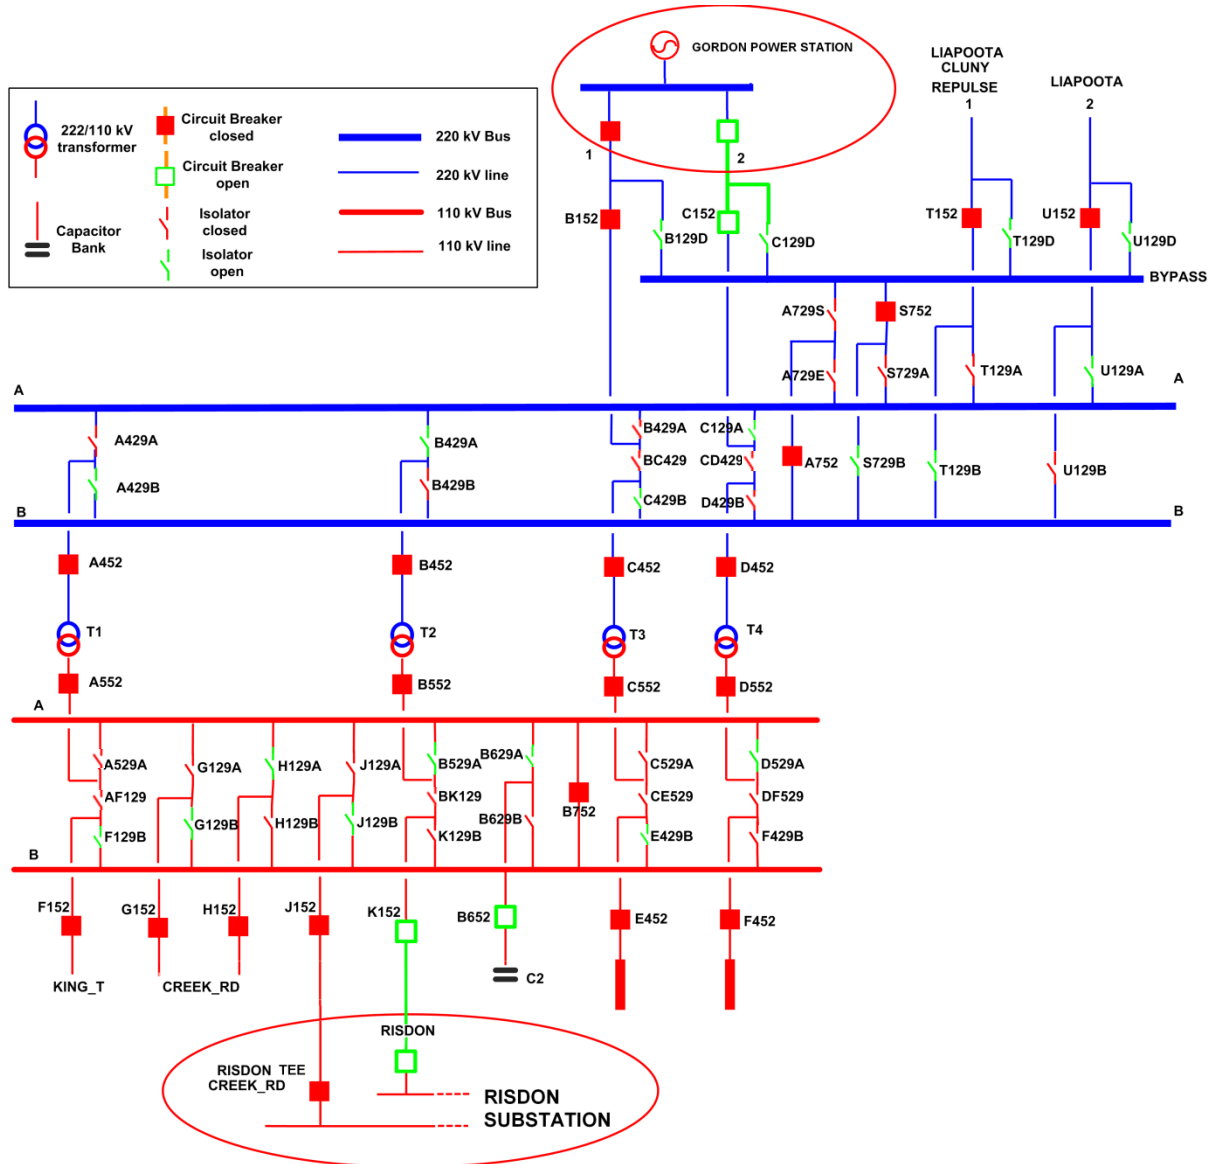
Figure 2 - Status of the Chapel Street substation immediately after the incident

At 0144 hrs on 13 May 2012, the No.2 Gordon - Chapel Street 220kV transmission line and the No.1 Chapel Street - Risdon 110kV transmission line simultaneously tripped. The status of the power system immediately after the incident is shown in Figure 2.

Transend investigations revealed that the fault on No.2 Gordon – Chapel Street line was caused by the conductor clash following ice build-up on the line. Transend records indicated that the fault was cleared in 40ms.

Transend also investigated the trip of No.1 Chapel Street - Risdon line. Transend conducted numerous tests and noted some issues with the communication systems at Chapel Street that had contributed to the line trip. Following its investigation Transend replaced relevant components of the communication system to avoid similar occurrences in future.
