POWER SYSTEM OPERATING INCIDENT REPORT – SIMULTANEOUS TRIP OF FARRELL-REECE NO.1 AND NO.2 220 KV LINES ON 8 AUGUST 2012

PREPARED BY: Systems Capability

DATE: 24 October 2012

FINAL

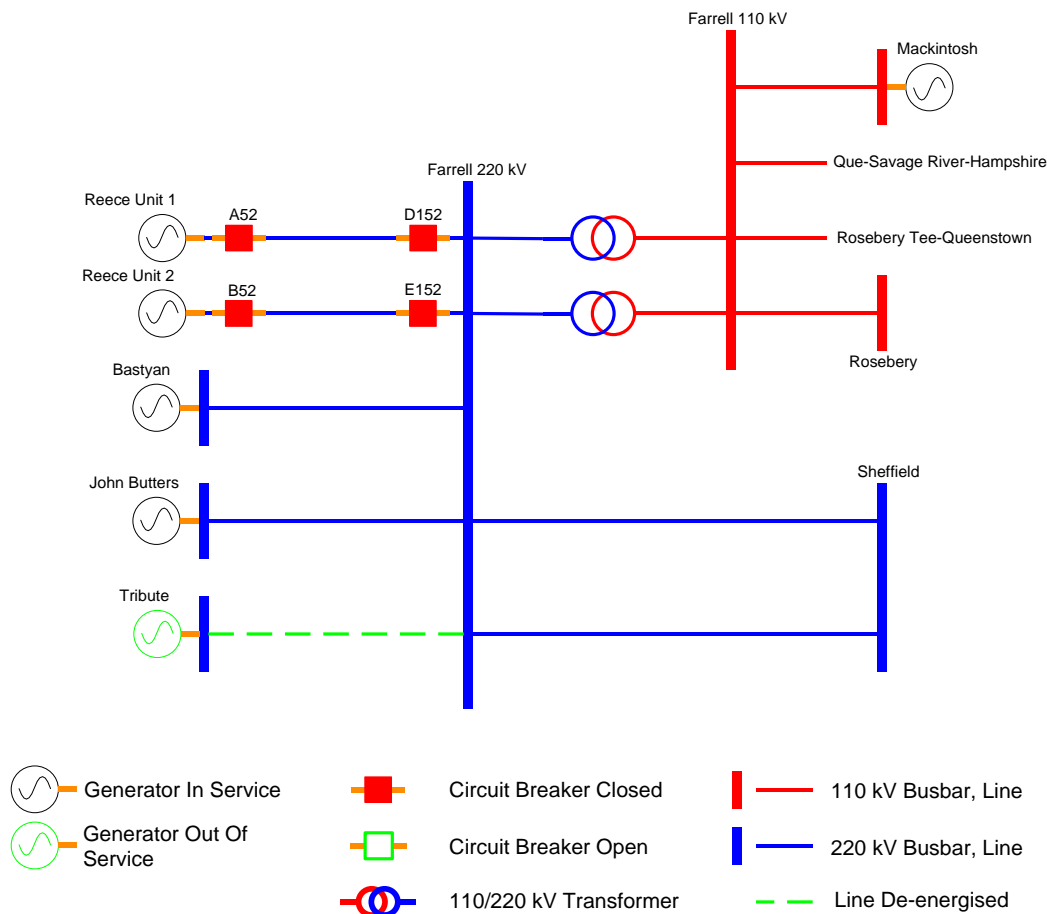
Figure 1 - Status of the power system prior to the incident

Prior to the incident, all equipment connected to the Farrell 220 kV busbars was in-service except for the Tribute generator, which was offline. There were no planned outages or protection system works being carried out in the vicinity prior to the system incident.

The status of the power system prior to the incident is shown in Figure 1. For clarity only equipment relevant to this incident has been included in the diagram.

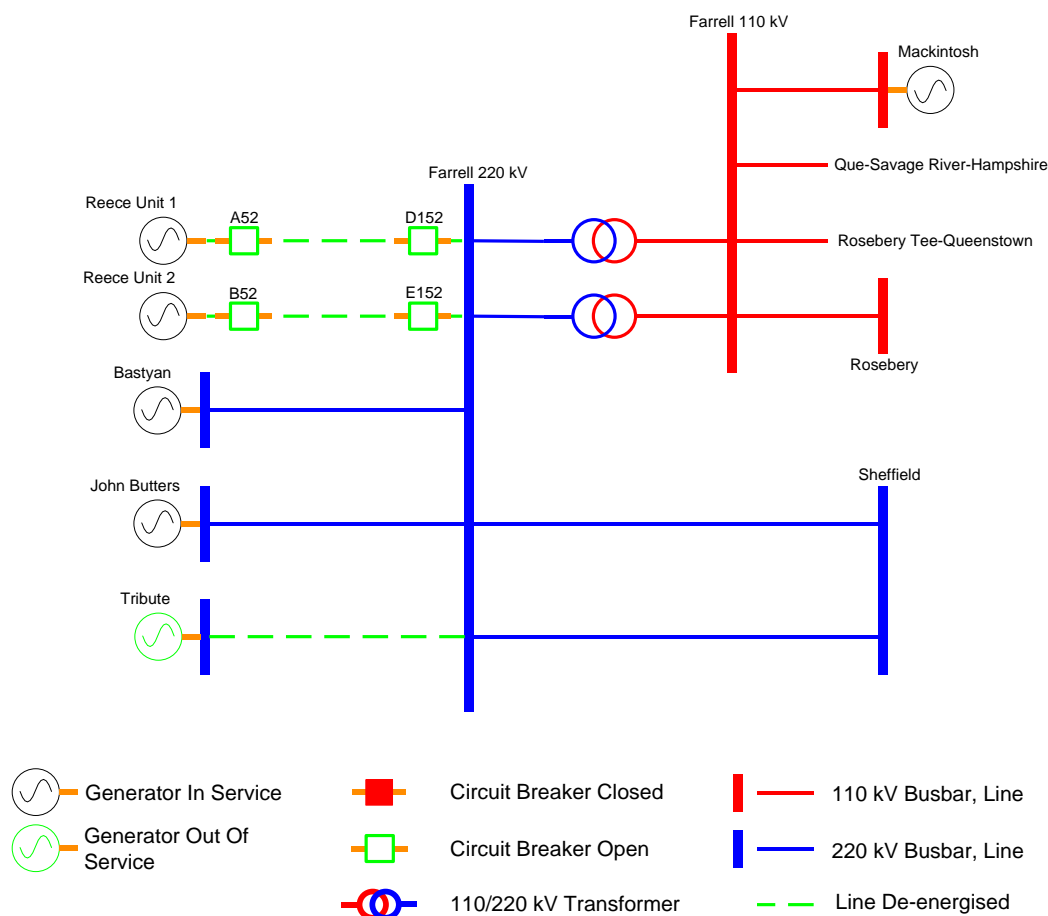
Figure 2 - Status of the power system immediately after the incident

At 2159 hours on 8 August 2012, the Farrell-Reece No.1 and No. 2 220 kV transmission lines simultaneously tripped due to a phase to phase fault, opening the following circuit breakers at Farrell Substation and Reece Power Station:

- 220 kV D152 Circuit breaker at Farrell Substation;
- 220 kV E152 Circuit Breaker at Farrell Substation;
- 220 kV A52 Circuit Breaker at Reece Power Station; and
- 220 kV B52 Circuit Breaker at Reece Power Station.

The status of the power system immediately after the incident is shown in Figure 2.

The line protection systems on the Farrell-Reece No.1 and No. 2 transmission lines detected a fault on the white and blue phase conductors of each line. The protection system for each line issued a three pole trip to the circuit breakers D152 and E152 at Farrell Substation respectively, and locked out single pole auto-reclose. The protection system also operated correctly by transmitting permissive inter-trip signals to the remote end line protection systems, and tripped the circuit breakers A52 and B52 at Reece Power Station.

Ground inspection was performed by Transend at the fault location indicated by the GPATS and protection systems, but the exact cause of the fault was not found. However the information from Transend GPATS suggested that the lightning strike may have hit the ground beside the Farrell-Reece No.1 and No. 2 transmission lines. Based on the GPATS information, fault recordings and past experiences, Transend believe that due to the resistive nature of the soil in the transmission line easement the lightning strike to the ground near the transmission line caused a ground potential rise, and subsequently initiated a flash over from the tower to the white and blue phase conductors on the lines.

1. Transend to inform AEMO on any findings from the aerial inspection on the Farrell-Reece No.1 and No. 2 220 kV transmission lines by 31 October 2012.
2. Transend to resolve the time stamping issues with the relevant protection relays on the Farrell-Reece No.1 and No. 2 220 kV transmission lines by 30 December 2012.
3. Transend to resolve the incorrect protection relay indications on the Farrell-Reece No.1 and No. 2 220 kV transmission lines by 30 December 2012.
4. Transend to investigate and report on the adequacy of the earthing and lightning protection arrangement on the Farrell-Reece No.1 and No.2 220 kV transmission lines by 30 December 2012.
