POWER SYSTEM OPERATING INCIDENT REPORT

SIMULTANEOUS TRIP OF 5A6 MT PIPER – BANNABY 500 KV LINE AND MT PIPER NO. 2 UNIT ON 9 FEBRUARY 2012

PREPARED BY: Electricity System Operations Planning and Performance

DATE: 5 June 2012

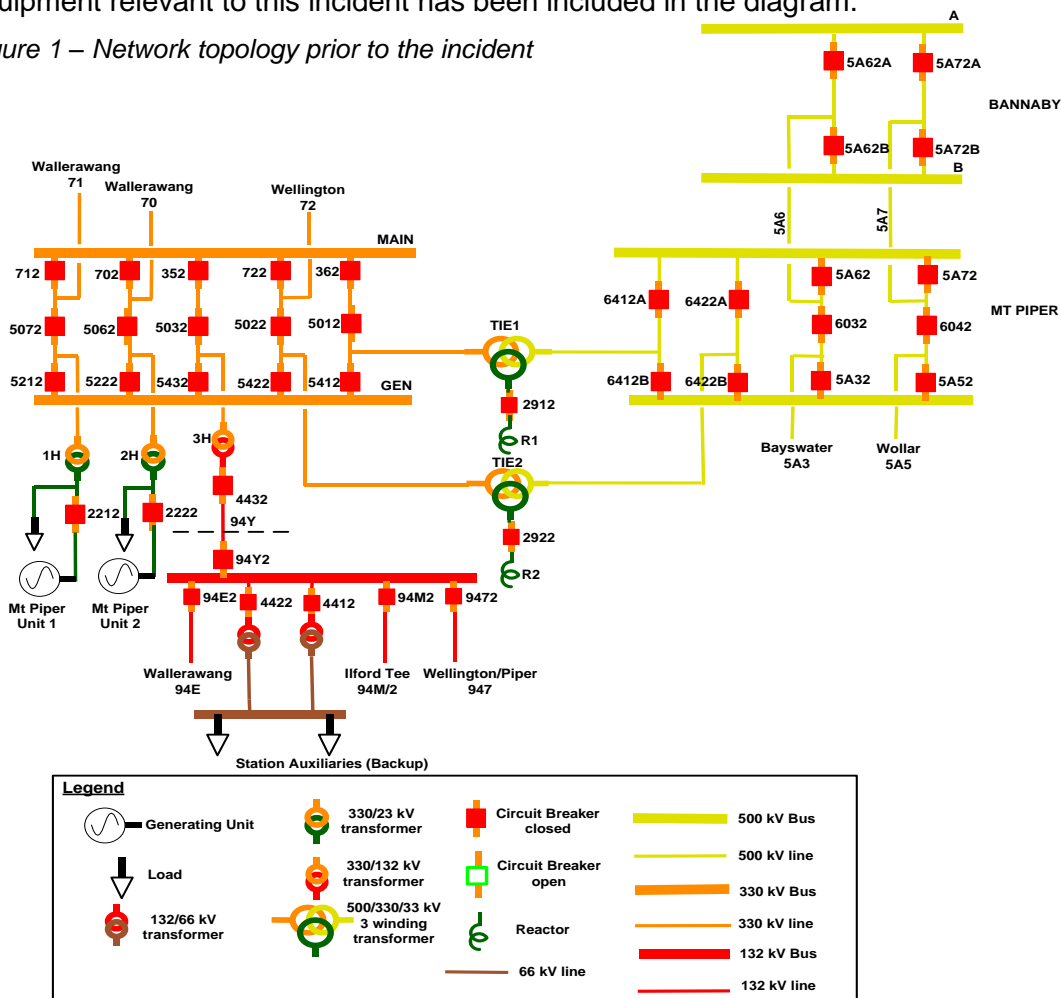
Figure 1 – Network topology prior to the incident

The status of the power system prior to the incident is shown in Figure 1. For clarity only equipment relevant to this incident has been included in the diagram.

The auxiliary supply to the Mt Piper 500 kV switchyard (including tie transformers), as per current operating arrangements, is supplied through the Mt Piper No.1/2 unit 11 kV switchboard. TransGrid had not advised this special auxiliary supply arrangement to AEMO prior to this incident. At the time of the incident, the Mt Piper Station 11 kV switchboard was operated such that there was an open point between the Unit 1 and 2 supply to the switchboard.

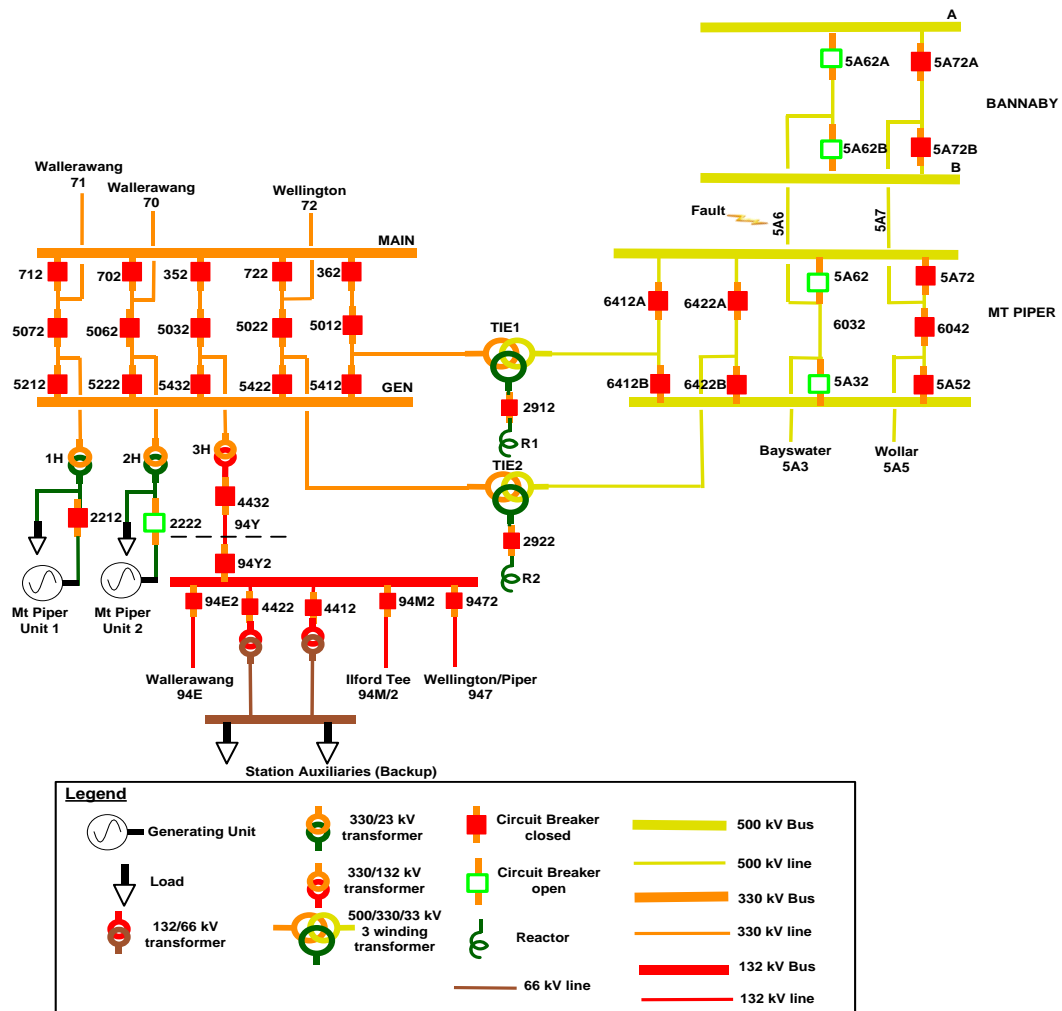
Figure 2 – Network topology immediately following 5A6 line trip and Mt Piper generating unit trip

At a time of lightning activity on 9 February 2012, a one phase to ground fault occurred on the red phase of the 5A6 Mt Piper – Bannaby 500 kV transmission line resulting in a three phase trip of the line. Zone 1 distance protection at Bannaby 500 kV substation detected the fault and tripped CBs 5A62A and 5A62B at Bannaby. Zone 1 distance protection at Mt Piper 500 kV substation detected the fault and tripped CBs 5A62 and 6032 at Mt Piper. The fault was cleared within 52 ms from the Mt Piper end and 62 ms from the Bannaby end. The fault was cleared within the required fault clearance times specified in the NER. All CBs auto-reclosed within 20 seconds of the trip. The distance to fault measured by the protection relays was approximately 33.19 km from the Mt Piper end.

Coincident with the 5A6 line trip, the Mt Piper No. 2 generator CB 2222 and its 11 kV auxiliary supply CBs (not shown in the diagrams) opened, disconnecting the generating unit from the power system and de-energising all its auxiliary supplies including auxiliary supplies to the Mt Piper switchyard and No.2 generator transformer cooling systems. Approximately 1 minute and 43 seconds later, the Mt Piper No.2 generator transformer 330 kV CBs 5062 and 5222 opened, de-energising the Mt Piper No.2 generator transformer group.

The status of the power system immediately following the trip of the 5A6 line and Mt Piper No.2 generating unit is shown in Figure 2. Figure 3 shows the status of the power system after the subsequent auto-reclose of 5A6 line and de-energisation of the Mt Piper No.2 generator transformer group.

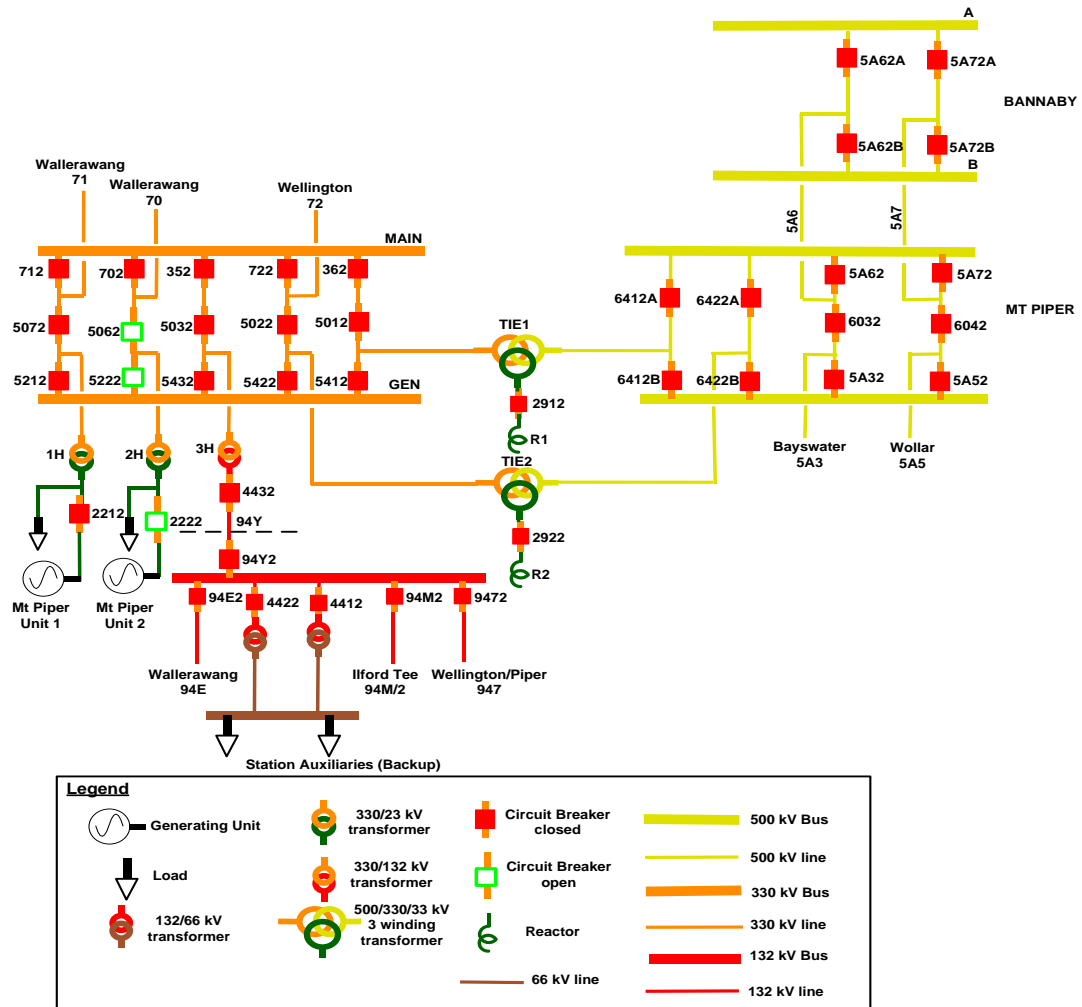
Figure 3 – Network topology after 5A6 line auto-reclosed and Mt Piper generator transformer group de-energised

- Mt Piper No.2 generator transformer trip: Delta Electricity has informed AEMO that the subsequent trip of the generator transformer 330 kV CBs is reasoned to have been initiated by the Mt Piper protection systems. The trip of the generating unit and its auxiliary CBs caused the loss of all auxiliary supplies to the unit, including the 415 V main and standby power supplies to the cooling oil pumps of the generator transformers. The flow of oil for cooling is an essential requirement for the generator transformers to remain in service. The loss of oil flow was detected by the transformer protection and, after the set time-out, sent a trip signal to the Mt Piper No.2 generating unit protection system. This protection in turn relayed the signal to the TransGrid interzone protection systems which tripped the Mt Piper No.2 generator transformer 330 kV CBs 5062 and 5222.
