POWER SYSTEM OPERATING INCIDENT REPORT – TRIP OF TARONG NO.2 66 KV BUSBAR ON 22 MARCH 2012

PREPARED BY: Electricity System Operations Planning and Performance

DATE: 12 June 2012

FINAL

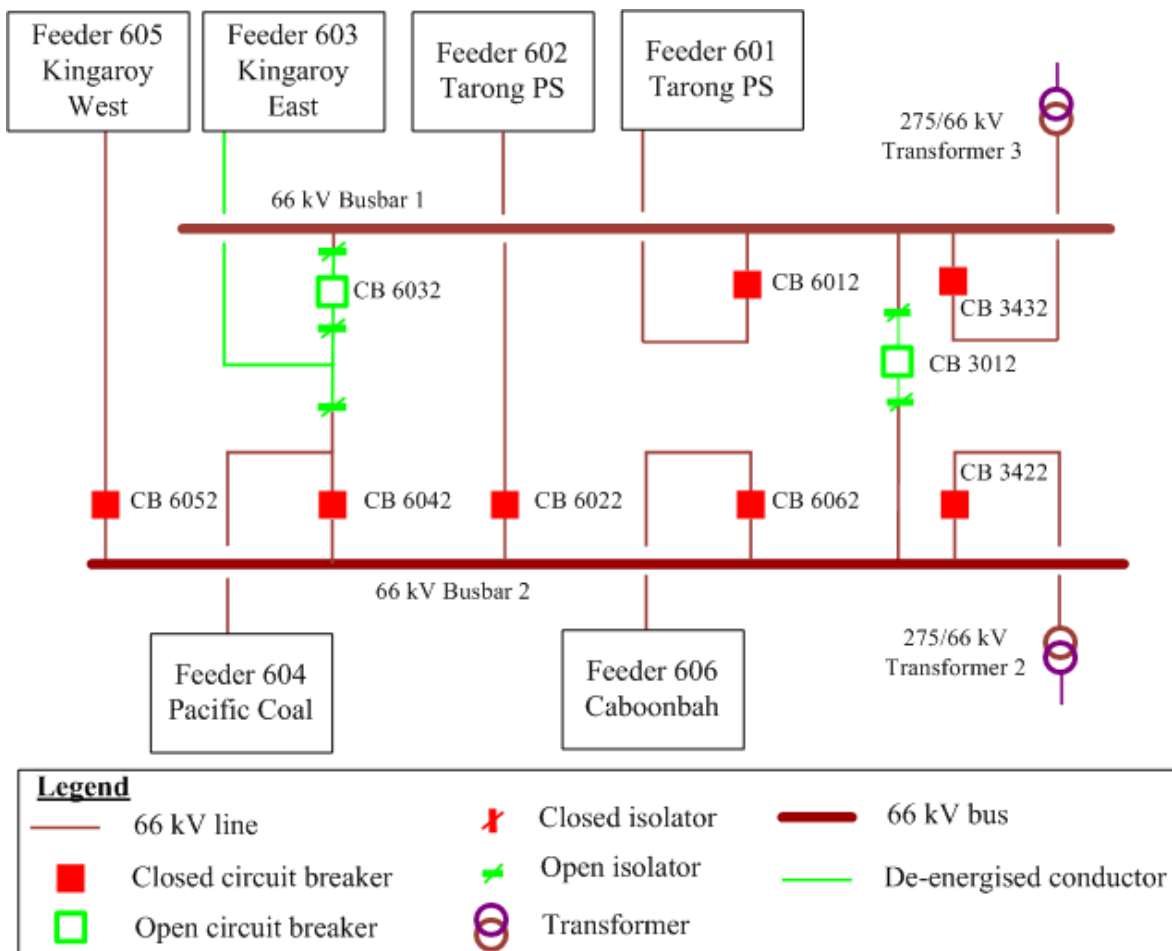
Figure 1 - Status of the Tarong substation prior to the incident

Prior to the incident the 603 Tarong – Kingaroy East 66 kV feeder was out of service for the planned replacement of the Tarong 66 kV circuit breaker (CB) 6032. CB 6032 was isolated from the power system. The Tarong 66 kV CB 3012 was also out of service and isolated for planned protection system testing associated with the replacement of CB 6032.

Figure 1 shows the status of the power system prior to the incident. For clarity only equipment relevant to this incident has been included in the diagram.

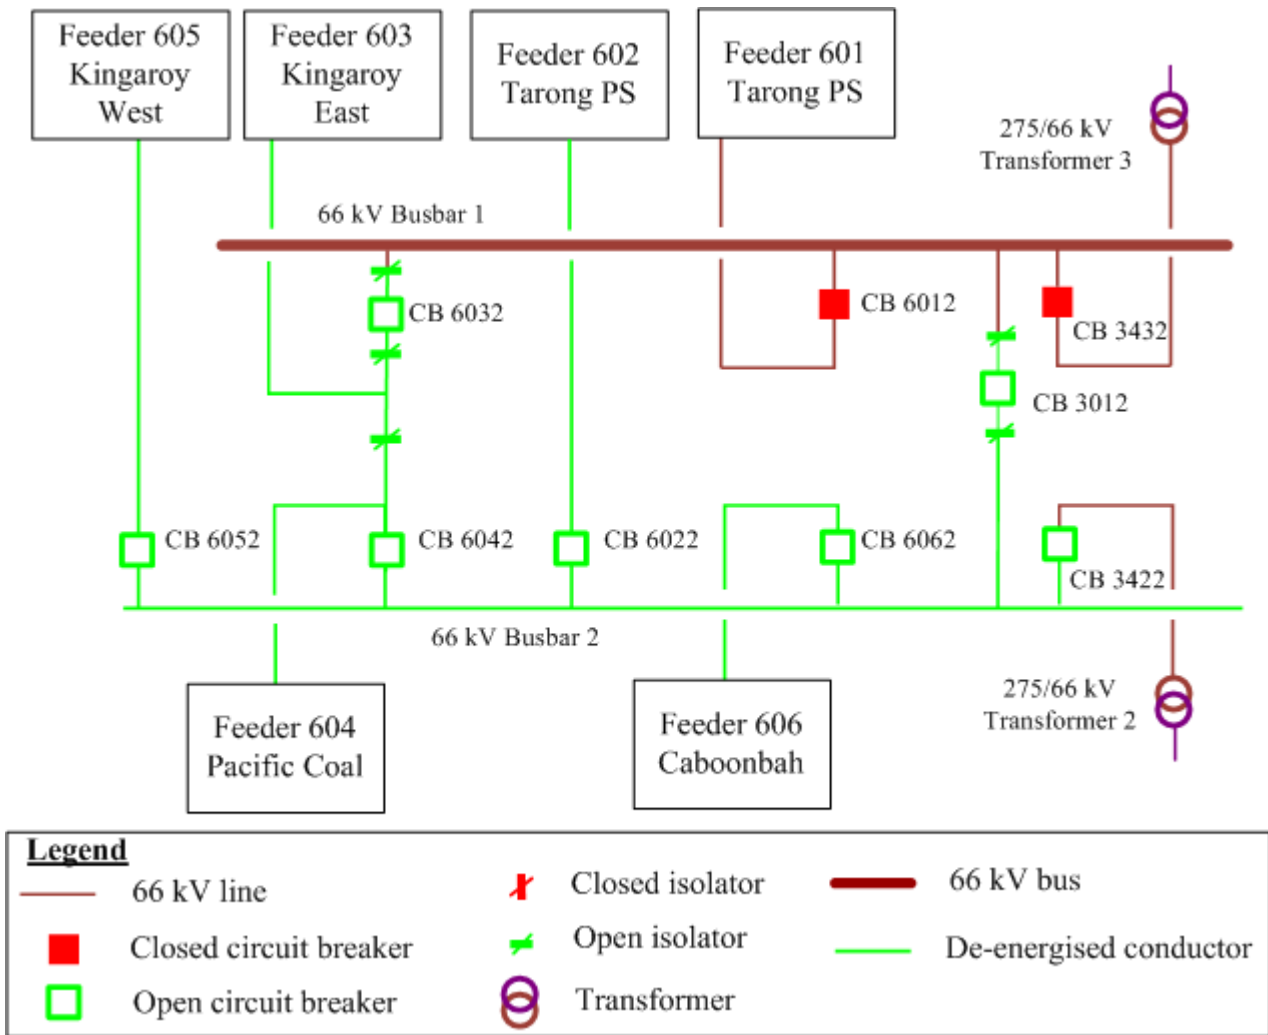
Figure 2 - Status of the Tarong substation immediately after the incident

At 1034 hrs on 22 March 2012 the Tarong No. 2 66 kV busbar protection systems operated to trip the No. 2 66 kV busbar. The circuit breakers 6022, 6042, 6052, 6062 and 3422 operated, off-loading the 602, 604, 605 and 606 66 kV feeders and the Tarong No.2 275/66 kV transformer. This resulted in the loss of 24 MW of Ergon load.

Figure 2 shows the status of the power system immediately after the incident.

Powerlink has found that the Tarong No. 2 66 kV busbar tripped because of the operation of one of the 66 kV busbar protection systems due to a test signal being sent to the in-service busbar protection system during planned testing work.

After the incident Powerlink has undertaken an investigation on the busbar protection systems associated with the planned protection system testing work. The investigation found that the busbar protection systems operated due to a test signal being sent to the in-service busbar protection system during the planned testing work. Powerlink has taken further precautions to avoid the risk of similar incidents in the future.
