POWER SYSTEM OPERATING INCIDENT REPORT – TRIP OF B 220 KV BUSBAR AT GEORGE TOWN ON 27 NOVEMBER 2012.

PREPARED BY: System Performance & Commercial

DATE: 1 March 2013

FINAL

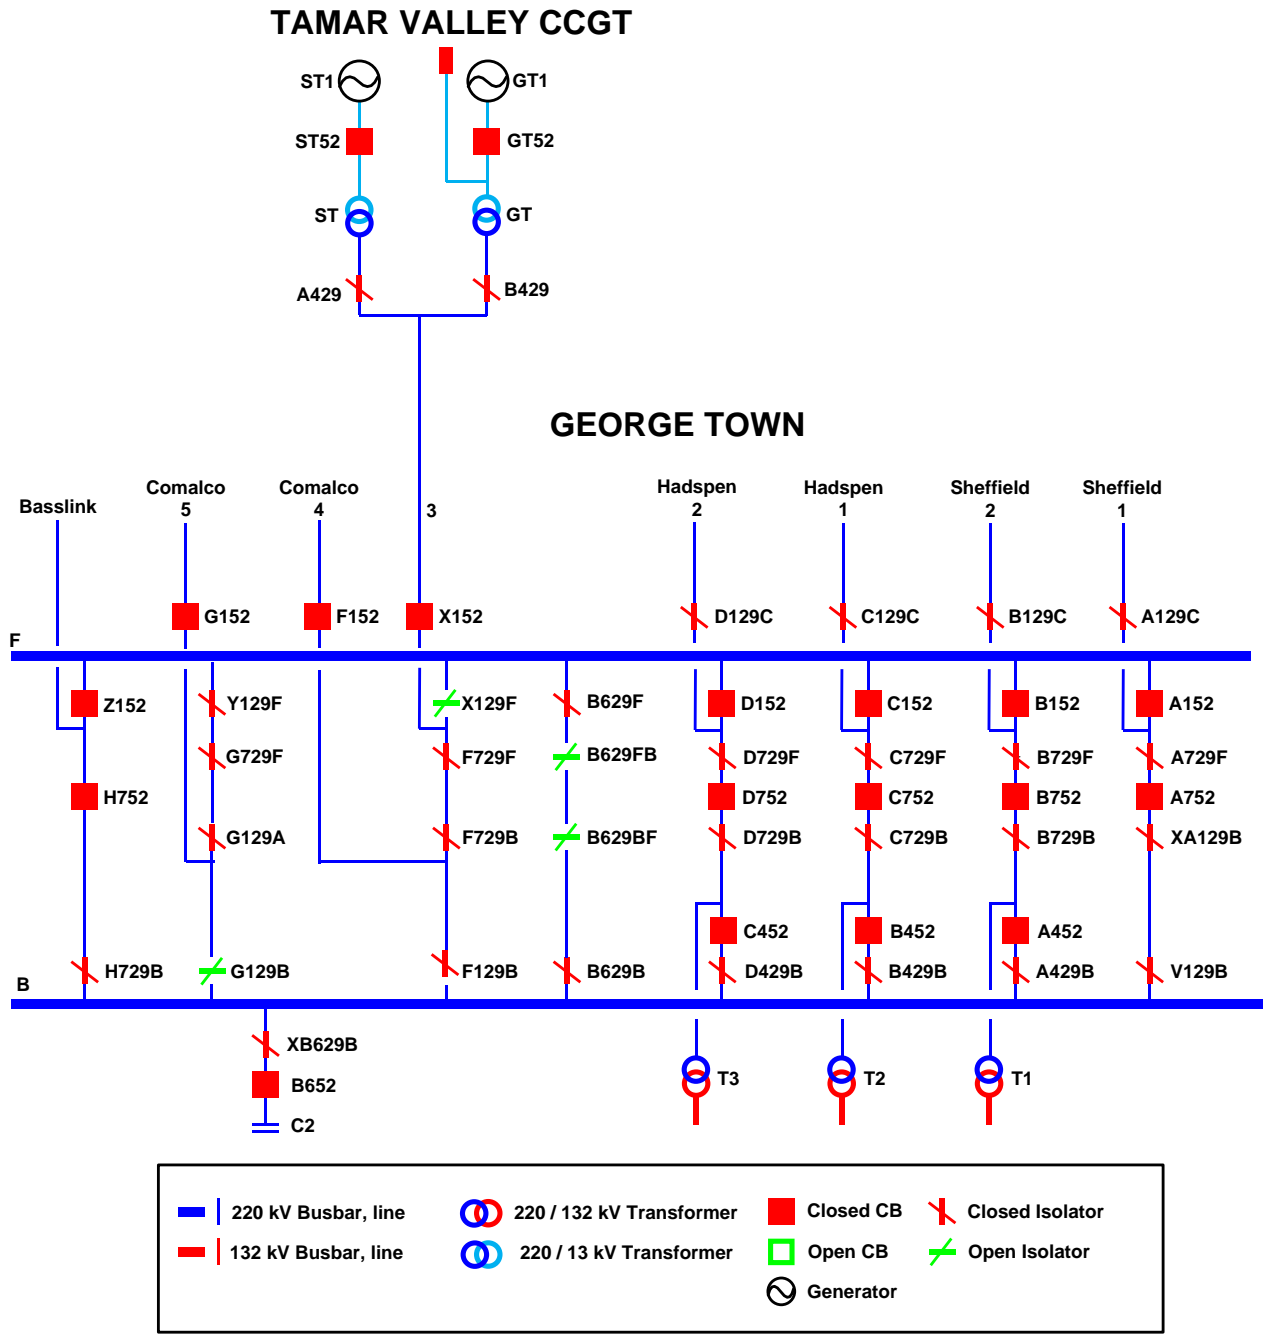
Figure 1 – Status of the power system prior to the incident

Prior to 0732 hrs, there was a planned outage of a protection scheme at George Town Substation to upgrade the George Town Substation bus zone A protection.

No primary equipment was out of service at that time.

The status of the power system prior to the incident is shown in Figure 1. For clarity only equipment relevant to this incident has been included in the diagram.

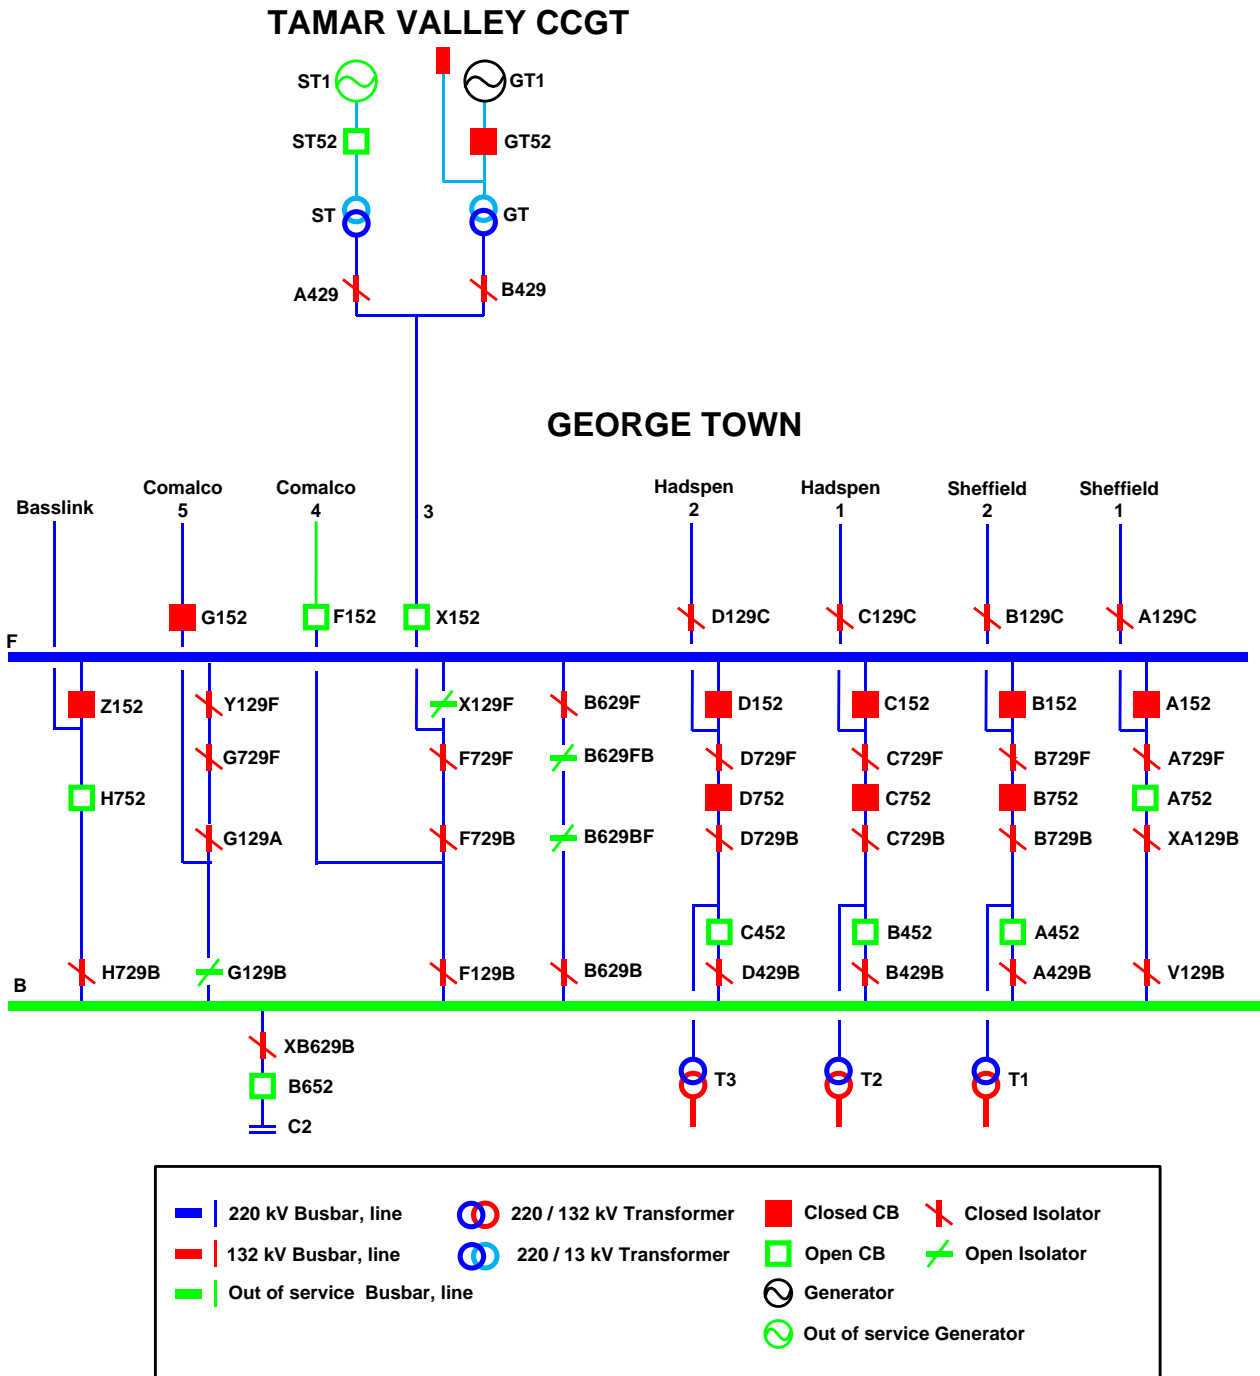
Figure 2 - Status of the power system immediately after the incident

At 0732 hrs on 27 November 2012, the B 220 kV Busbar at George Town Substation tripped due to an incorrect protection operation (operator involved) that occurred during work on the protection scheme at George Town Substation. The George Town–Tamar Valley No 3 220 kV transmission line and the George Town–Comalco No 4 220 kV transmission line also tripped. Prior to the event, the Tamar Valley Combined Cycle Power Station was generating 202 MW, and the George Town–Comalco No 4 220kV transmission line was loaded to 106 MW (Rio Tinto Aluminium Smelter load).

The George Town–Comalco No 4 220kV transmission line supplies the auxiliaries of the load connected to George Town–Comalco No 5 220 kV transmission line. Therefore, when the George Town–Comalco No 4 220kV transmission line tripped and interrupted auxiliary supplies to Rio Tinto load blocks, the load blocks at Rio Tinto also tripped.

Further load blocks at Nyrstar tripped due to oversensitive control/protection settings within their plant.

The status of the power system immediately after the incident is shown in Figure 2. For clarity, only the equipment relevant to the incident has been included in the diagram.

The Tamar Valley Power Station Gas Turbine (GT1) remained in-service supplying the Tamar Valley Power Station’s house load and energising the following :-

- the Tamar Valley Power Station Gas Turbine 220/14.5 kV Generator Transformer (GT)
- the Tamar Valley Power Station Steam Turbine 220/13.2 kV Generator Transformer (ST) to the open CB ST52, and
- the off-loaded George Town–Tamar Valley No 3 220 kV transmission line to the open 220 kV CB X152 at George Town Substation.

Transend subsequently investigated the reasons for protection operation that occurred during the work on the protection scheme at George Town Substation. There was an incorrect labelling of a cable within the bus zone protection wiring which the test procedures had not identified. The cable labelling is now corrected and the test procedures are modified.

Contractors are currently reviewing the control and protection settings of the Nyrstar equipment. The TVGCS has been reconfigured, and excludes Nyrstar load blocks since 1 January 2013.
