POWER SYSTEM OPERATING INCIDENT REPORT – SYDNEY WEST 330KV B1 BUSBAR TRIP ON 10 DECEMBER 2012

PREPARED BY: System Performance and Commercial

DATE: 20 February 2013

FINAL

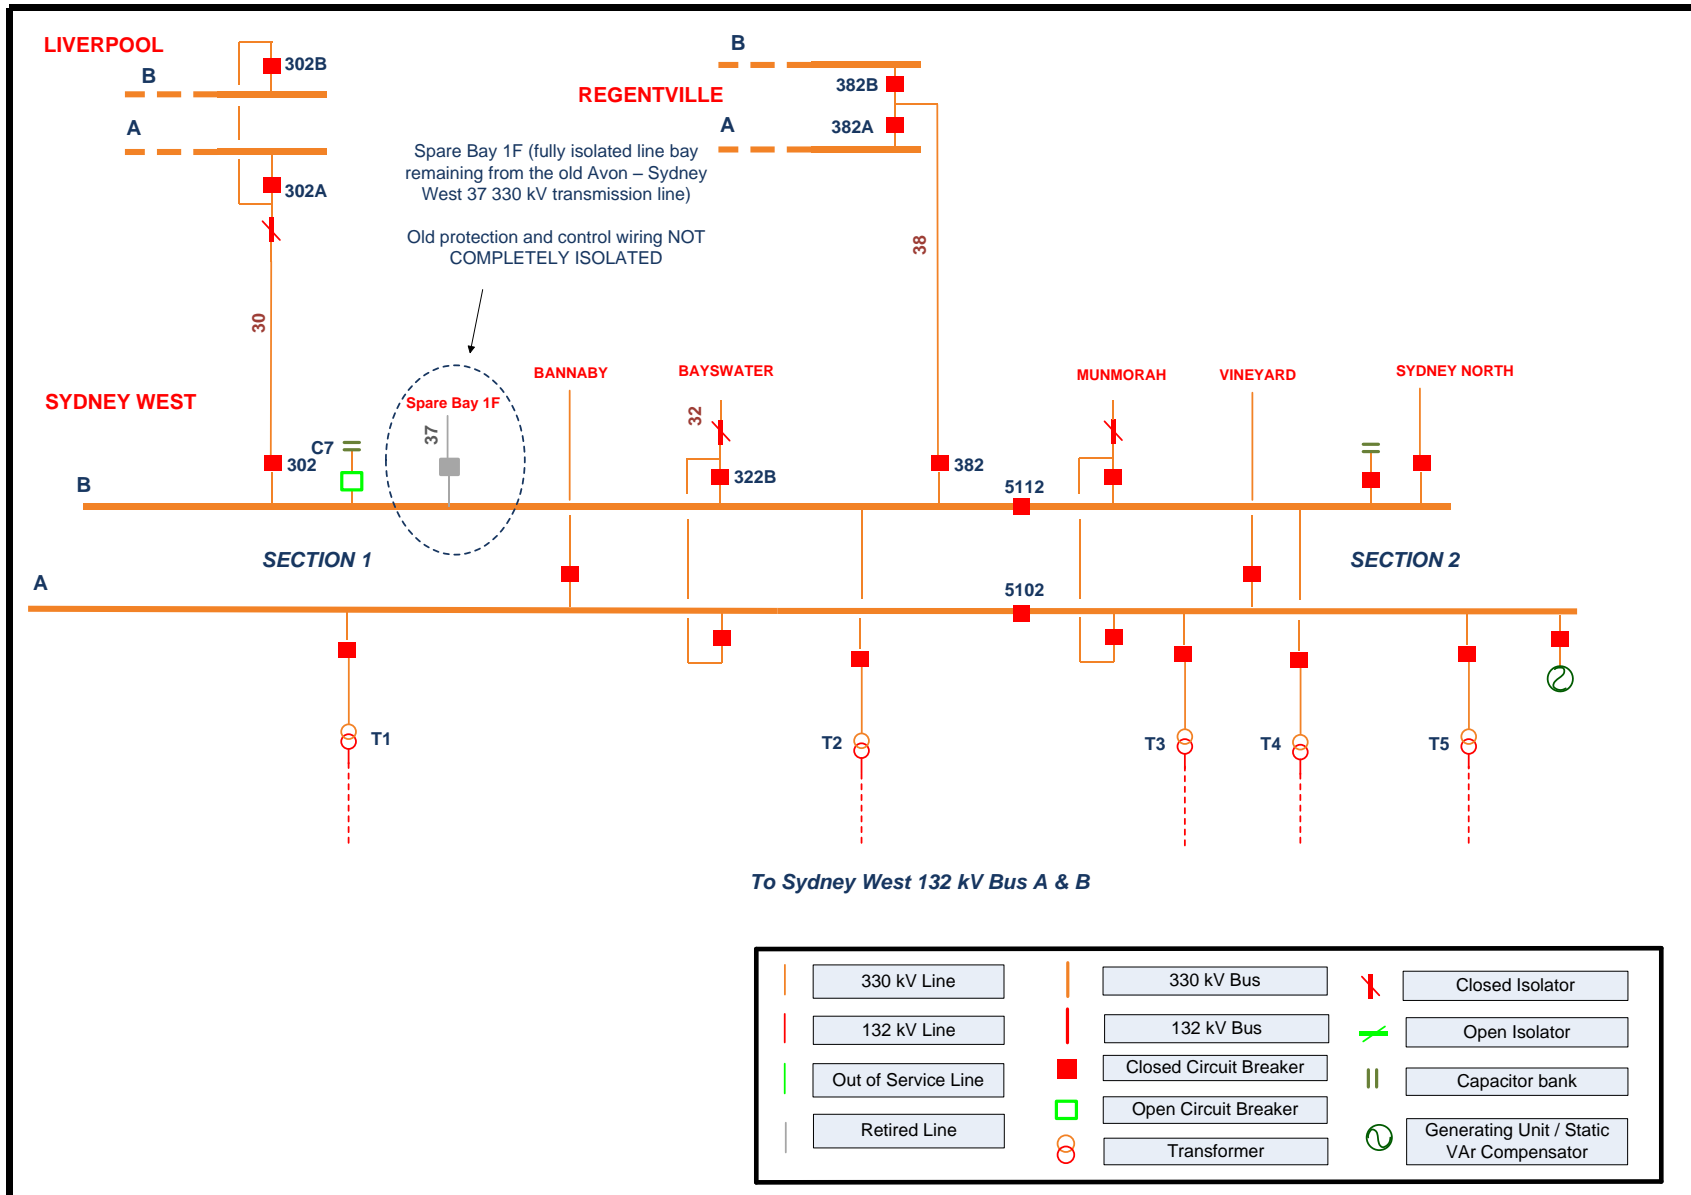
Figure 1 - Status of the power system prior to the busbar trip

The status of the power system prior to the incident is shown in Figure 1. For clarity only equipment relevant to this incident has been included in the diagram.

Note that the C7 Capacitor was disconnected from the B1 330 kV busbar at Sydney West prior to the incident.

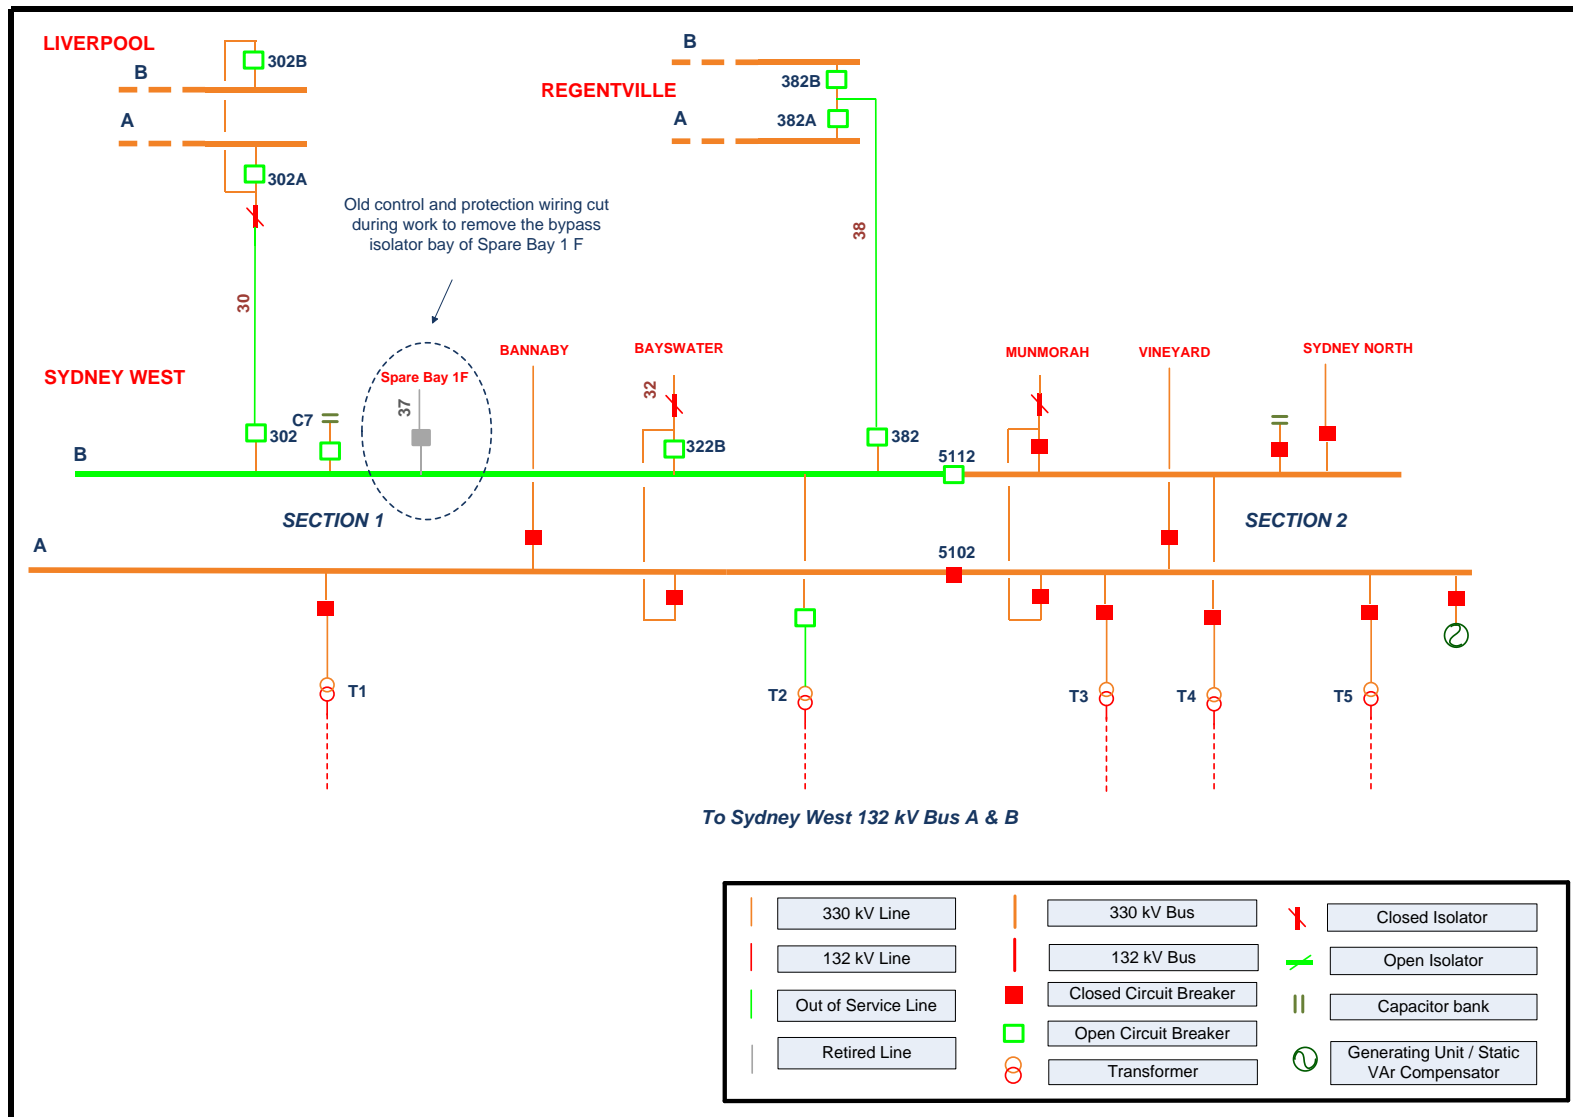
Figure 2 - Status of the power system immediately after the incident

At 1002 hrs on the 10 December 2012, old protection and control wiring associated with the line bay of the retired Avon – Sydney West 37 330 kV transmission line (Spare Bay 1F) at Sydney West was cut during work to remove the line bypass isolator bay of Spare Bay 1F.²

Cutting the wiring resulted in a trip signal being sent to the B1 330 kV Sydney West busbar protection, tripping the busbar. The Sydney West – Liverpool 30 and the Sydney West – Regentville 38 330 kV transmission lines and the T2 330/132 kV transformer were off-loaded as a result of the busbar trip. The circuit breakers at the remote ends of each of these transmission lines also opened, de-energising these transmission lines³. The Sydney West – Bayswater 32 330 kV transmission line remained on-load via section 1 of the 330 kV A busbar. Figure 2 shows the status of relevant circuit breakers and transmission lines after the busbar tripped.
