MULTIPLE CONTINGENCY EVENT FOLLOWING AN EARTHQUAKE IN VICTORIA ON 19 JUNE 2012

PREPARED BY: Systems Capability

DATE: 15 January 2013

FINAL (Version 3)

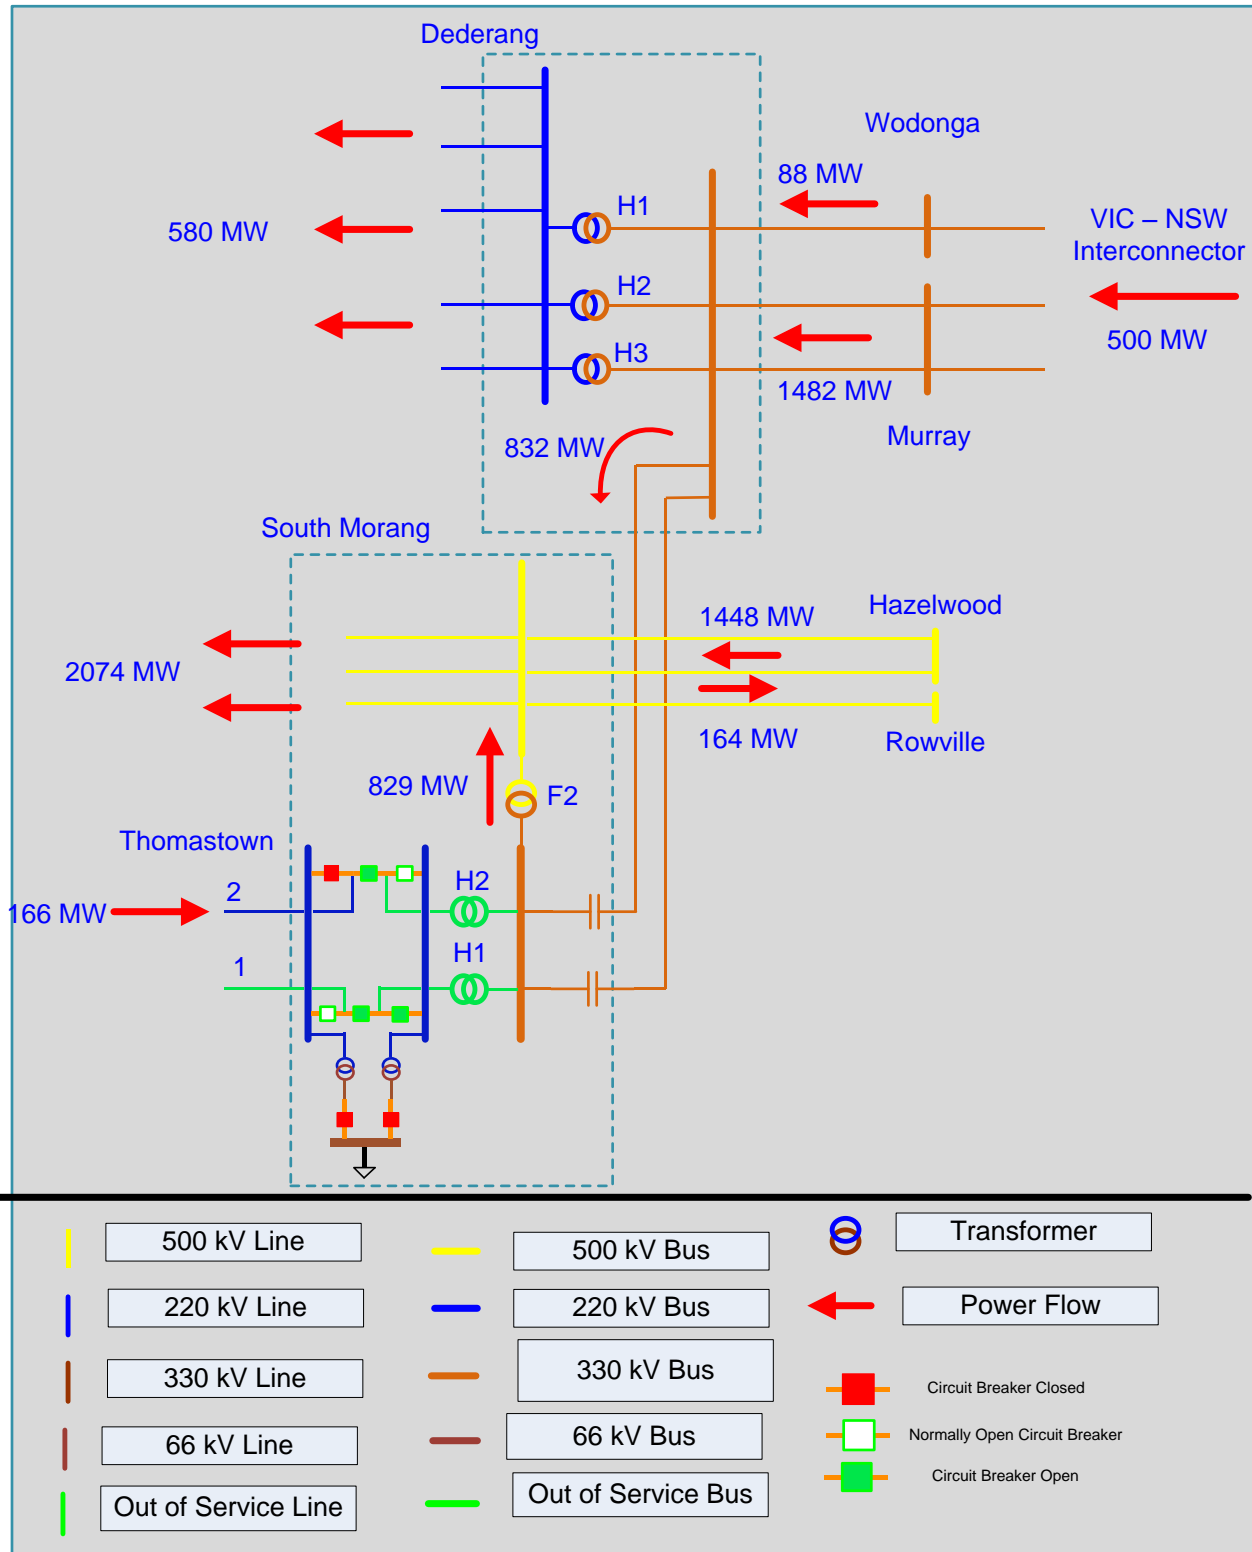
Figure 4 Post event system conditions

The South Morang H1 and H2 transformers tripped at 2054 hrs on Buchholz relay operation. Due to the switching arrangement at the South Morang station, the No.1 South Morang – Thomastown 220 kV transmission line also de-loaded with the H1 transformer. Figure 4 shows the state of the network following the event.

After further investigation, SP AusNet advised that the earth tremors triggered an oil surge within the transformers causing the Buchholz relay operation. SP AusNet has advised that the type of Buchholz relay used at South Morang is exclusive to the South Morang station. SP AusNet found no evidence of damage to the transformers or associated plant. In addition, inspection and checks carried out on the Buchholz relays found the Buchholz relays to be operating correctly.

SP AusNet has advised that due to the low probability of earthquakes in the region and based on its cost/benefit analysis, there are no immediate plans to replace the Buchholz relays. However, the South Morang H1 and H2 transformers are expected to be replaced within the next 10 years subject to regulatory approval.

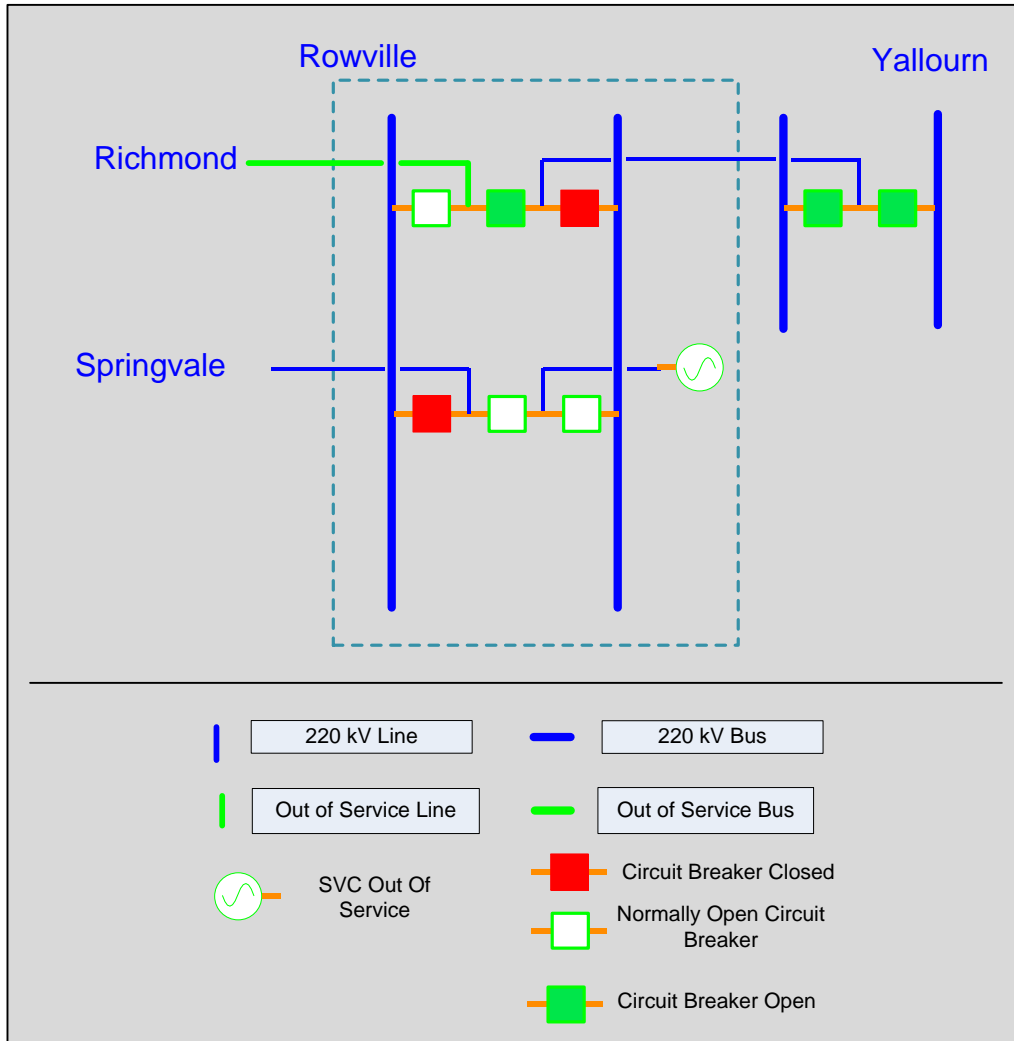
Figure 6 Post event system conditions

At 2118 hrs, approximately 25 minutes after the earthquake, the No.5 Rowville – Yallourn 220 kV transmission line tripped on X and Y protection at both ends of the transmission line. The line auto reclosed at the Rowville end as a result of the Single End Auto Reclose (SEAR) function at Rowville. Due to the switching configuration at Rowville terminal station, the No.4 Rowville - Richmond 220 kV transmission line was also unloaded. The state of the power system following the incident is shown in Figure 6.

At 2125 hrs, the V-ROYP5_R constraint set was invoked by AEMO. The No.4 Rowville – Richmond 220 kV transmission line was restored at 2152 hrs by closing the CB at the Rowville end. The Yallourn end of the Rowville – Yallourn 220 kV transmission line was restored at 0051 hrs on 20/06/2012 after a line patrol was completed by SP AusNet staff and found no cause of a fault.

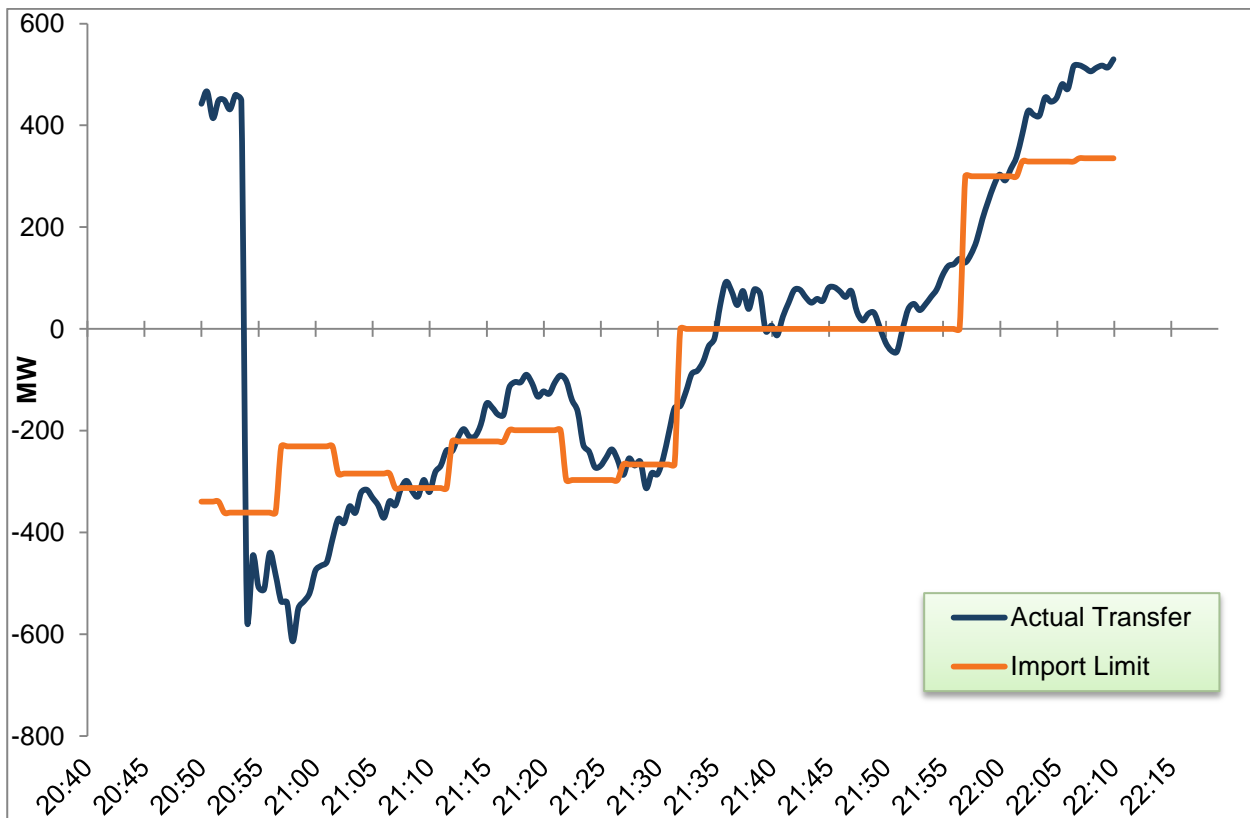
Figure 7 Victoria - New South Wales Interconnector Flows

Prior to the event, Victoria was transferring approximately 430 MW into New South Wales. Following the tripping of the generating units, the interconnector flow reversed with New South Wales transferring approximately 500 MW to Victoria, representing a change of approximately 930 MW. The limit at this time was set by voltage stability constraints for flow out of NSW. Given the revised technical envelope these limits were no longer applicable.

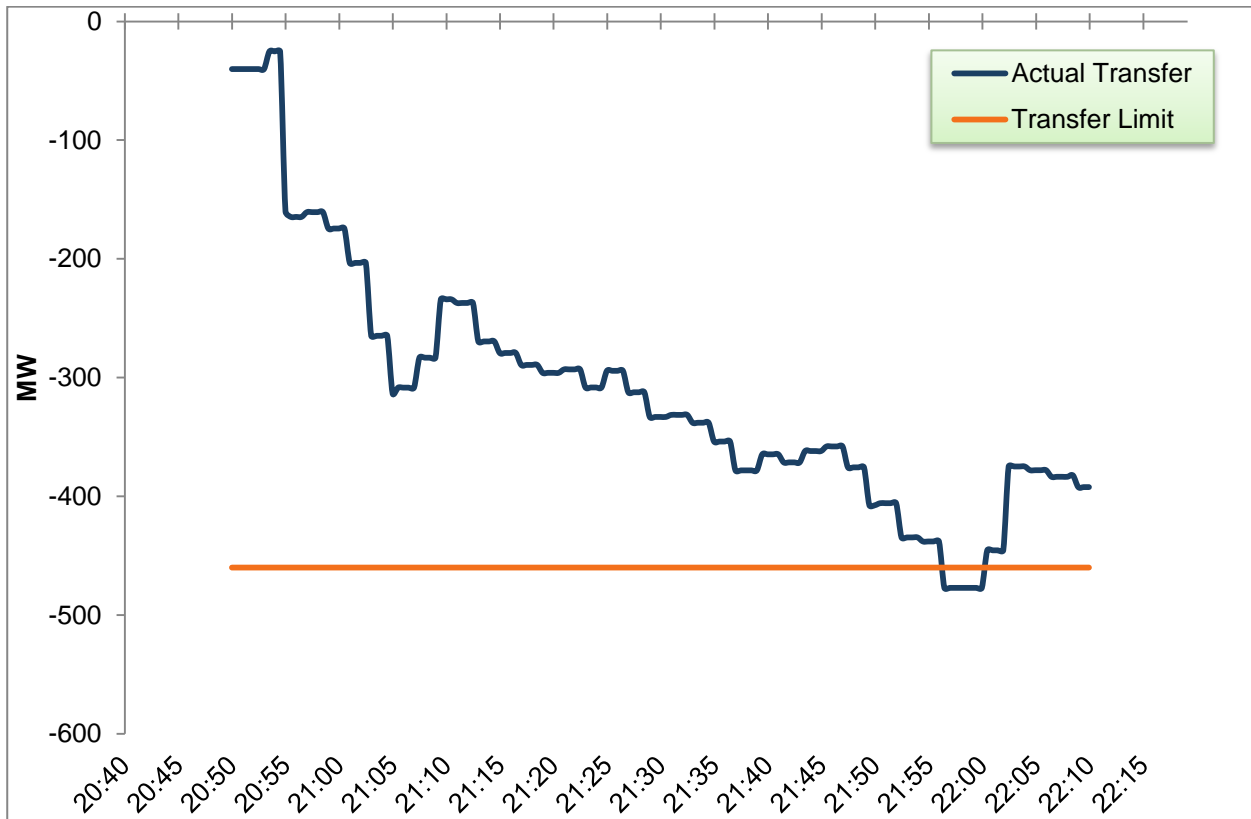
Figure 8 Victoria - South Australia Interconnector Flows

At the time of the event, South Australia was transferring approximately 15 MW to Victoria. The transfer increased to approximately 180 MW immediately following the event, representing a change of approximately 195 MW. The transfer eventually increased up to the transfer limit of 460 MW at 2155 hrs as the transfer from NSW was reduced. The transfer limit was set by the S>V_NIL_HYTX_HYTX thermal constraint equation to avoid overloading the remaining Heywood 275/500 kV transformer for the trip of the other Heywood 275/500 kV transformer.

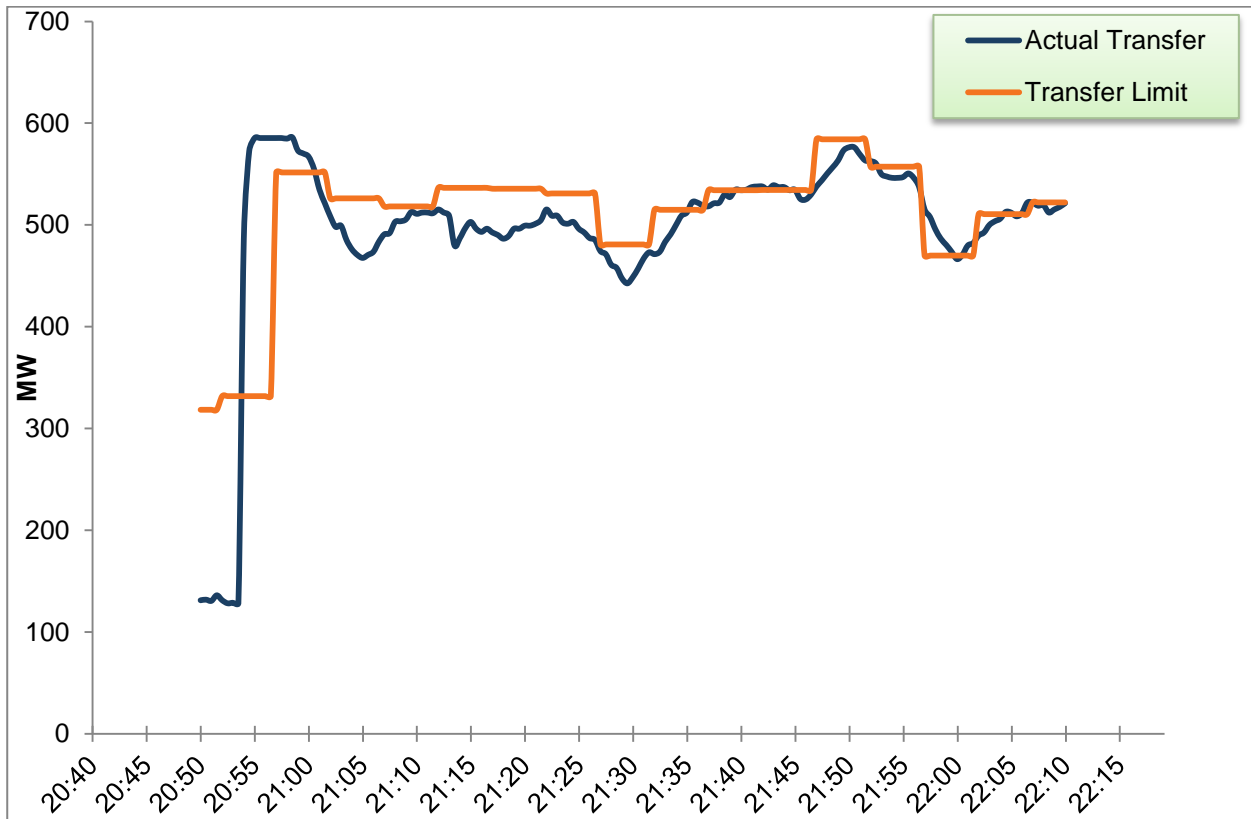
Figure 9 Basslink Flows

Prior to the event, Tasmania was transferring about 130 MW to Victoria. In response to the frequency excursion in Victoria, the interconnector increased power flow into Victoria close to its design limit at approximately 580 MW, representing a change of approximately 450 MW. The transfer exceeded the transfer limits set by FCAS requirements, for short durations due to the normal action of the Basslink frequency controller.

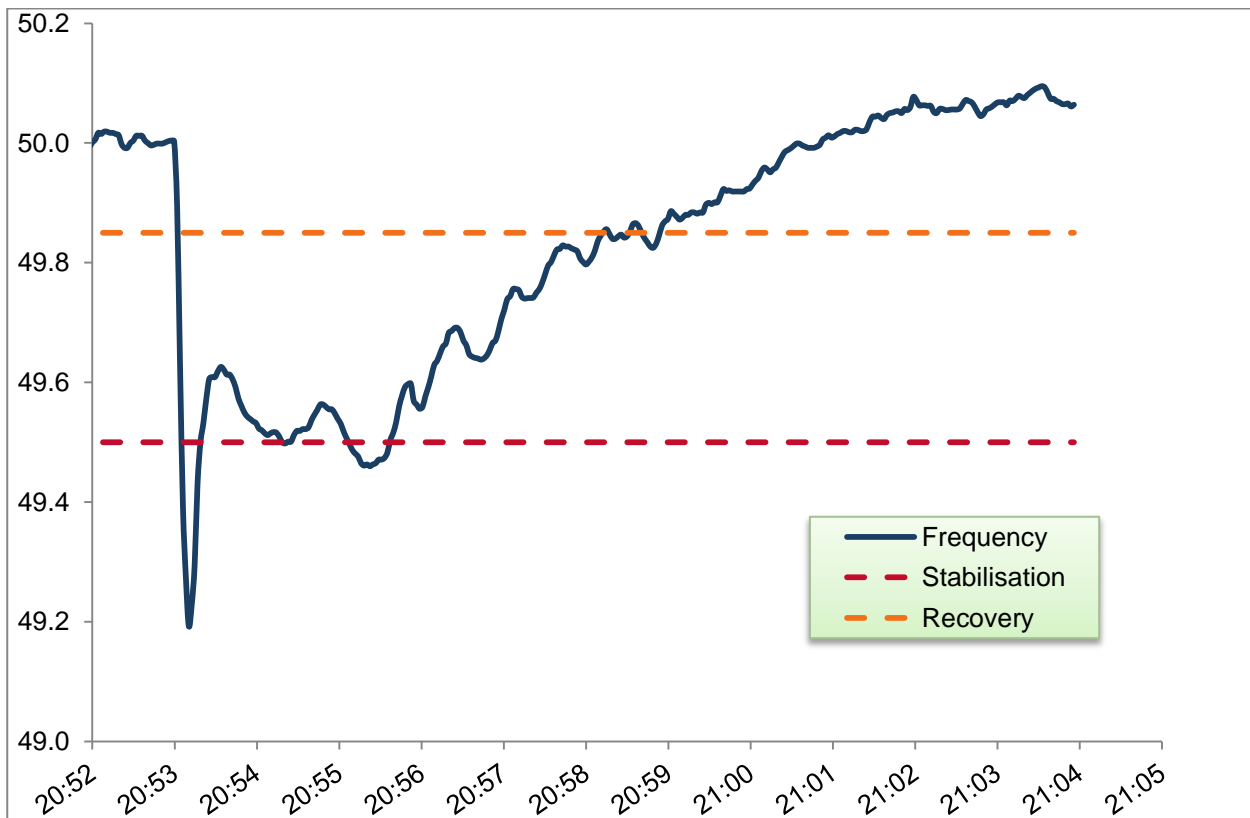
Figure 10 Mainland frequency on 19 June 2012

The power system frequency in the Mainland fell to a minimum of 49.2 Hz at 20:53:54 hrs. The power system responded to bring the system frequency back within the stabilisation lower limit in

approximately 14 seconds. However, the system frequency fell below the stabilisation lower limit again after 122 seconds which is in violation of the Mainland FOS.

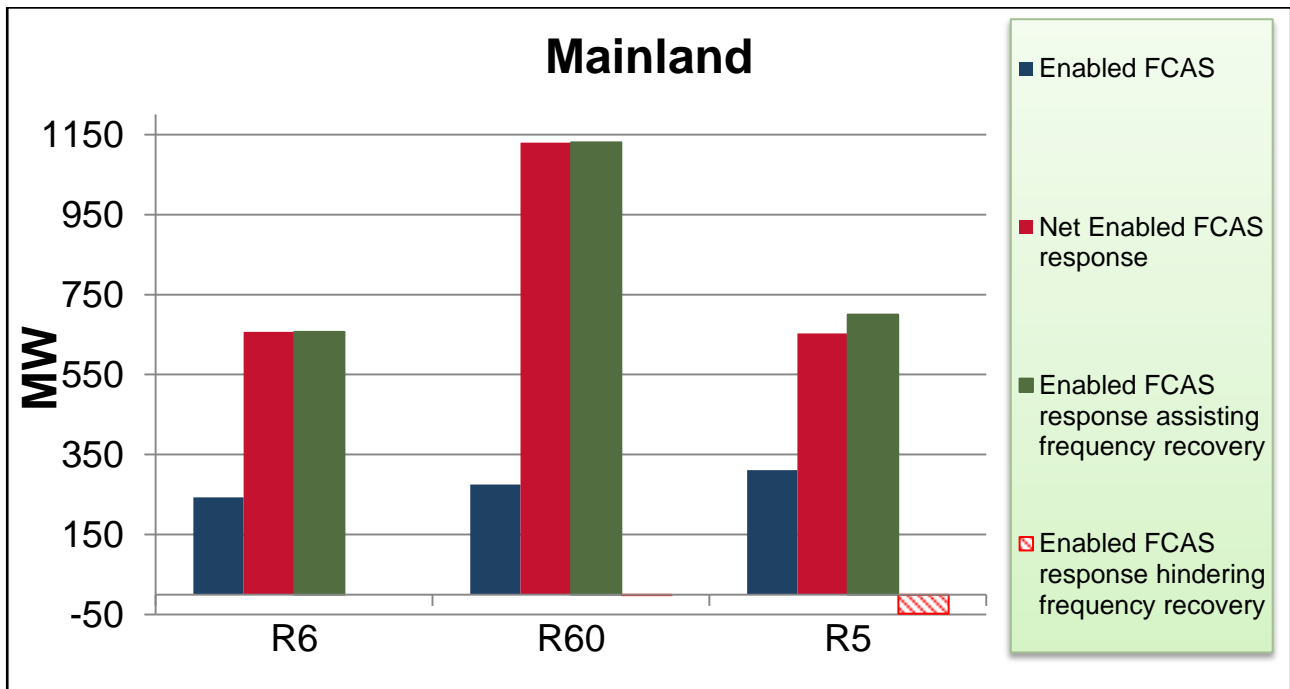
Figure 11 Mainland FCAS raise service enabled on 19 June 2012.

The amount of FCAS that is enabled is only sufficient to cover any single credible contingency event⁷. Approximately 243 MW of R6 was enabled but 657 MW was effectively delivered from the enabled units to assist in frequency recovery. For the R60 service, approximately 275 MW was enabled but 1130 MW was delivered from the enabled units. With regards to the R5 service, 311 MW was enabled but 700 MW was delivered from the enabled units to help increase the frequency.

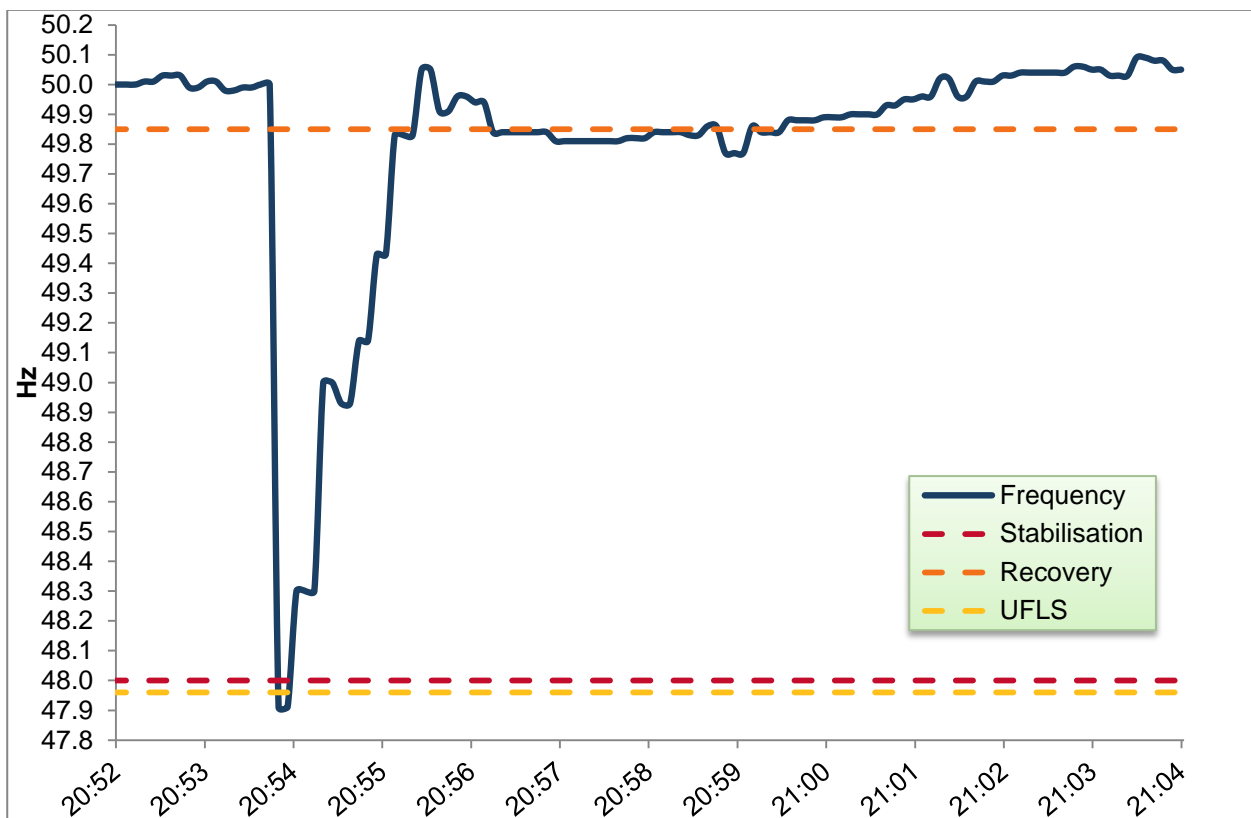
Figure 12 Tasmania frequency on 19 June 2012

The loss of approximately 1955 MW from the Mainland resulted in a drop in Mainland frequency. The Basslink frequency controller responded as expected to increase the export from Tasmania from approximately 130 MW to 580 MW into Victoria. This resulted in a frequency excursion in the Tasmanian frequency from 49.99 to 47.95 Hz.

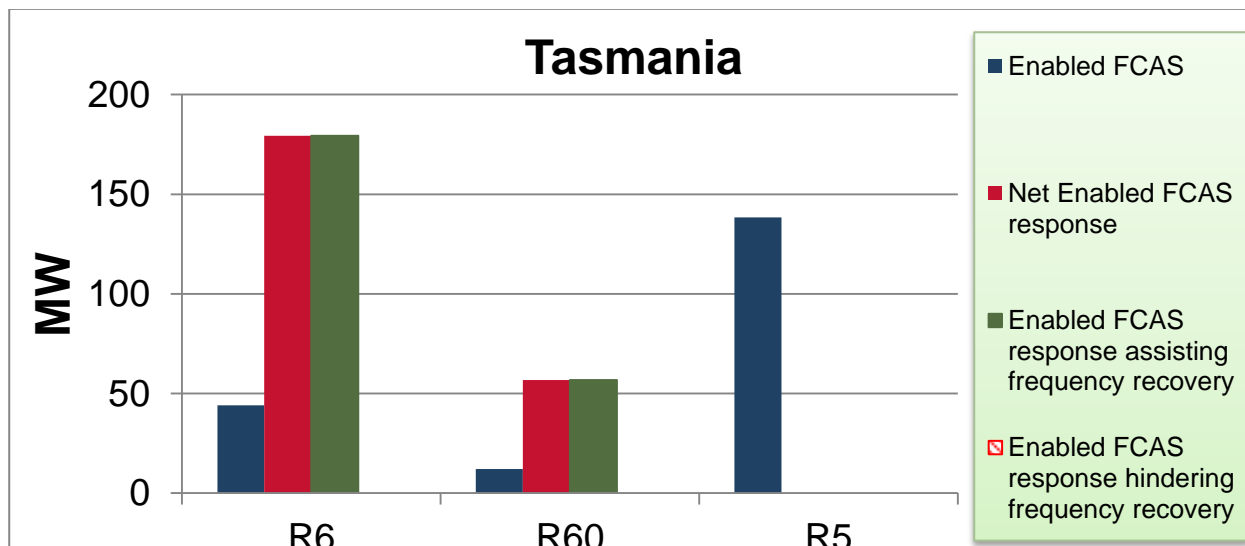
Figure 13 Tasmania FCAS raise service enabled on 19 June 2012

The amount of FCAS that is enabled is only sufficient to cover any single credible contingency event. Approximately 44 MW of R6 was enabled but 179 MW was effectively delivered to assist in frequency recovery. For the R60 service, approximately 12 MW was enabled but 57 MW was delivered. With regards to the R5 service, 138 MW was enabled but none was delivered.
