POWER SYSTEM OPERATING INCIDENT REPORT – MULTIPLE ELEMENT TRIP AT CAPITAL SUBSTATION ON 8 JANUARY 2013

PREPARED BY: System Performance and Commercial

DATE: 6 May 2013

FINAL

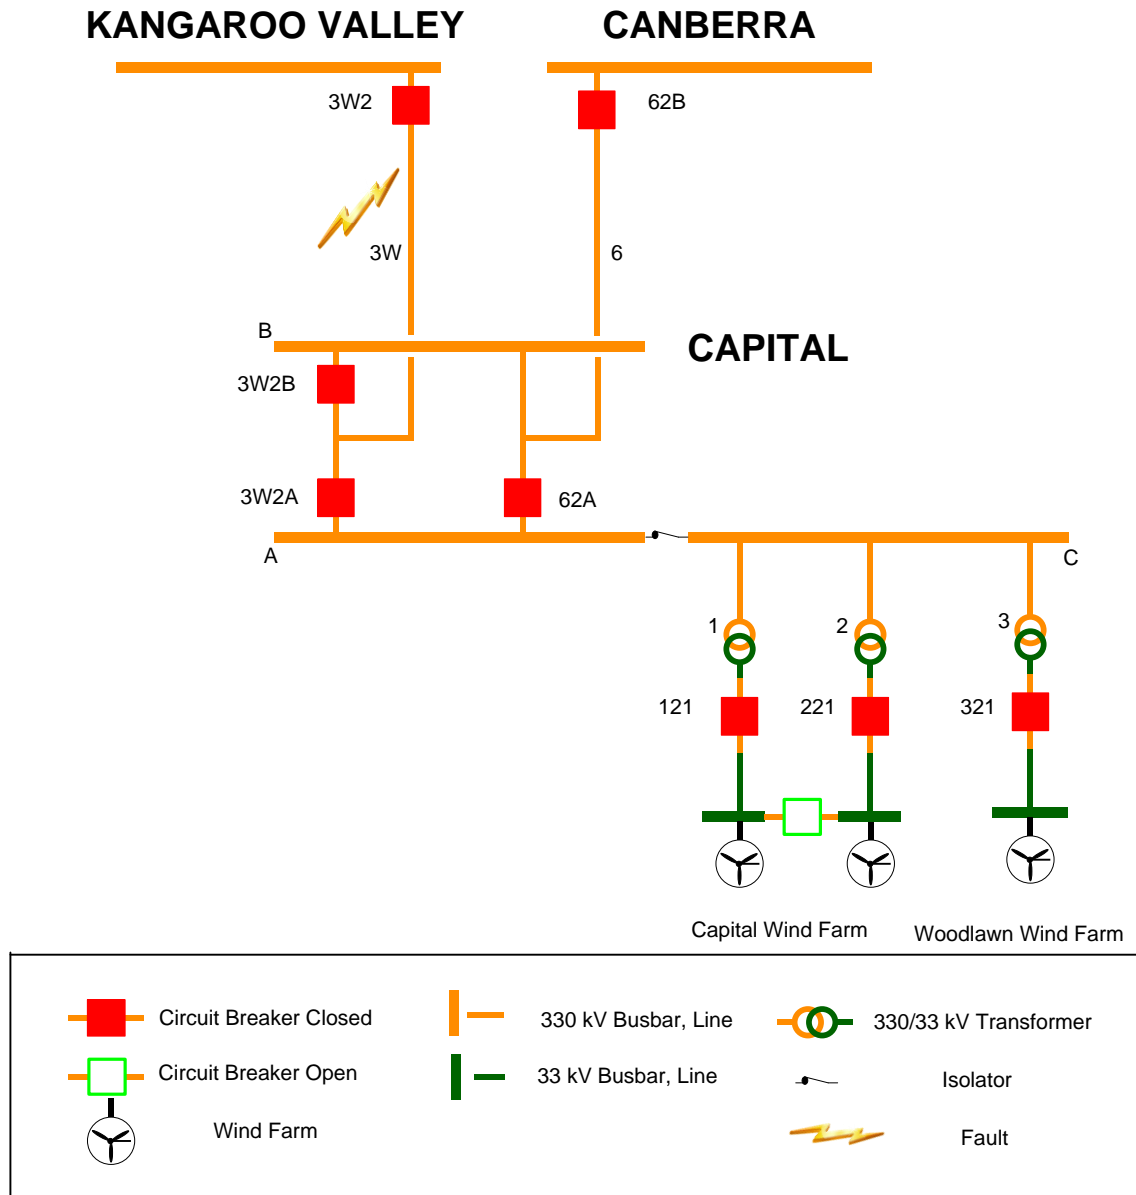
Figure 1- Status of the power system prior to the incident

The status of the power system prior to the incident is shown in Figure 1. For clarity only equipment relevant to this incident has been included in the diagram.

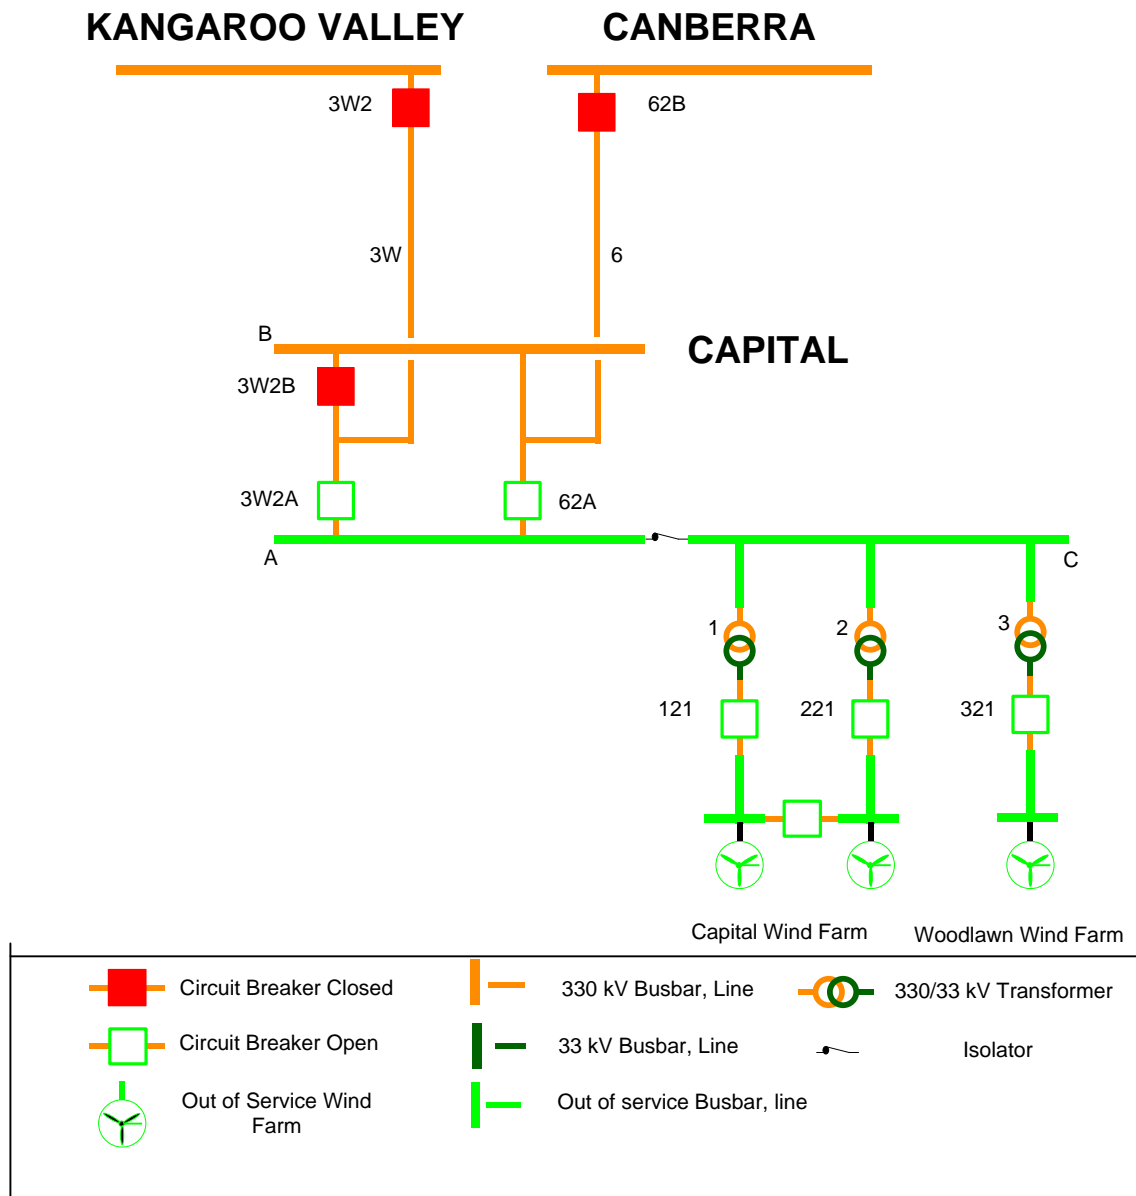
Figure 2 - Status of the power system after the trip at 1346 hrs

At 1346 hrs on 8 January 2013, a high impedance phase to earth fault on the Capital - Kangaroo Valley 3W 330 kV Transmission Line was detected by protection systems. Trip signals were initiated to open the following elements as designed to clear the fault:

- 330 kV Circuit Breaker (CB) 3W2 at Kangaroo Valley Substation opened within 190 ms
- 330 kV CB 3W2A and CB 3W2B at Capital Substation opened within 240 ms

During the process of clearing the fault on the Capital - Kangaroo Valley 3W 330 kV Transmission Line, the earth fault protection on No.2 33/330 kV Transformer at Capital Substation was triggered. As a result, the following elements opened which cleared the A and C 330 kV Busbars at Capital Substation:

- 330 kV CB 62A at Capital Substation (Canberra - Capital 6 330kV Transmission Line remained energised from B 330 kV Busbar at Capital Substation)
- 33 kV CB 121 and CB 221 at Capital Substation (opening the line to the Capital Wind Farm)
- 33 kV CB 321 at Capital Substation (opening the line to the Woodlawn Wind Farm)

The Capital and Woodlawn wind turbines tripped on high voltage protection as designed.

After several seconds, the Capital - Kangaroo Valley 3W 330 kV Transmission Line auto-reclosed as designed onto the B 330 kV Busbar at Capital Substation.

The status of the power system immediately after the incident is shown in Figure 2.

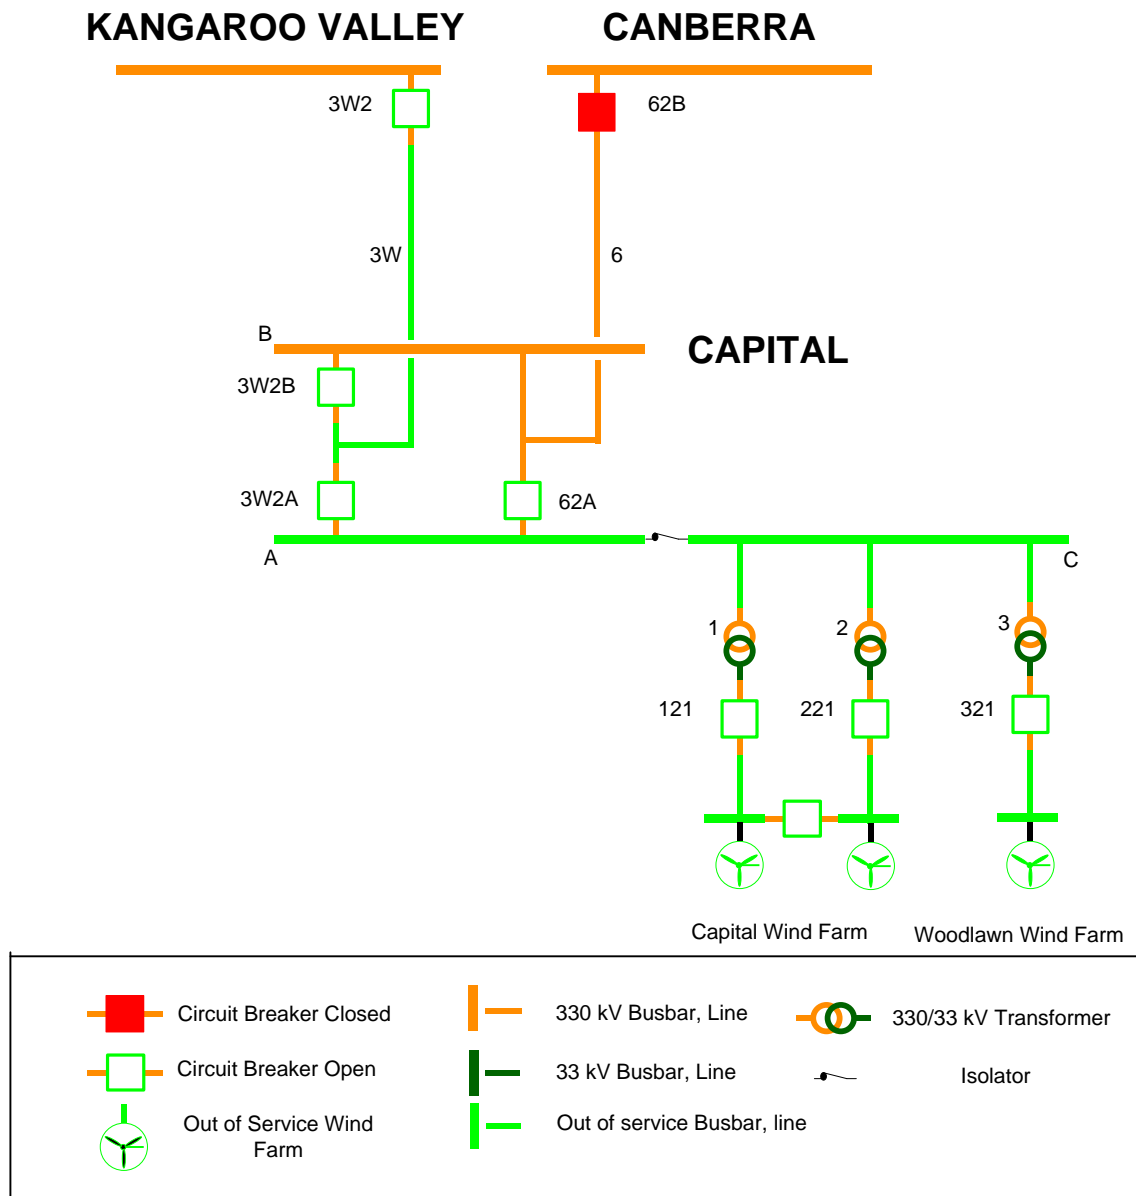
Figure 4 Status of the power system after the trip at 1406 hrs

At 1406 hrs, another high impedance phase to earth fault on the Capital - Kangaroo Valley 3W 330 kV Transmission Line was detected by protection systems. The Capital – Kangaroo Valley 3W 330 kV Transmission Line tripped to lockout.¹

Figure 3 shows the status of the power system after the trip at 1406 hrs.
