Power System Operating Incident Report – Trip of Murray – Lower Tumut No.66 330 kV Transmission Line at Murray End Only on 18 November 2013

PREPARED BY: AEMO Systems Capability

DATE: 13 December 2013

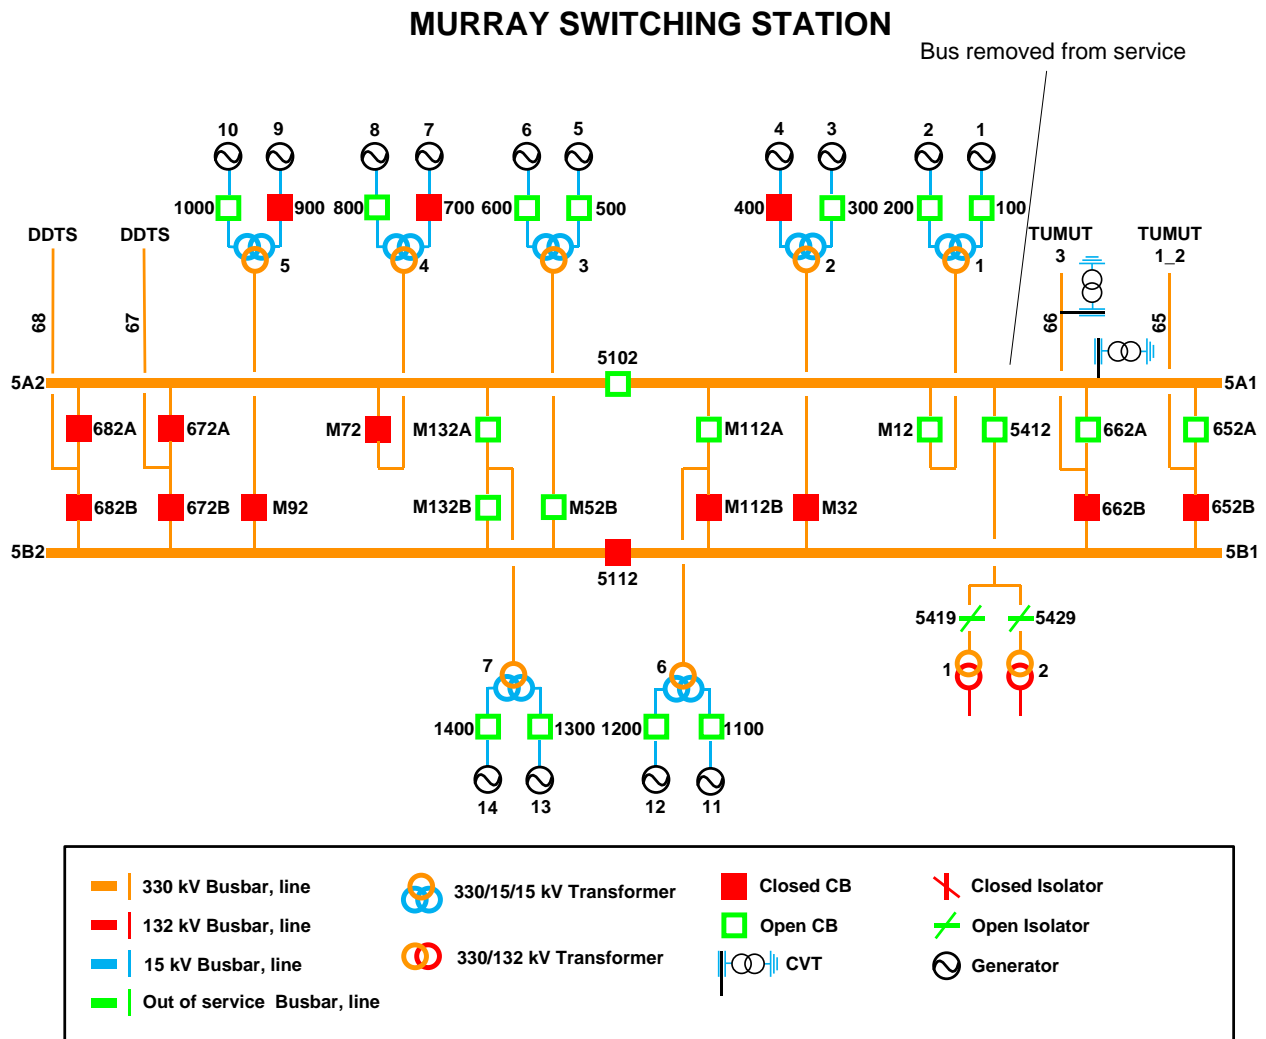
Figure 1 - Status of the power system prior to the incident

The status of the power system prior to the incident is shown in Figure 1. For clarity only equipment relevant to this incident has been included in the diagram. The diagram shows No. 5A1 330 kV busbar at MSS out of service for planned work.

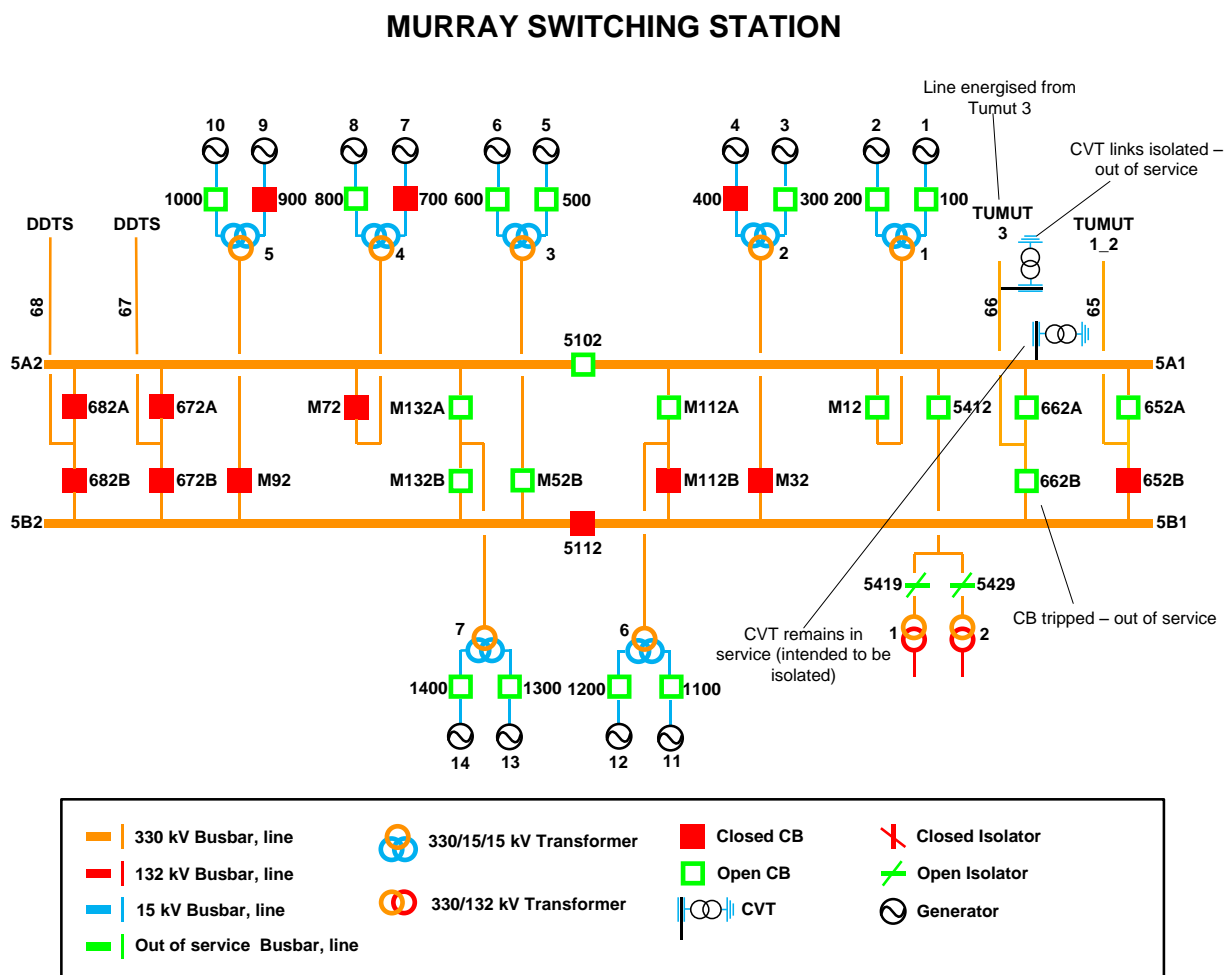
Figure 2 - Status of the power system immediately after the incident

The status of the power system immediately after the incident is shown in Figure 2. The diagram shows the 330 kV CB 662B at MSS open and the Murray – Tumut 3 No. 66 330 kV transmission line energised from the Tumut end.

The cause of the trip was immediately identified by TransGrid, and the links to the CVT were restored. At 1731 hrs the 330 kV CB 662B at MSS was reclosed manually by TransGrid. This prompt response obviated the need for AEMO to invoke constraints to manage power system security. TransGrid then advised AEMO that the cause of the event had been identified, resolved and was unlikely to reoccur.
